# **Evaluation and Recommendations for Bear Run Passive Treatment Systems, Bloss Township, Tioga County**

**Technical Report provided by Hedin Environmental through the  
Trout Unlimited AMD Technical Assistance Program**

**May 2009**

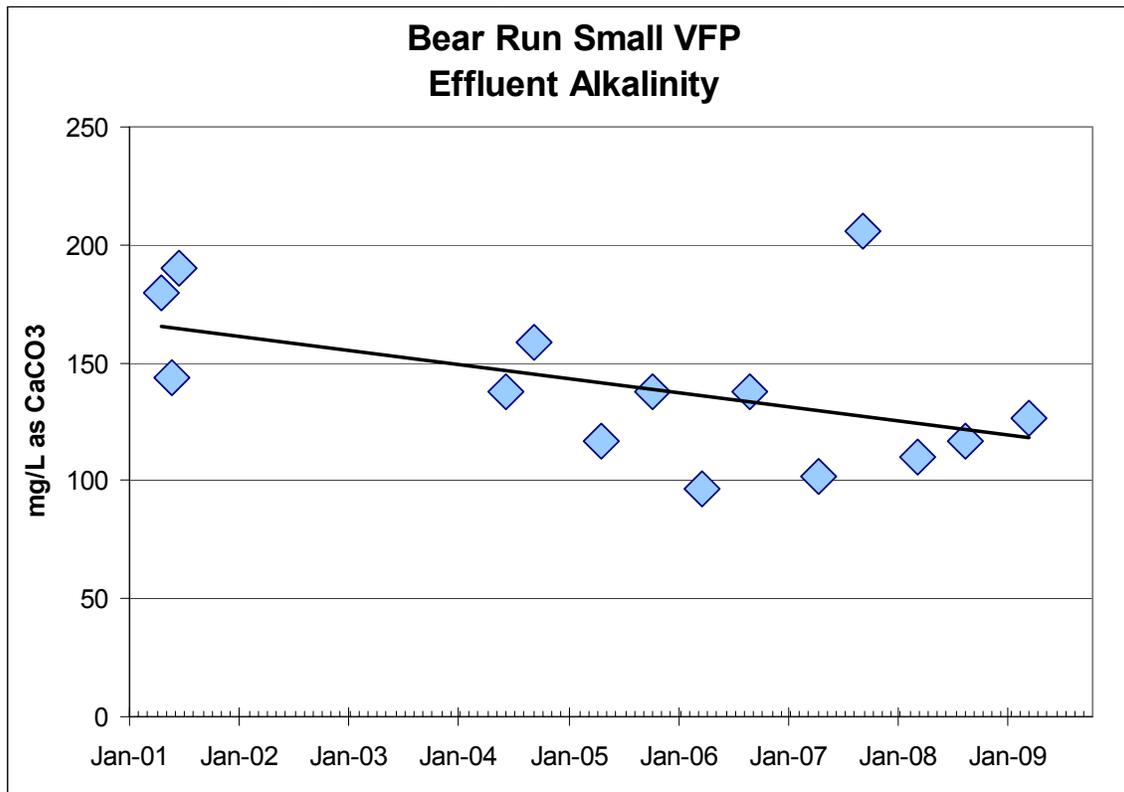
Figure 2. Small VFP effluent alkalinity over time

The Small VFP is not overloaded in terms of acidity per unit area with an average loading of 17 (g/m<sup>2</sup>)/day. Typically, VFPs are designed to receive 35-40 (g/m<sup>2</sup>)/day of acidity loading. The modest loading rate has allowed for highly reliable performance for nearly a decade. However, a trend of decreasing effluent alkalinity is apparent in the data (Figure 2). The trend is gradual and is a natural part of the life cycle of passive treatment systems. Future maintenance is required to maintain treatment system effectiveness but the risk of net acidic discharge is quite small for years to come.

The existing sampling regimen should be continued. Effluent alkalinity is perhaps the most significant parameter to consider for these systems. While a downward trend exists, any significant deviation from that trend should trigger additional sampling.

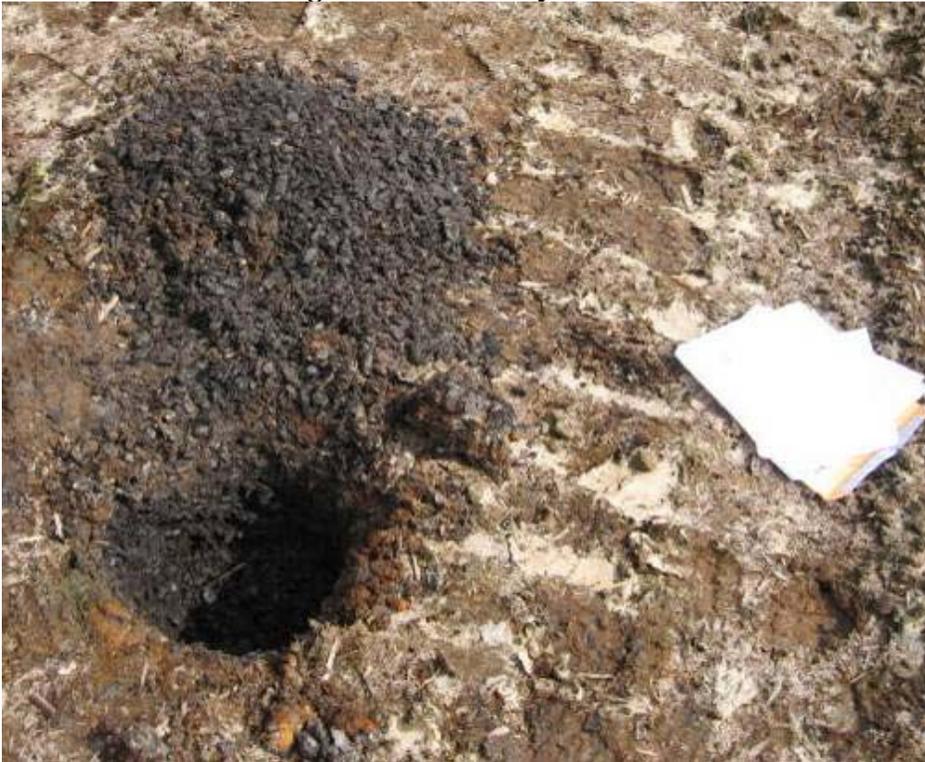
On March 27, 2009 the Small VFP was drained to allow access to the system's contents for investigation. A shovel was used to dig holes through the organic substrate layer to the top of the limestone layer. The thickness of the organic substrate layer was found to be approximately 18 inches or 6 inches less than what was originally specified. This is likely the result of compaction and consumption of the materials by the treatment process. Photo 1 shows one of the holes. The organic substrate layer contained very little visible SMC and was made up largely of limestone aggregate and wood chips. Only minor metals accumulation was noted on the top of the organic substrate layer. The material has compacted over time and has reduced permeability, though not enough to prevent treatment of the full discharge flow.

**Photo 1. Small VFP organic substrate layer contents**

The recommended action is to physically disturb the full thickness of the organic substrate layer in both systems. The specified thickness of the organic substrate layer was two feet. Test holes dug in the organic substrate layer reveal that it has compacted to approximately 18 inches. The full thickness of the organic substrate layer should be mixed to reestablish permeability. Care should be taken to produce a final surface that is regular, level and protected from compaction.

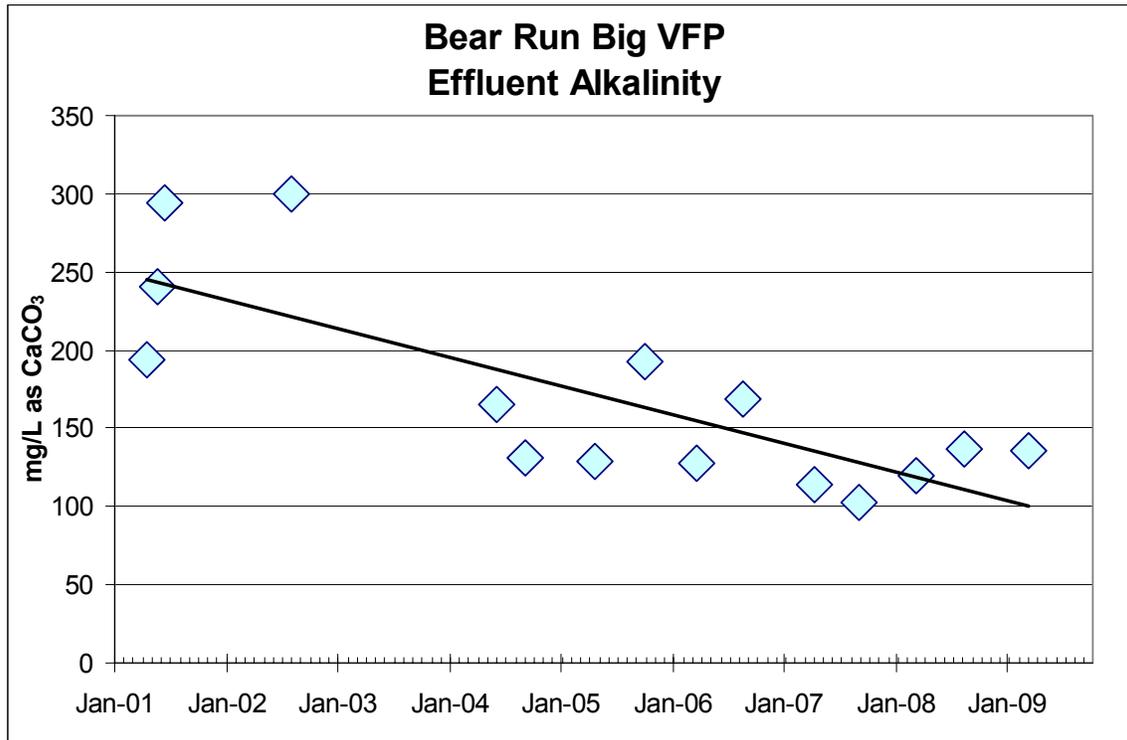
Figure 3. Big VFP effluent alkalinity over time

The Big VFP is not overloaded in terms of acidity per unit area with an average loading of 22 (g/m<sup>2</sup>)/day. Typically, VFPs are designed to receive 35-40 (g/m<sup>2</sup>)/day of acidity loading. The modest loading rate has allowed for highly reliable performance for nearly a decade. However, a trend of decreasing effluent alkalinity is apparent in the data (Figure 3). The trend is gradual and is a natural part of the life cycle of passive treatment systems. Future maintenance is required to maintain treatment system effectiveness.

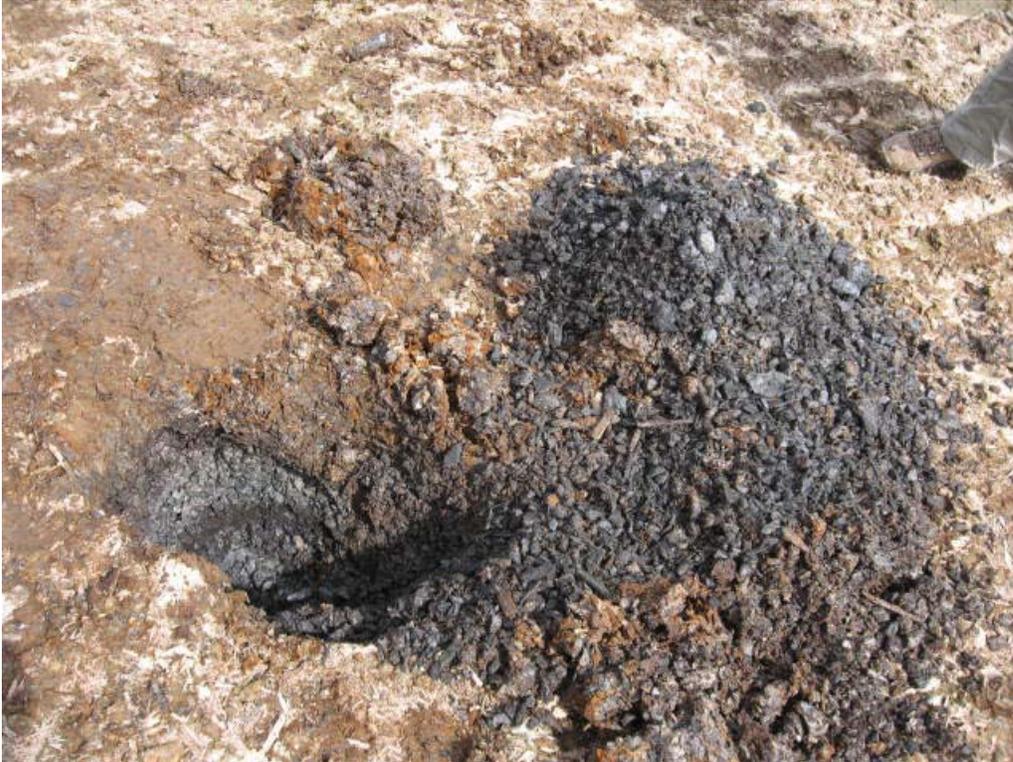
On March 27, 2009 the Big VFP was drained to allow access to the system's contents for investigation. A shovel was used to dig holes through the organic substrate layer to the top of the limestone layer. Photo 2 shows one of the holes. The organic substrate layer contained very little visible SMC and was made up largely of limestone aggregate and wood chips. What little SMC that was found occurred in a thin layer about one foot below the surface. This thin layer of SMC was probably an isolated pocket that wasn't completely mixed during construction. The top 2-3 inches of material was cemented with metals solids (Photo 3). Much of the organic substrate had standing water on top of it despite the fact that the system was drained (Photo 4). The permeability of the organic substrate layer is very low.

***Photo 2. Big VFP organic substrate layer contents***

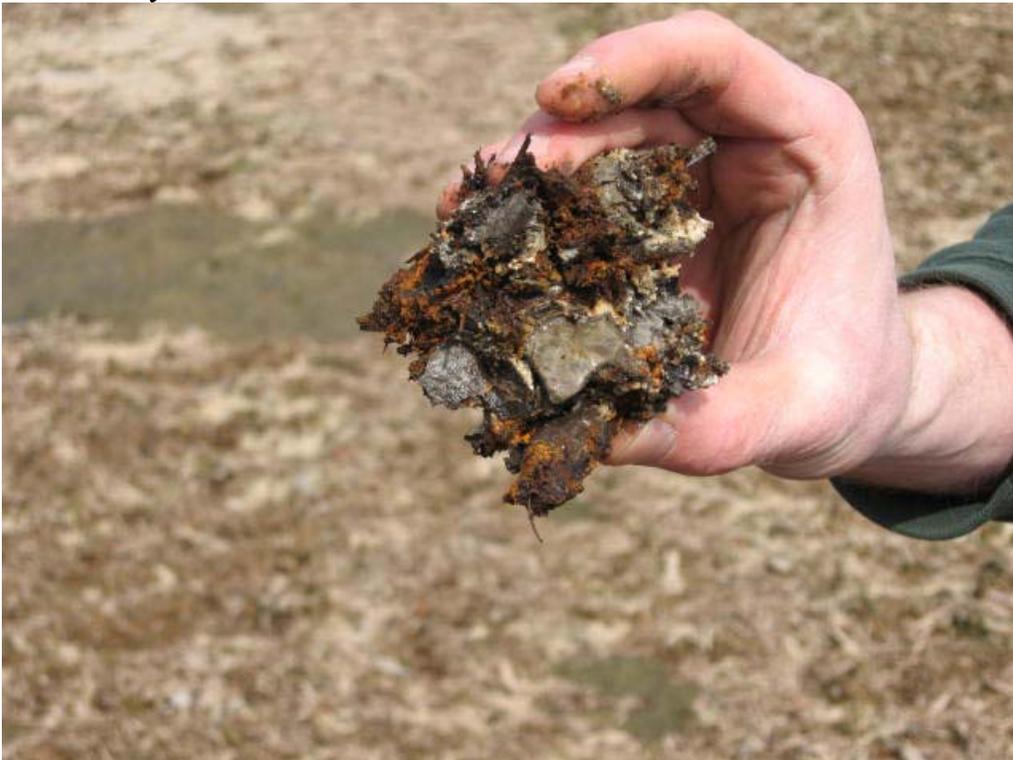
***Photo 3. Materials cemented by metals solids at the top of the Big VFP organic substrate layer***

The decline in acidity over time was largely driven by the 51% decline in iron concentration. This is critical to system maintenance interval because the permeability loss observed in the Big VFP appeared to be largely due to an accumulation of iron solids in the top 2-3 inches of the organic substrate layer. If the system receives less iron the time required for this problem to redevelop will be greater and thus so will the maintenance interval.

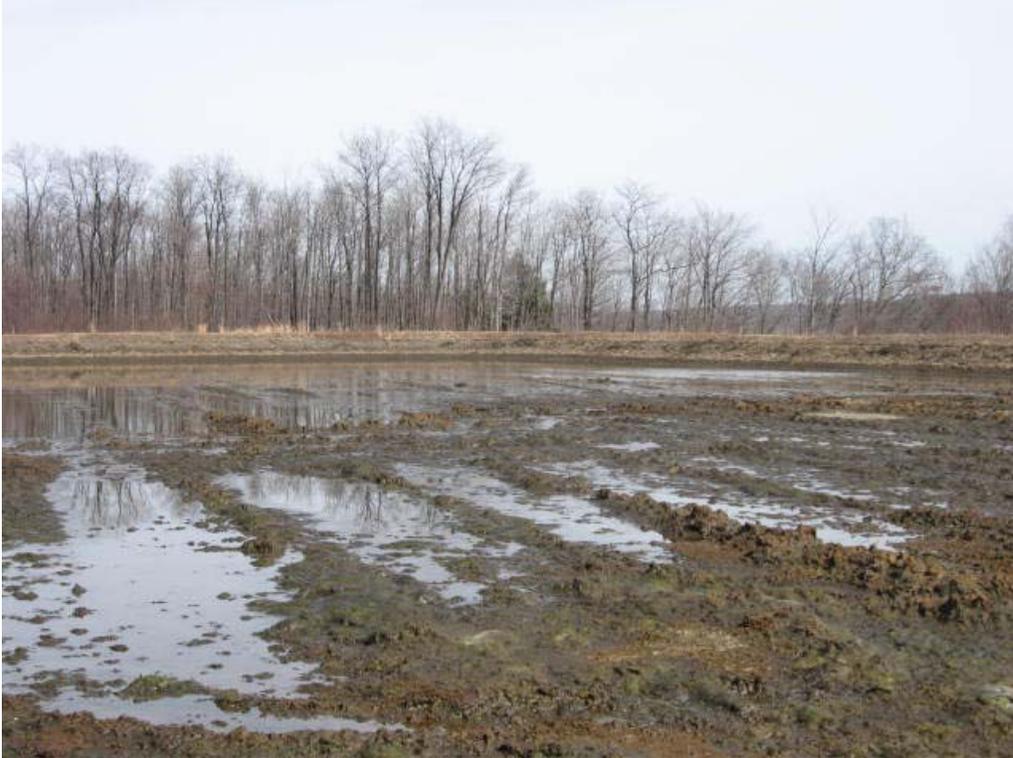
***Photo 4. Standing water on top of organic substrate layer in drained Big VFP***

Permeability loss is a major concern in the Big VFP. High flows frequently overwhelm the permeability of the system and untreated water is bypassed to the stream. The Small VFP is developing a similar permeability problem but it is not as apparent due to the fact that it does not receive large erratic flows.
