Pit 431 Passive Treatment System Autopsy and Recommendations, Glasgow, Cambria County

Technical report provided by Hedin Environmental through the Trout Unlimited Technical Assistance Program Project TUTAG-21 (Glasgow II)

June 2007

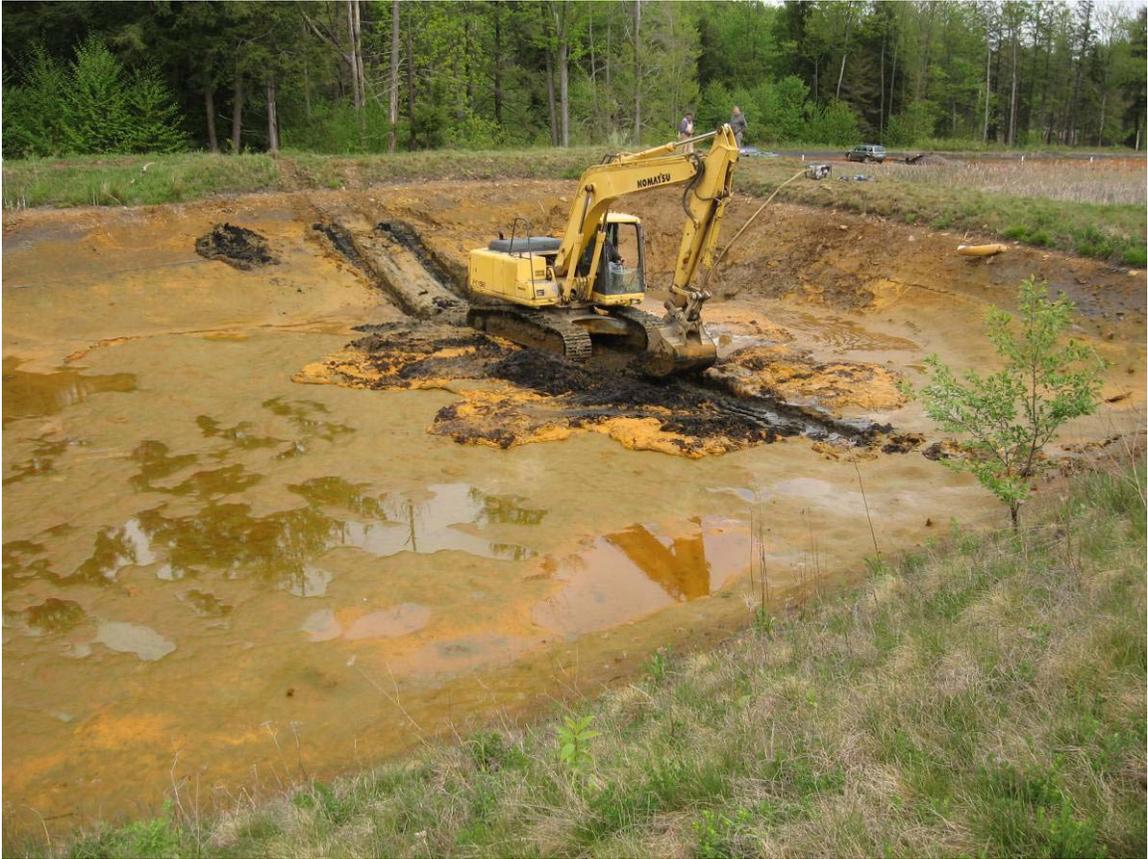
VFP 2 was plugged and could not be drained by gravity to allow for excavation of the substrate so the standing water was siphoned and pumped out. Only a few gallons per minute would flow from the flushing system. There was approximately 5 to 6 feet of water above the compost (Photo 1). This represents approximately three feet of head loss due to plugging (estimated from the apparent difference in elevation between the primary outlet pipe and the overflow pipe).

Two trenches were excavated into and through the substrate of VFP 2 (Figure 1). The first trench was dug parallel to the presumed location of the underdrain header at the north end of VFP 2 (Photo 1). The second trench was excavated approximately 40 feet to the south of and parallel to the first.

Photo 1. Excavating Trench 1. Note water line on berm. Water depth was approximately 5 to 6 feet above the compost.

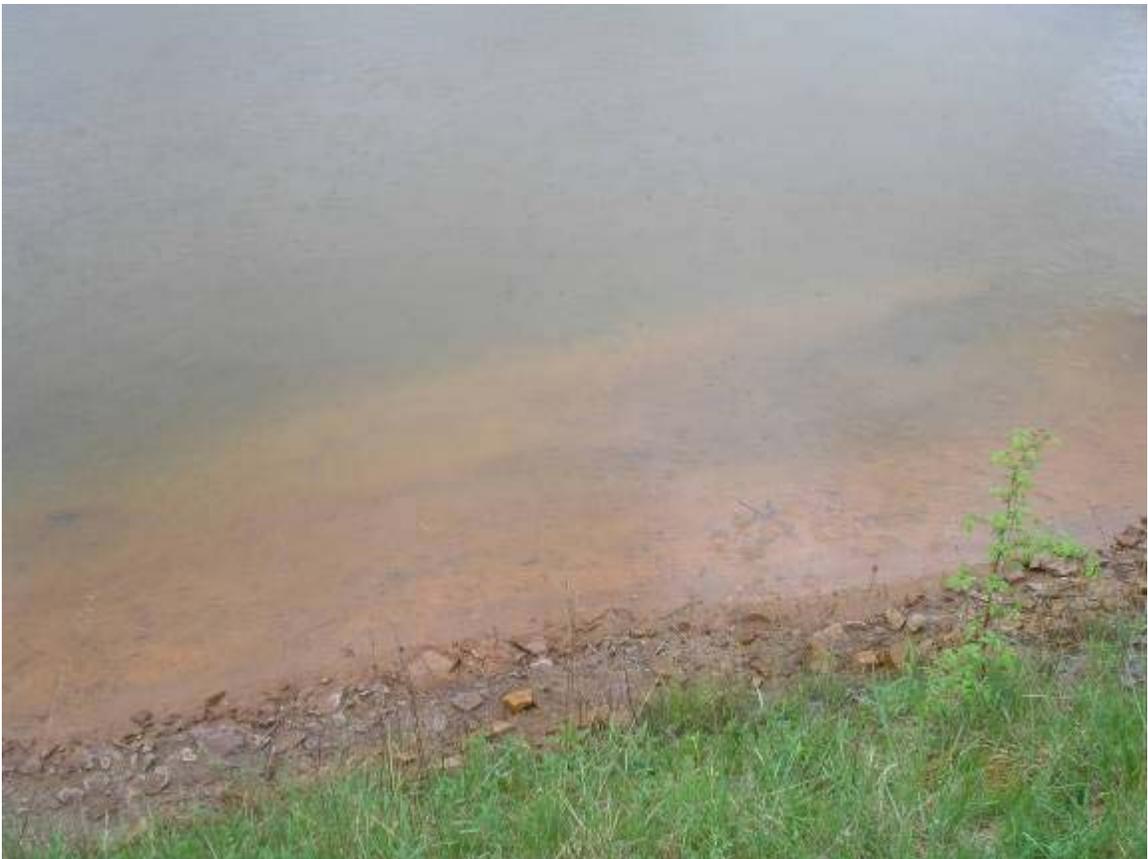
Photo 2 Minor turbidity in standing water caused by backflush of VFP 1

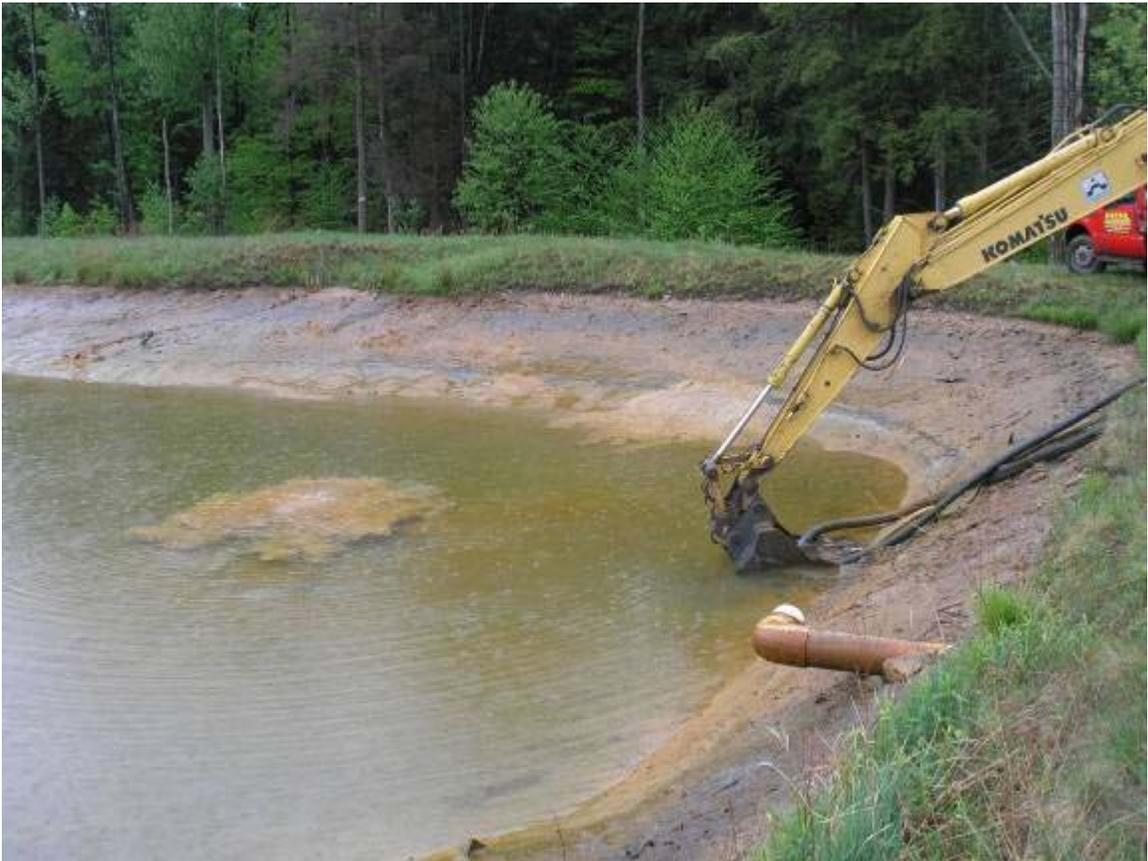
Photo 3 Turbidity caused by backflush of VFP 2. Note flow of water from berm just above the excavator bucket.

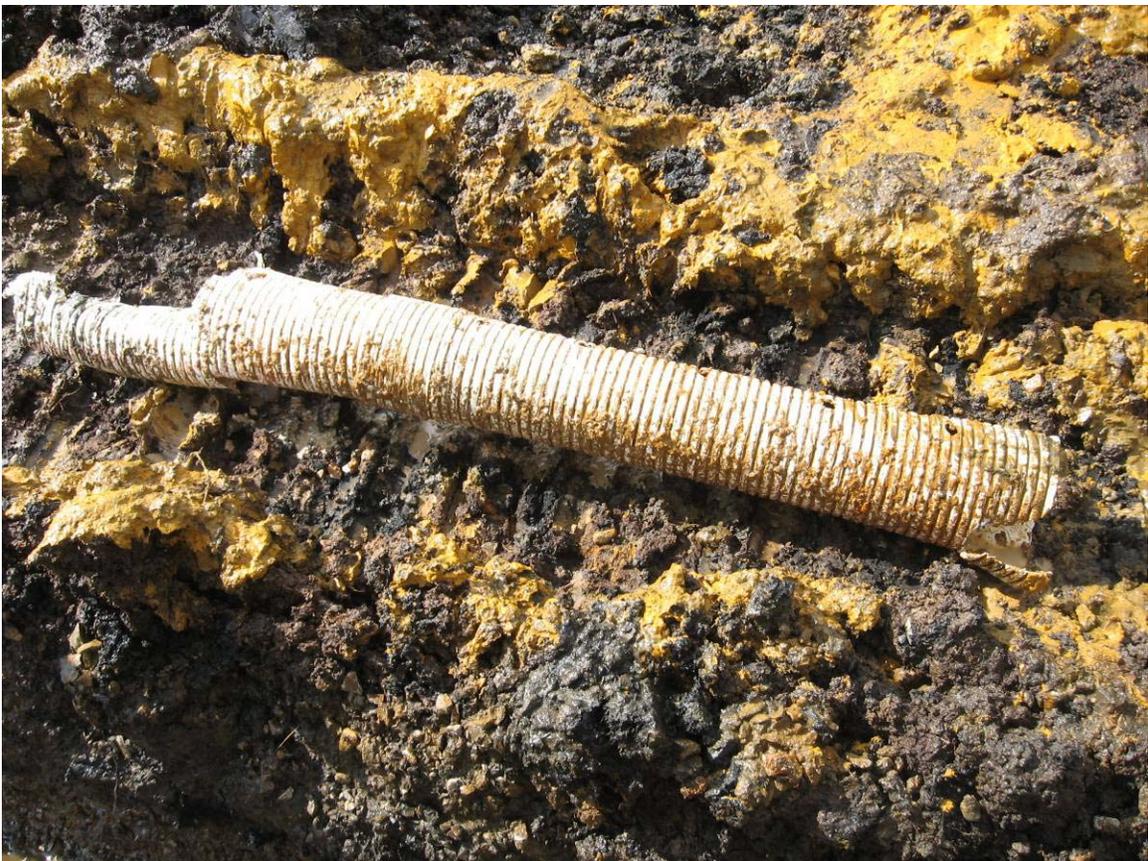
VFP 2 has only a single outflow pipe, and a single flushing pipe and valve. Two perforated laterals were located in trench 1 with a spacing of 21 feet. One of these laterals was near and parallel to the eastern side of the VFP while the second was approximately in the center of the VFP. It is assumed that at least one more lateral exists along the western edge of the VFP but it was not uncovered in order to prevent damage. The design had called for 5 laterals so two more may exist, but were not detected because the trench was not extended more than a few inches into the limestone in many places. The pipe itself was thin walled 4 inch corrugated PVC with two rows of 0.5 inch perforations at approximately the four and eight o'clock positions (Photo 4). Perforations were spaced 5 inches apart. The exact specification of the pipe is unknown but it was

unusually thin for this application. The thin walls of the pipe provided little feedback to the equipment operator and as a result the two laterals that were uncovered were broken. The pipe and the perforations were generally open and did not appear to be an impediment to flow.

Photo 4. Perforated pipe.

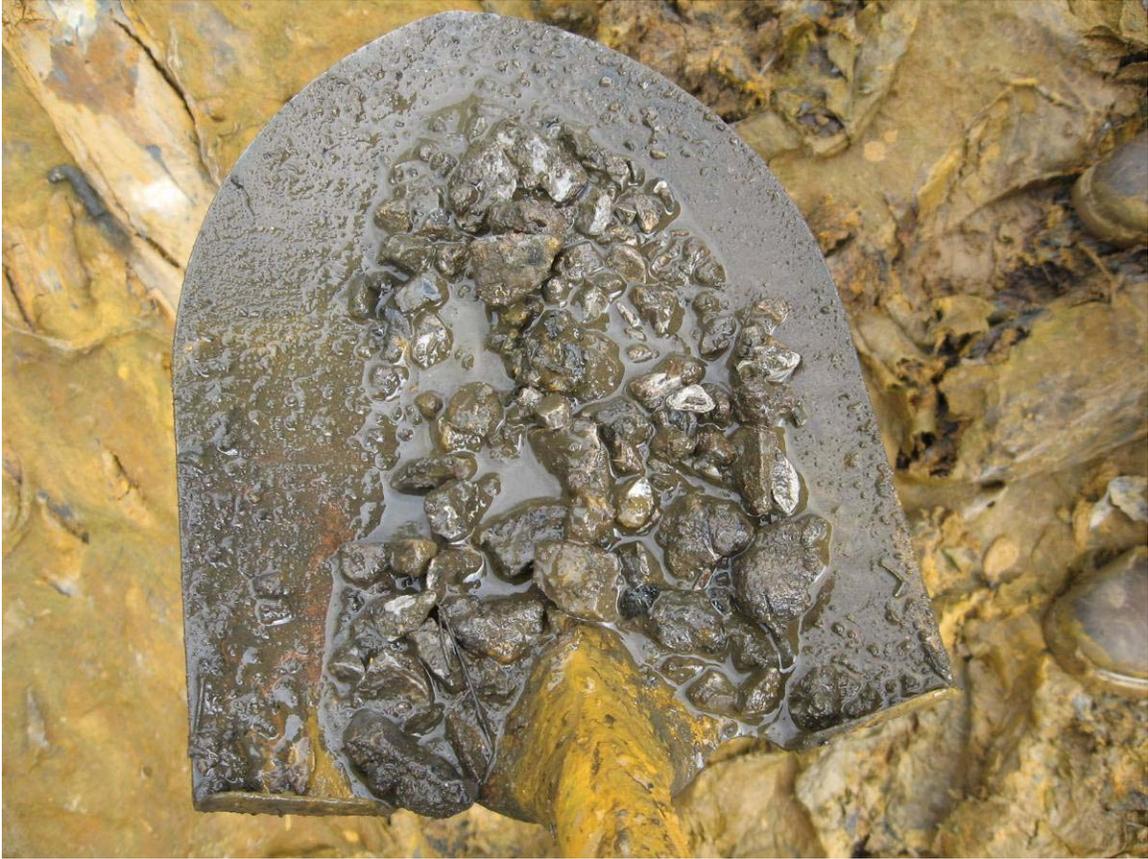
The limestone appeared to be 2b sized aggregate (all smaller than 1 inch diameter particles) as shown in Photo 5. This is an unusually small aggregate size for a VFP and likely contributed to the plugging problems. The thickness of the limestone layer varied from 6.5 inches to 1 foot. Aggregate thickness above the eastern lateral was only 2.5 inches (Photo 6).

Photo 5. Aggregate

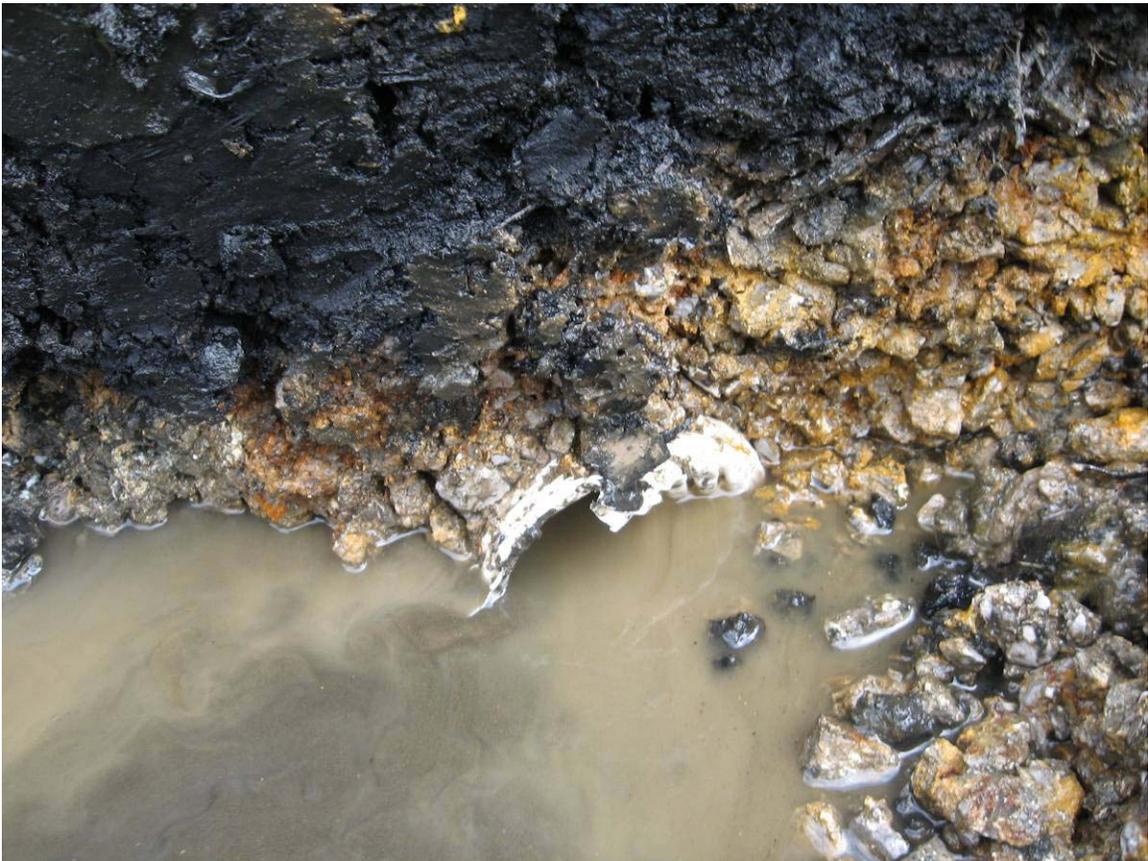
Photo 6. 2.5 inches of aggregate above eastern perforated lateral

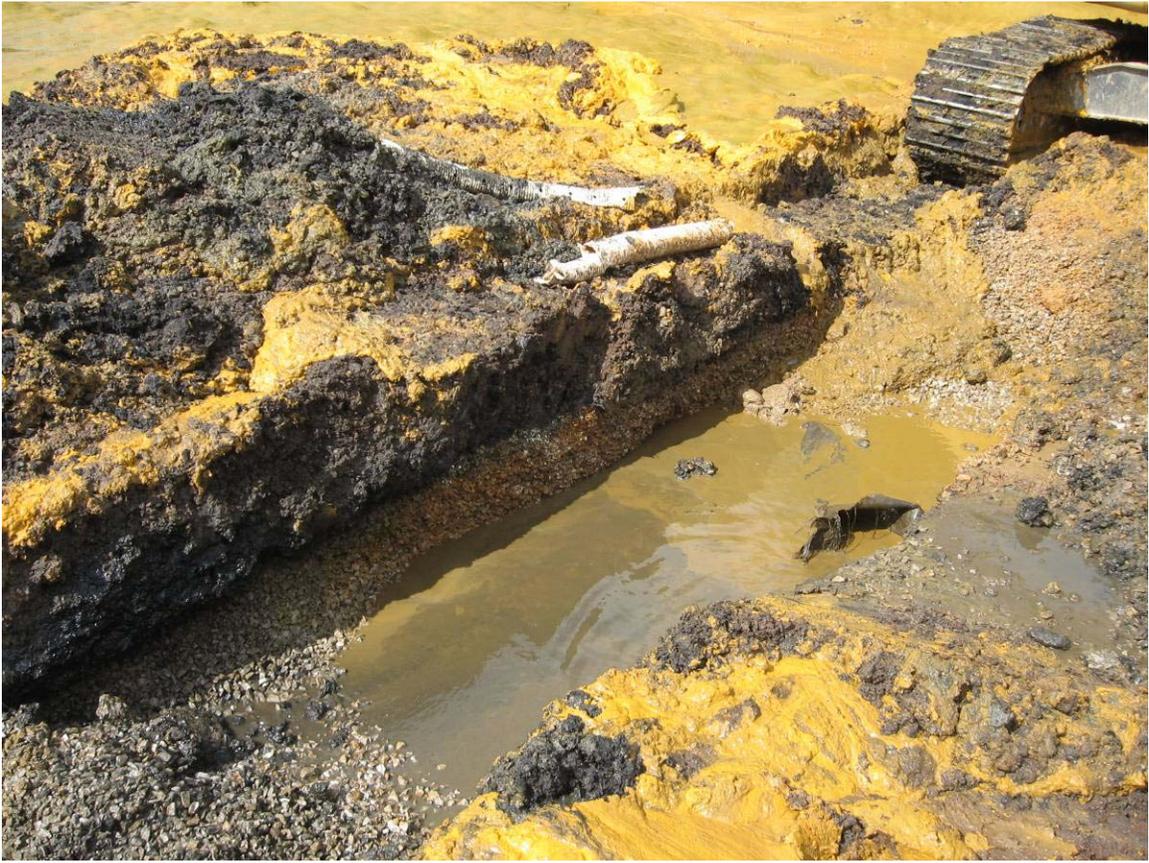
Staining of the limestone and solids deposition in the void spaces varied based upon distance from the underdrain plumbing. Aggregate within 3-4 feet of the perforated laterals was cemented with solids ranging in color from reddish orange to orange to white (Photo 7). The solids immediately above the pipe seemed to be where the reddish orange solids were concentrated. White solids were observed sporadically at and near the limestone-compost contact. Preliminary data indicates these are mostly Al hydroxide or similar material. Cementation of the limestone in the vicinity of the perforated laterals was such that digging the aggregate with a shovel was very difficult.

Limestone found mid-way between the perforated laterals was fairly clean and appeared to be in good condition (Photo 7). Here the aggregate had only a thin coating of whitish solids and could be easily dug into with a shovel. It appears that the zone of influence of each lateral was limited to 5-6 feet on either side with very little AMD flowing through the aggregate outside this zone (Photo 7).

Photo 7 Clean aggregate and fouled aggregate

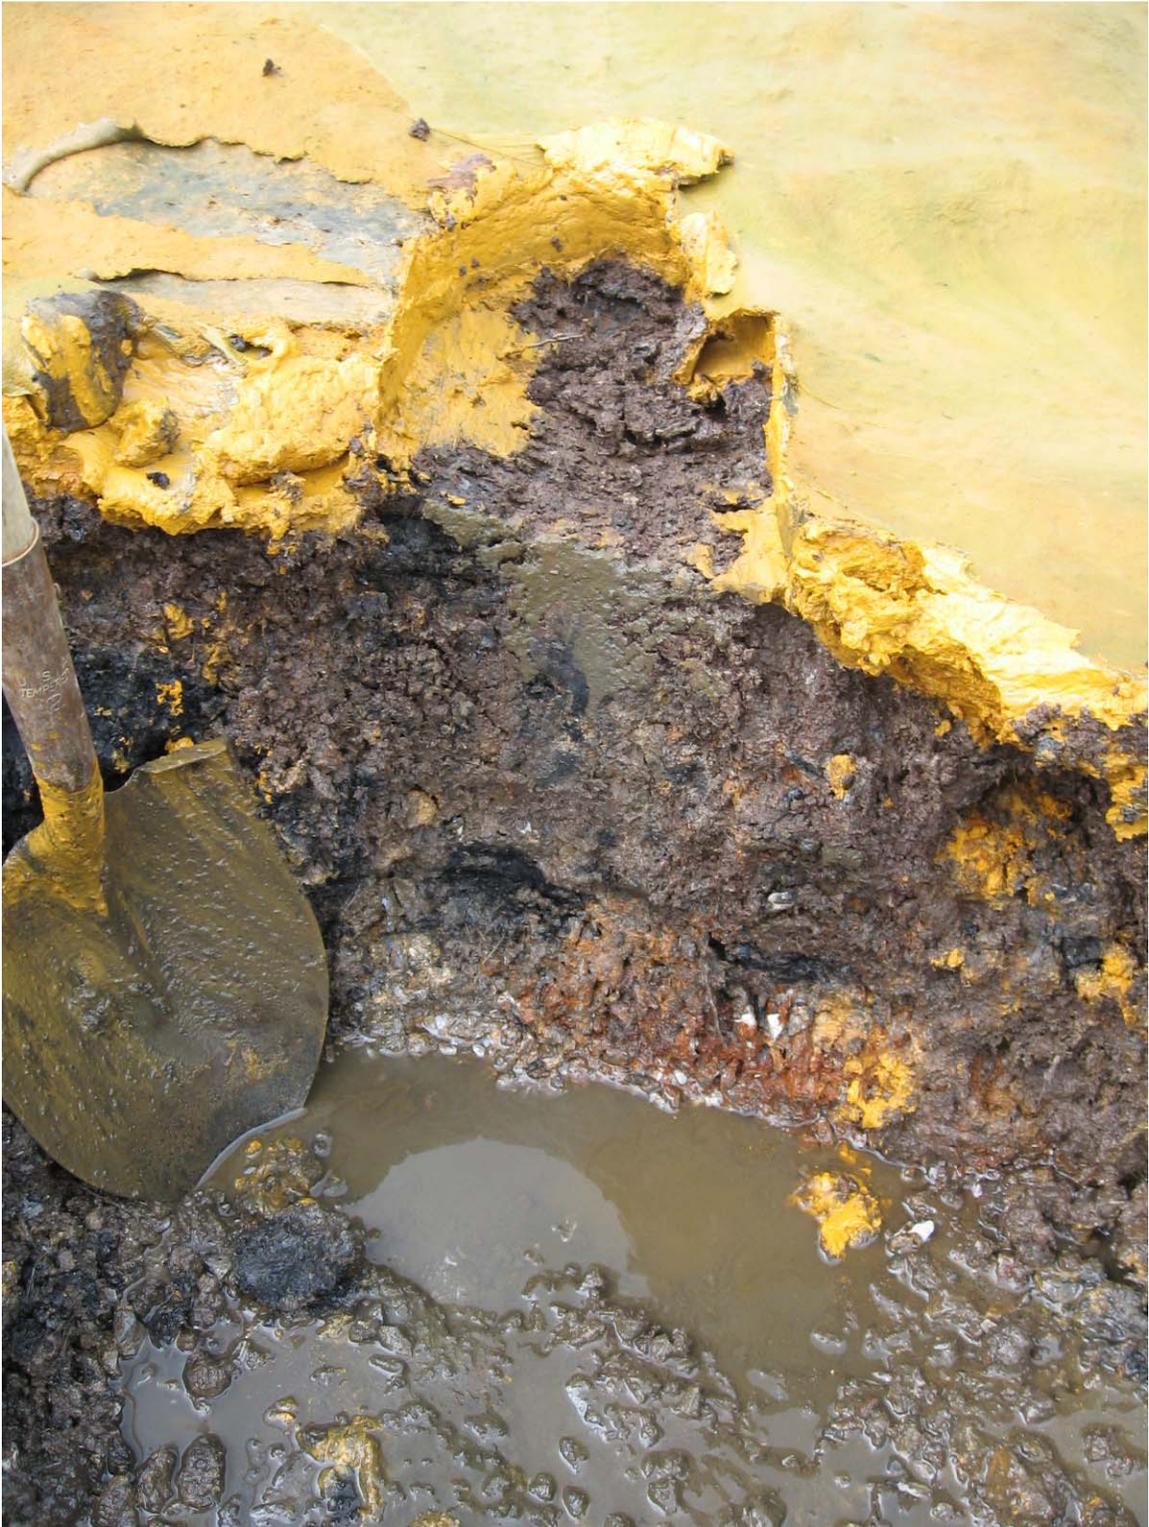
The compost was predominantly very dark brown to black in color but some areas were reddish brown (Photo 8). The reddish brown compost seemed to have a different texture than the black compost. The compost was solid enough to support a person's weight and when broken by the excavator it could be picked up in cantaloupe sized chunks. The thickness averaged 6 to 10 inches but varied considerably, with at least one much thinner area. Very little pore space remained in the compost.

The black compost is interpreted to contain considerable FeS precipitate filling the pore space. In other areas some brown Fe hydroxide fills pores. The combination of pore fillings and compaction has resulted in a dense layer of low permeability.

Photo 8. Full thickness of substrate. Note variable compost color.

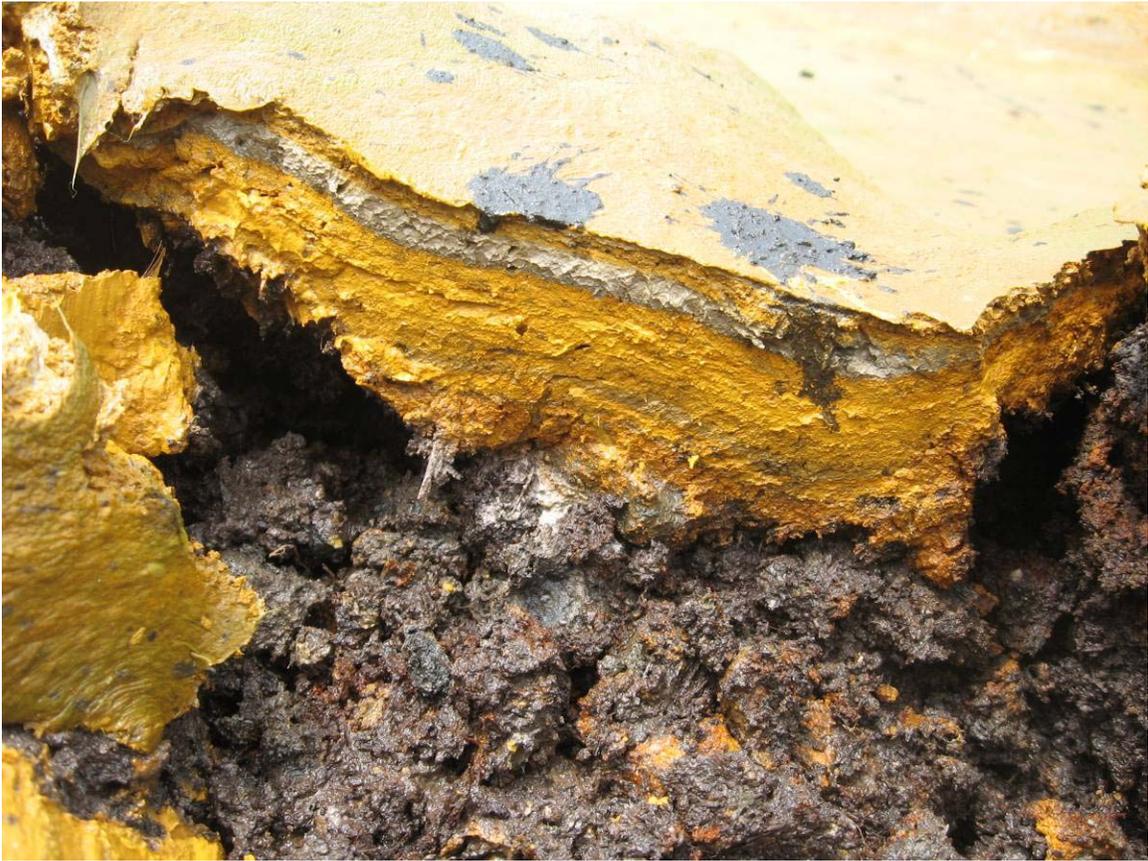
A layer of sludge of varying thickness and composition was observed on top of the compost (Photo 9). Sludge thickness was greatest near the influent (south) end of the VFP where the sludge was up to two feet thick. Sludge thickness was ~4 inches at the mid point of the VFP and 2-3 inches at the northern end. A prominent gray layer in the sludge was found to be consistent over the entire surface of the VFP (Photo 9). It is believed that this gray layer is Al hydroxide. At the influent end of the VFP the sludge was found to have multiple gray layers as well as numerous layers of varying colors (Photo 10). Most of the sludge layer appears to be Fe hydroxide that precipitated in the pond or in tail-end of the preceding wetland. A minor part of this sludge may be fine detrital clay from the inflow channel. Solids samples were collected of the sludge and forwarded to ACT Labs (Toronto, Canada) for elemental analysis. The results are attached. Interpretation of the results will be performed by Dr. Rose at a later date.

This sludge is considered to be a major cause of the impermeability problem. The material forms a complete cover over the compost, and is uniformly colloidal in nature. The layer appears very impermeable.

Photo 9. Sludge layer on top of compost. Note gray layers.

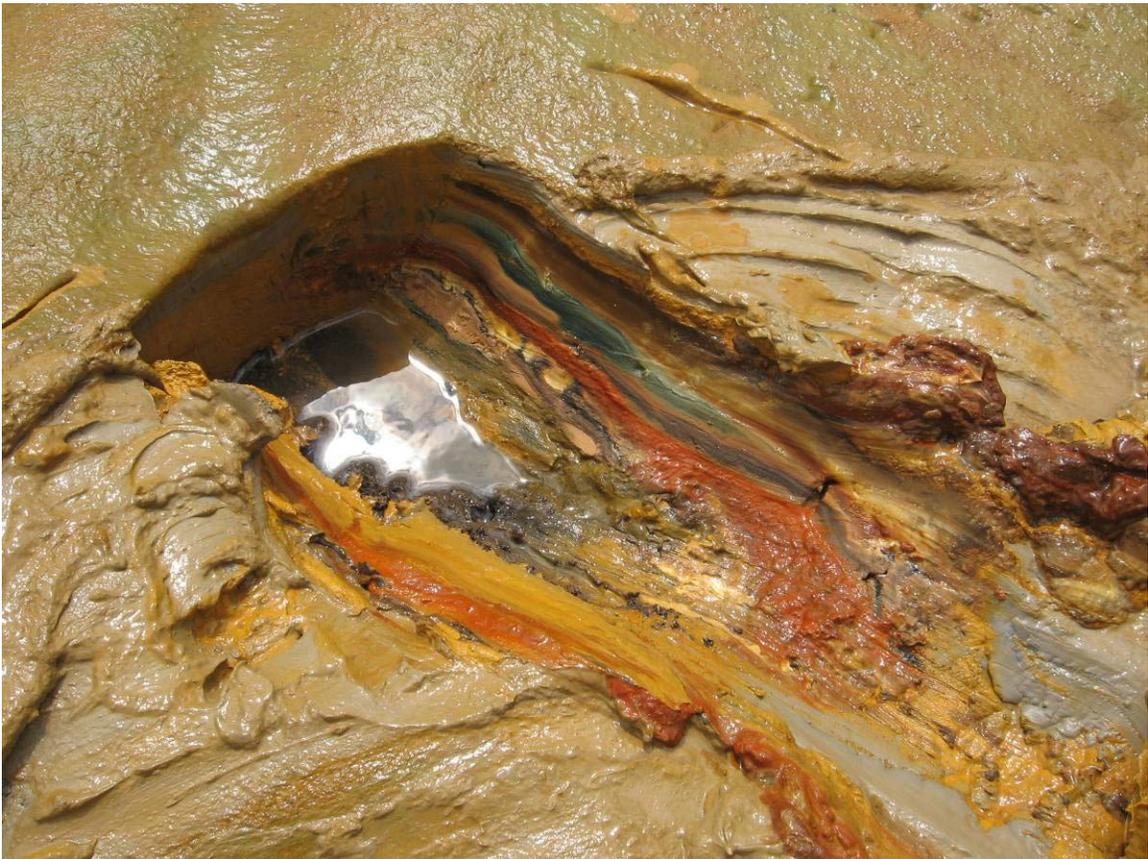
Photo 10. Multi-colored sludge found at south (inlet) end of VFP 2.

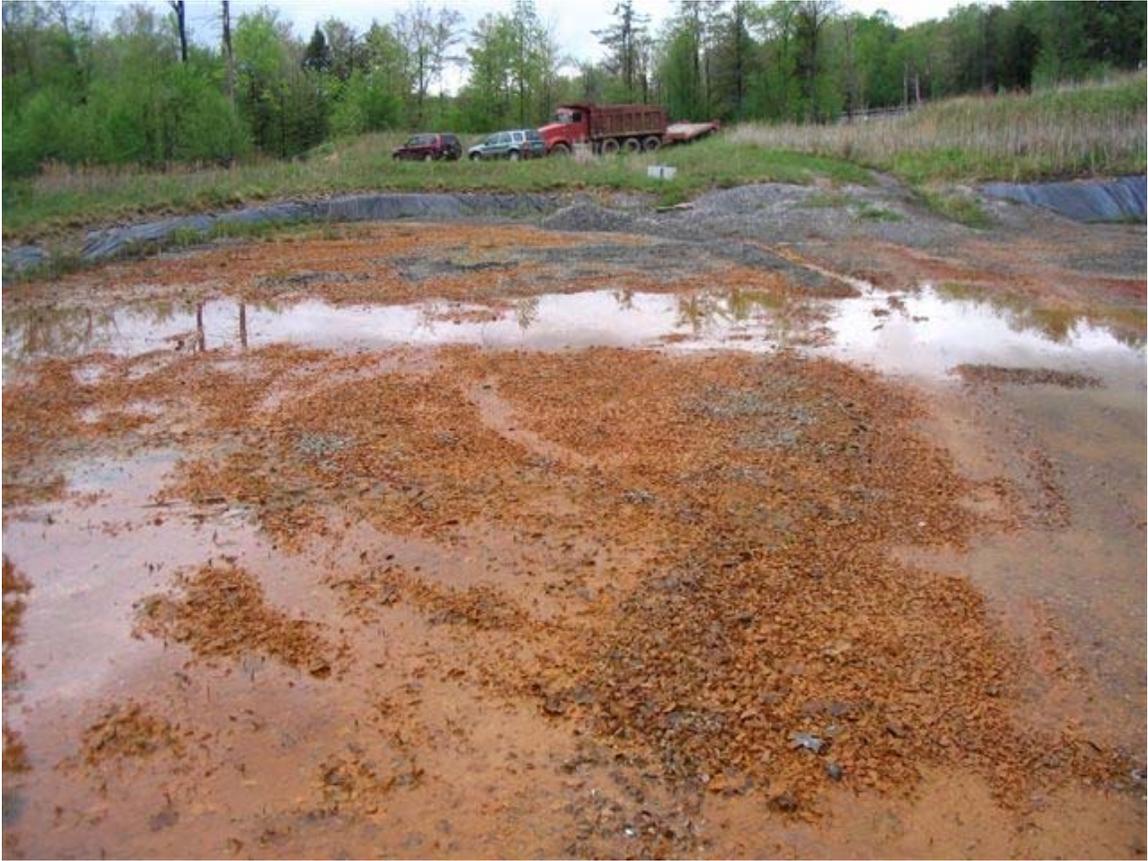
Two trenches were dug into the limestone of the manganese removal bed to determine the condition of the limestone at various depths. Limestone exposed at the surface was iron stained from recent flows of incompletely treated water (Photo 11). The top foot of limestone was cemented with a black coating that was comparable to charcoal (Photo 12). This is believed to be manganese minerals. Coating of the limestone with these minerals has cemented the top layer of the aggregate and severely limited its permeability. A basketball sized chunk of cemented limestone remained intact even when lifted (Photo 13). Limestone below this black zone was in fairly good condition

Photo 11. Iron staining of surface limestone in Mn bed

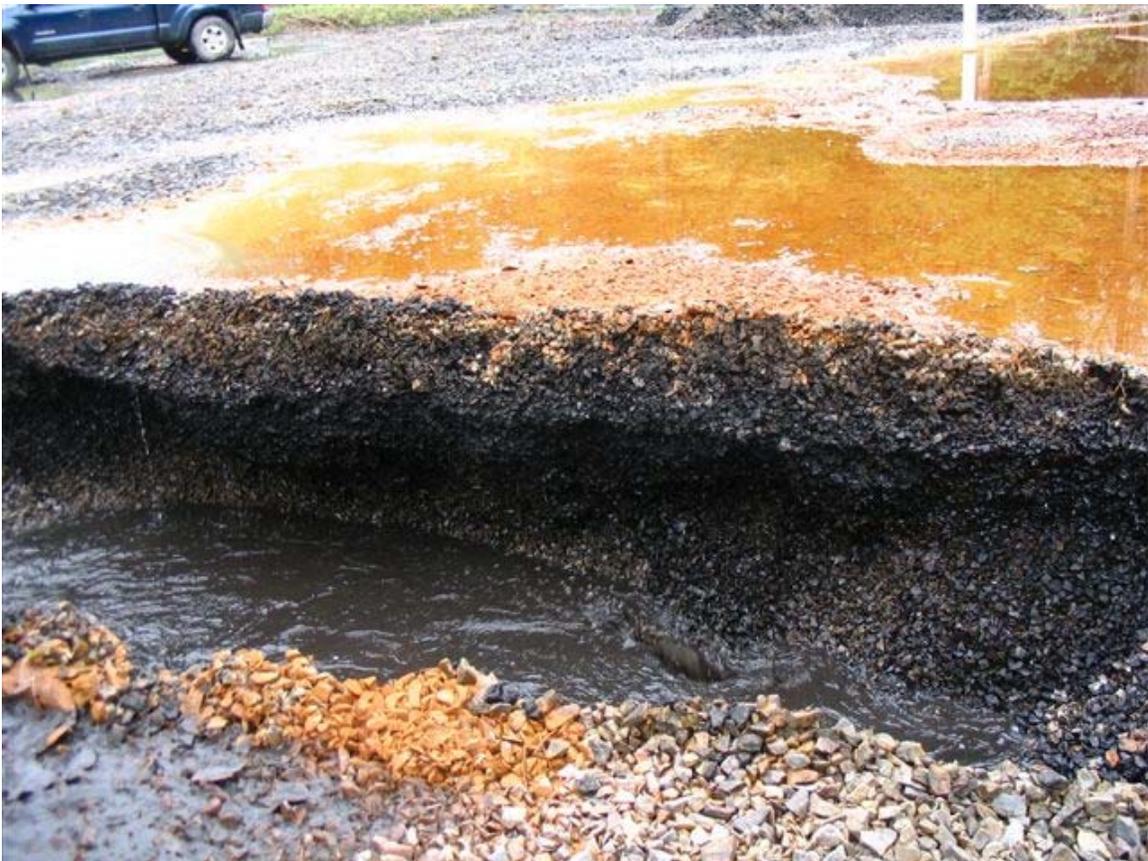
Photo 12. Limestone cemented with black solids stands out as a shelf, unsupported.

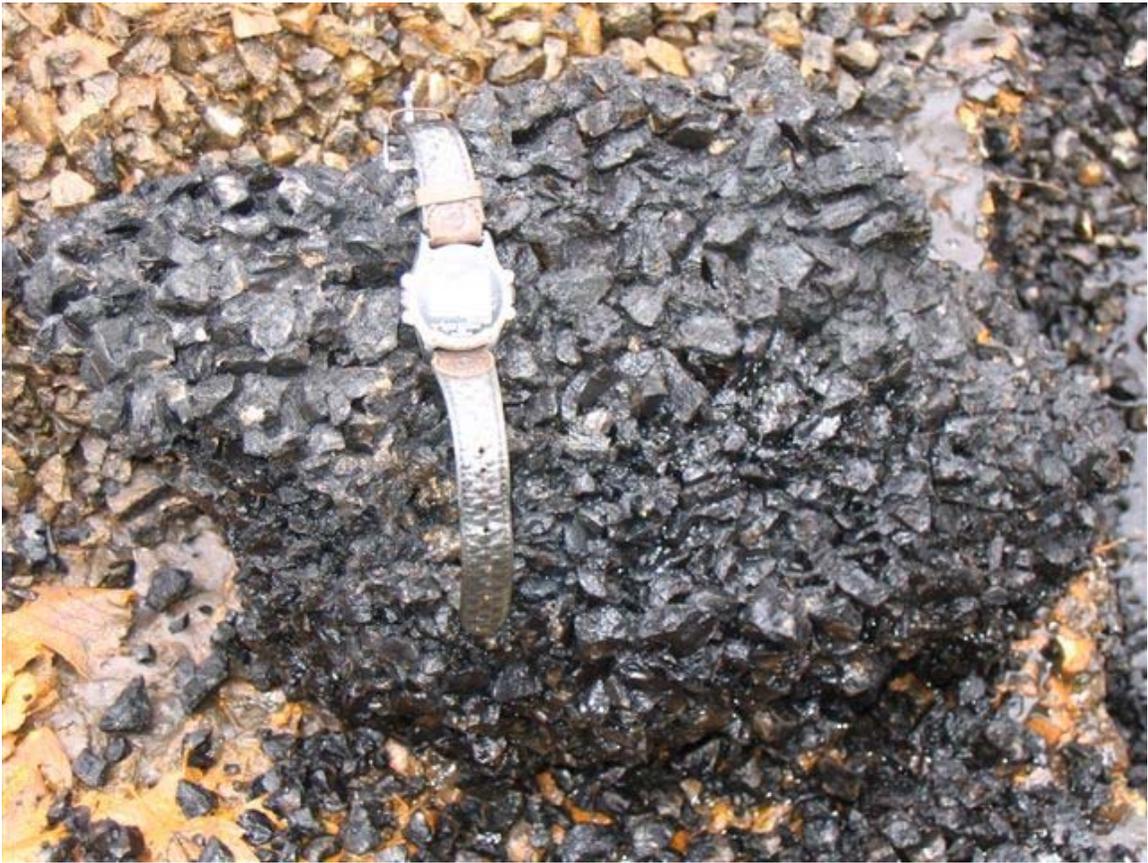
Photo 13. Large chunk of cemented aggregate. Wristwatch for scale.

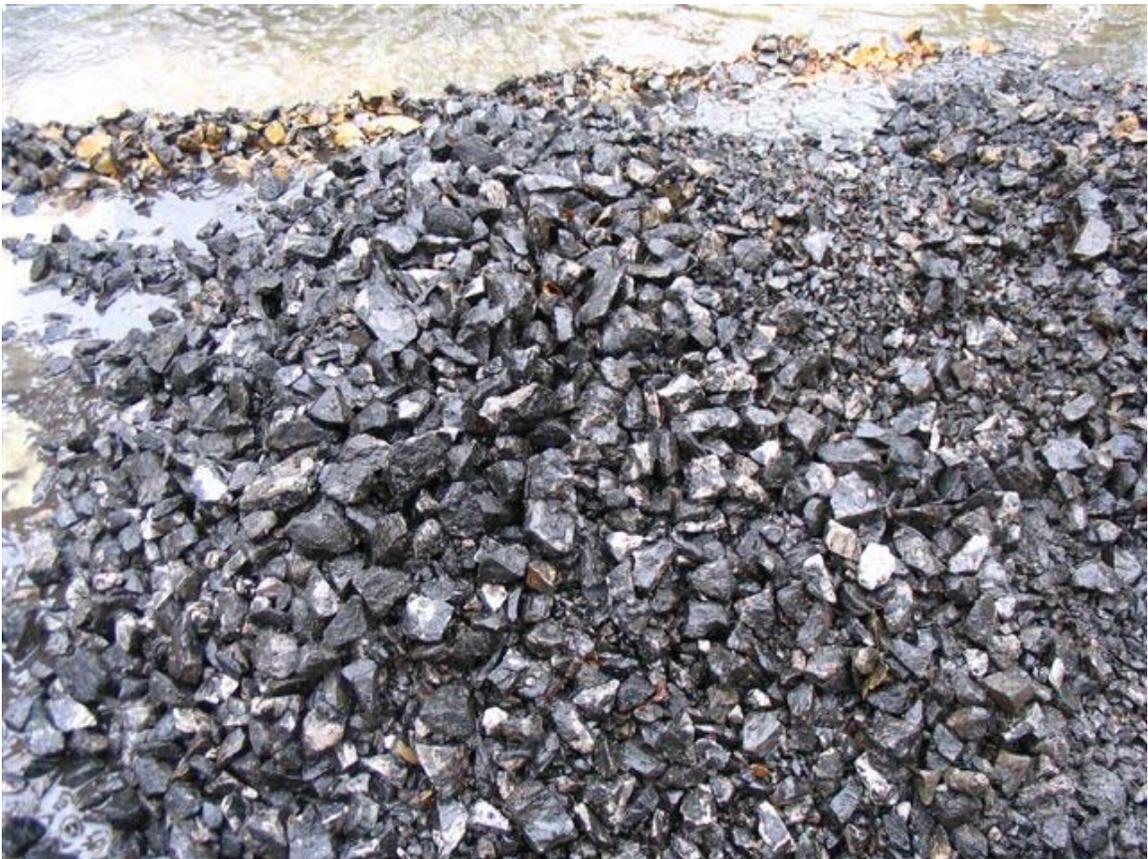
with little coating (Photo 14). Solids samples were collected and forwarded to ACT Labs (Toronto, Canada) for elemental analysis. The results are attached. Interpretation of the results will be performed by Dr. Rose at a later date.

Photo 14. Limestone excavated from the bottom of the Mn bed was in relatively good condition.

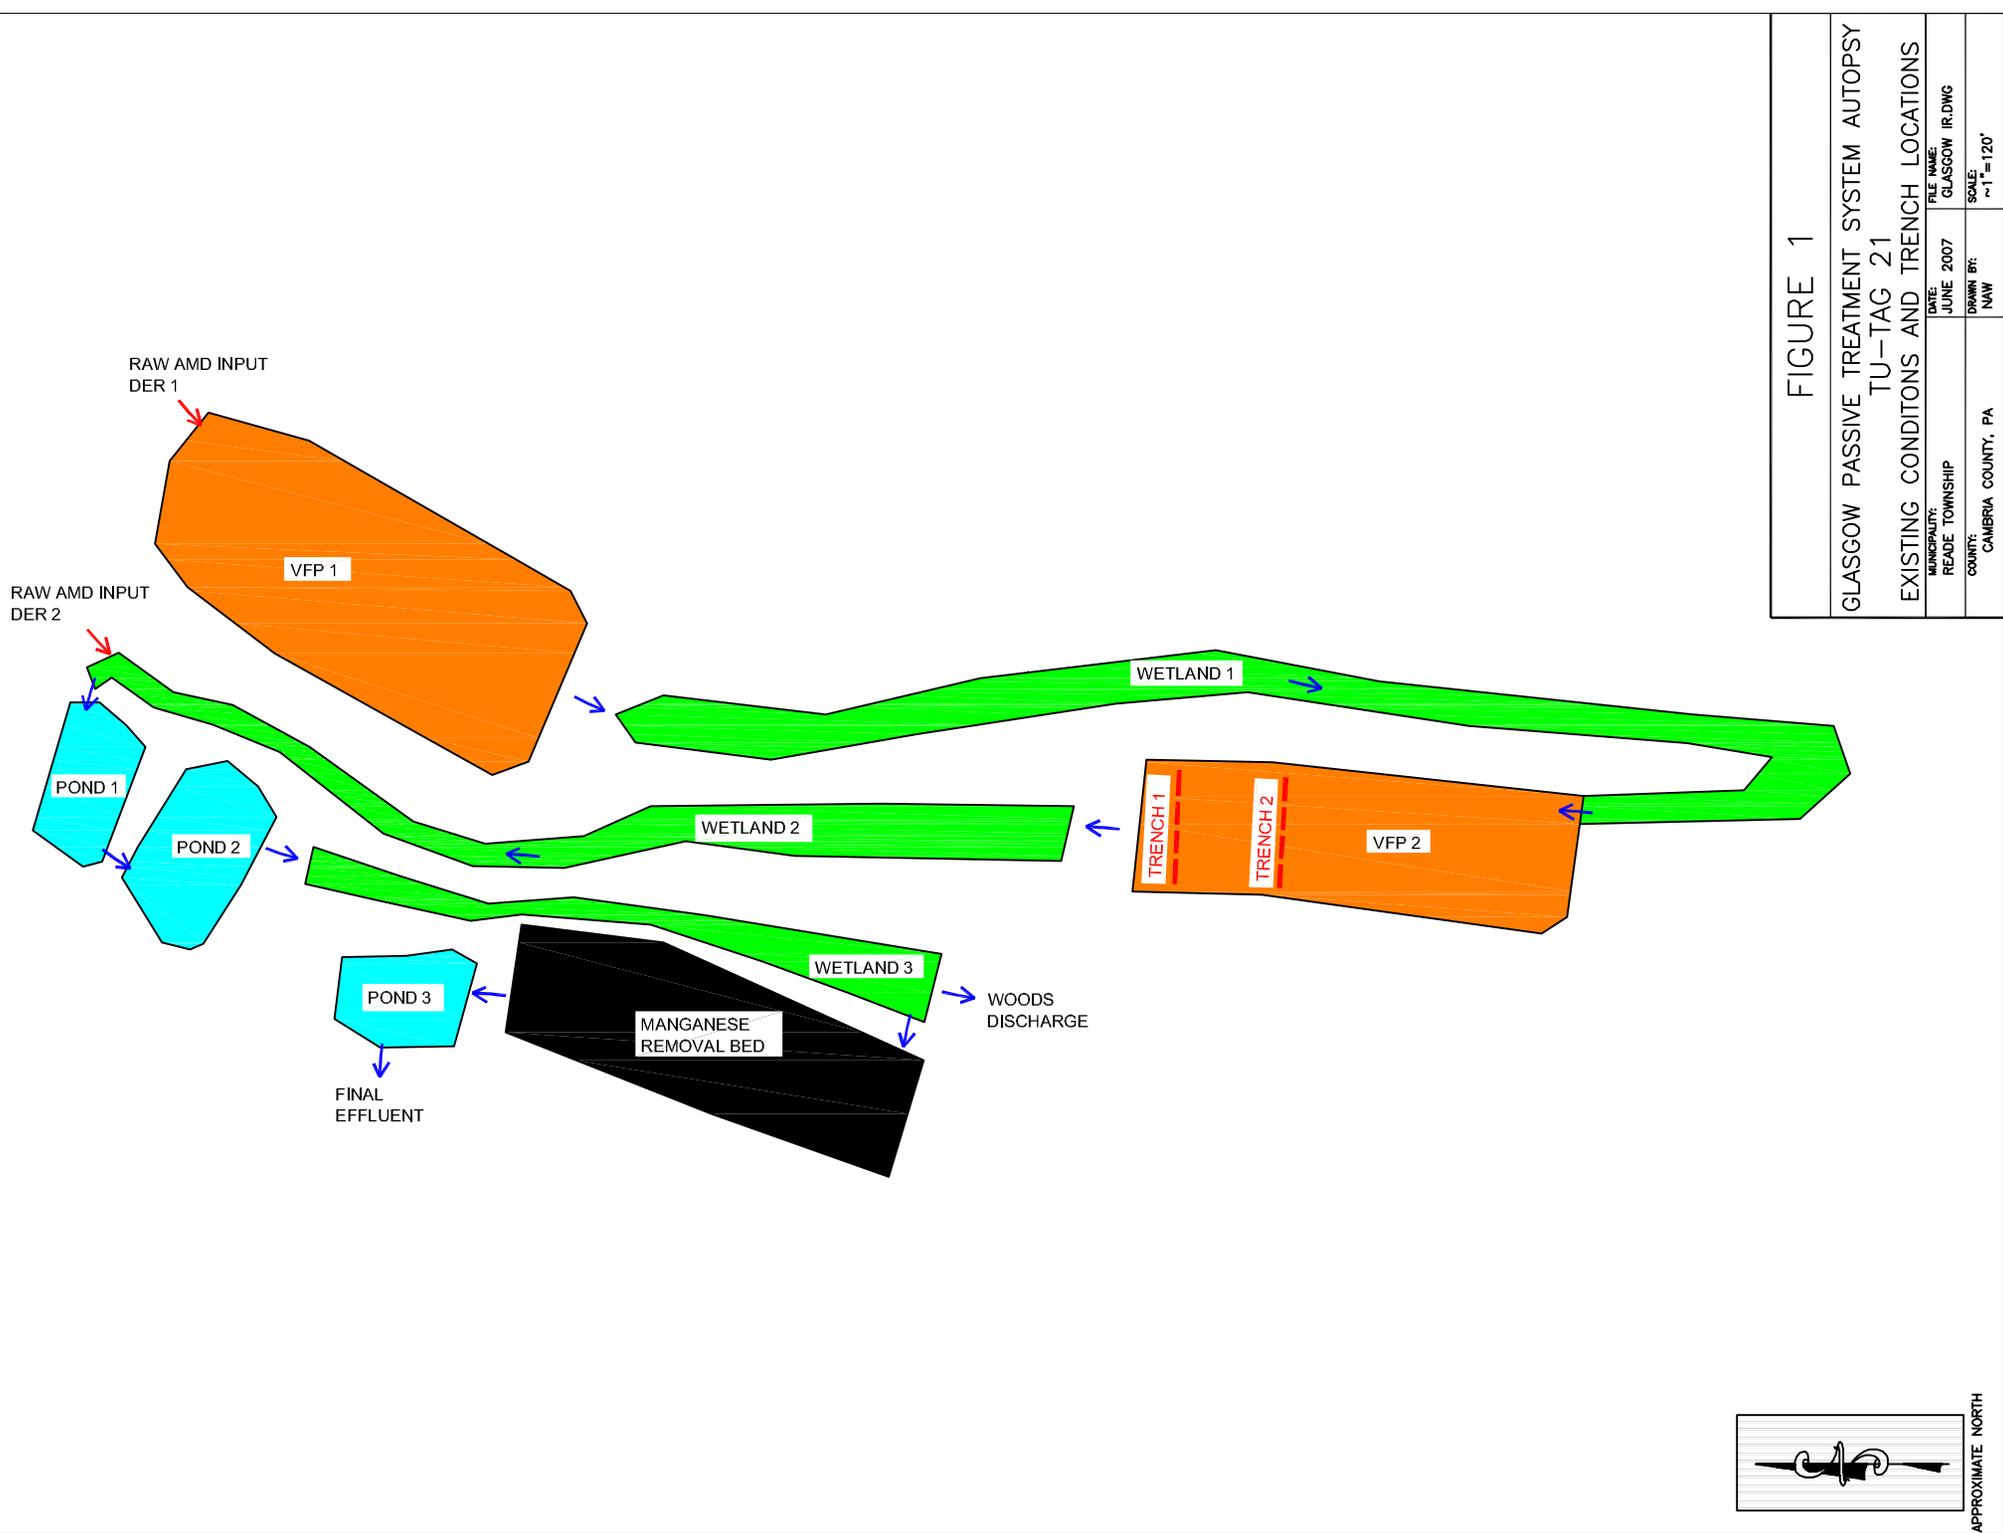
FIGURE 1

The layout of the system is shown on Figure 1 (attached). The TUTAG-9 report found that the system was experiencing permeability issues. In particular, VFP 2 was plugged and discharging through its emergency overflow. VFP 1 showed signs of plugging but to a lesser extent. Previous sampling by CCWA established that VFP1 was removing acidity at rates similar to other functional VFPs.

A flow control structure would allow the flow configuration of the system to be reconsidered. Currently the system operates in a strictly linear manner. All the AMD flows through VFP1, then through VFP2, and then through the Mn bed. Between the VFPs and Mn bed, the water flows in channels that are densely vegetated wetlands. Figure 1 shows this flow configuration.
