Klondike Passive Treatment System Investigation Babb Creek Watershed, Tioga County

Technical Report Provided by Hedin Environmental through the Trout Unlimited AMD Technical Assistance Program

August 18, 2009

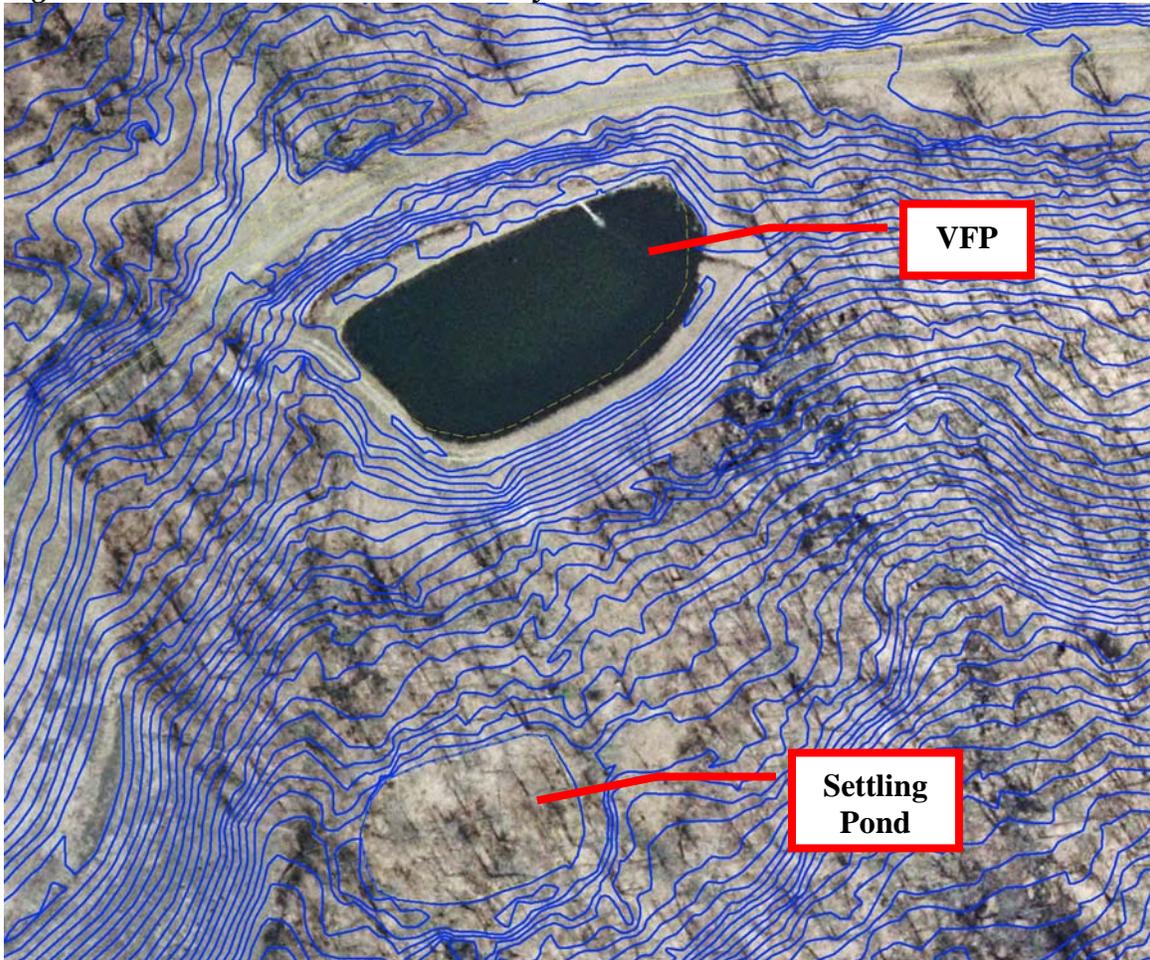
Figure 1. Klondike Passive Treatment System

Figure 1 shows the layout of the system. The VFP has a water surface area of 2,600 m². The settling pond is visible in the topographic contours, but not in the aerial photography because the pond was constructed between the acquisition of photography and elevation data.

Based on construction photos and discussions with BCWA it is apparent that neither the VFP bottom nor VFP substrate (limestone, compost) were installed level. In fact the bottom of the VFP appears to be sloping in the opposite direction from the top of the substrate. It is very likely that the thickness of treatment substrate varies widely and, as a result, creates zones of preferential flow through the thinner areas.

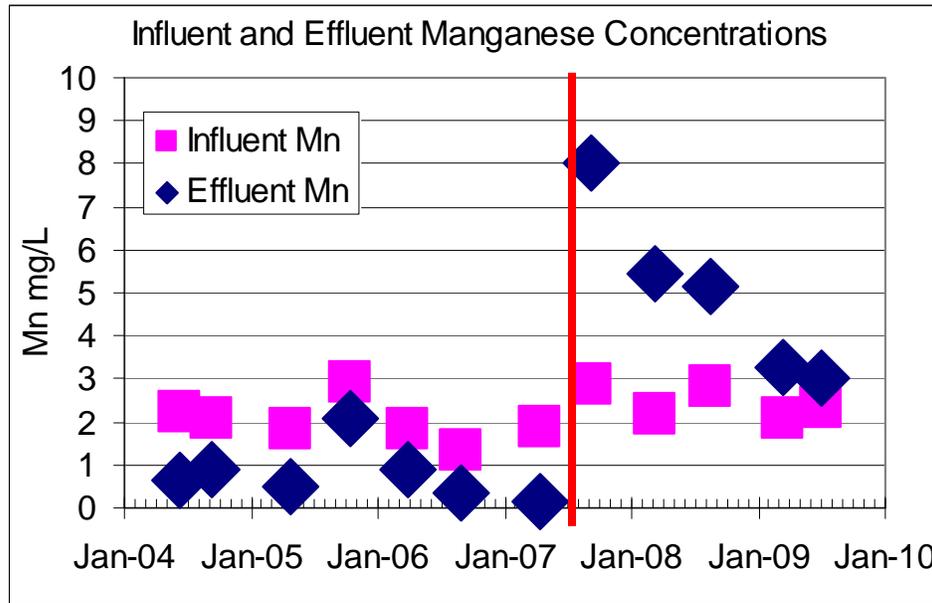
Figure 2. Manganese concentrations before and after compost replacement

Following the replacement of the compost the system became a source of iron and manganese. That is, they released more of these metals than they received from the discharge. Originally the system contained a compost layer that was heavily amended with limestone. By the time the compost layer was replaced in 2007 very little organic material remained. Such a system would not have sufficient organic material to create reducing conditions so the VFP was operating essentially as an oxic limestone bed. When the compost layer was replaced with a layer of spent mushroom compost with no limestone amendment (i.e. 100% organic material) the conditions in the limestone layer were switched from oxic to reducing.

Many of the metals solids that formed in the limestone layer under oxic conditions are soluble under reducing conditions. As a result, metals solids are going back into solution causing the system to discharge water having higher manganese concentrations than what is entering the system. Iron now passes through the system due to the reducing conditions. Since the system is no longer removing manganese and iron (and their associated acidity) the acidity removal rate is lower.

Figures 2 and 3 show the influent and effluent iron and manganese over time. The system appears to be stabilizing in terms of manganese release. Nonetheless, it is evident that even once stabilized the system will suffer from short-circuiting problems.

The red line indicates the approximate date of compost replacement.

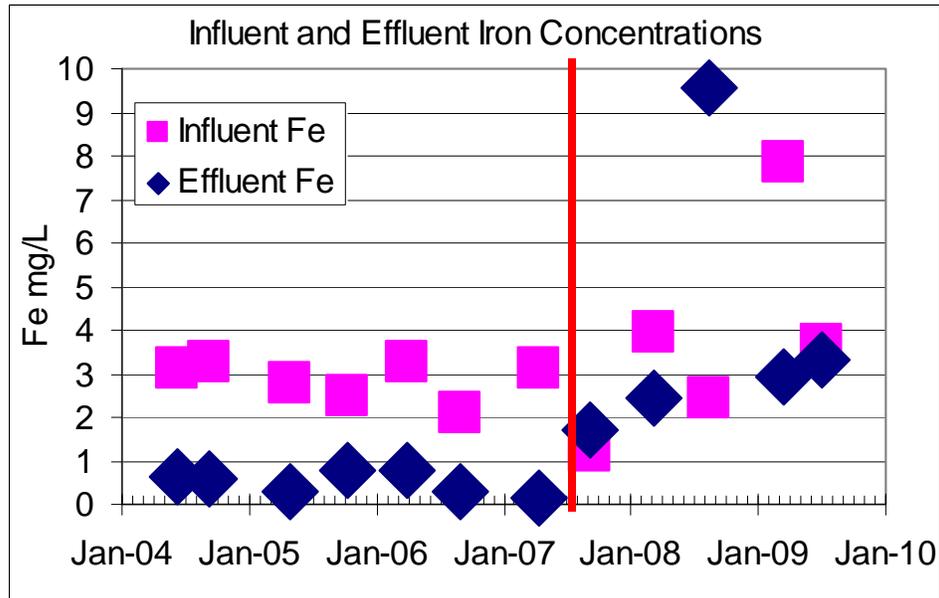
Figure 3. Iron concentrations before and after compost replacement

The red line indicates the approximate date of compost replacement.

Clearly the replacement of the compost layer changed the chemical performance of the system. However, there is some indication that the physical function of the system was altered as well. The effluent water is turbid with orange suspended solids. One potential cause of this could be a hydraulic short-circuit. Acidic, aerobic water is reaching the underdrain plumbing where it mingles with alkaline treated flow. Once mixed, iron precipitates from the solution forming the visible solids in the effluent.
