Data Collection Methods

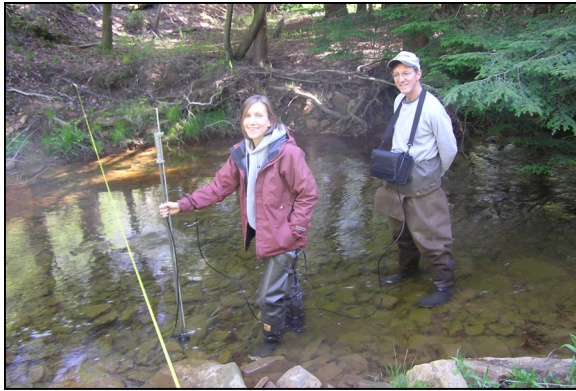
Photo: R. Kester

Alysha Trexler and Mark Killar measure flow rate.

Flow measurements were made perpendicular to the direction of mid-channel flow and in areas where backwater and as many obstacles as possible could be avoided. Cross-sectional measurements of depth, velocity at 6/10th of the stream depth, and distance from the bank were taken at approximately 20 locations or at intervals that comprised no more than 10% of the entire flow of the site. Where flows were too large to measure using conventional wading techniques, the existing USGS stream gage network was used.

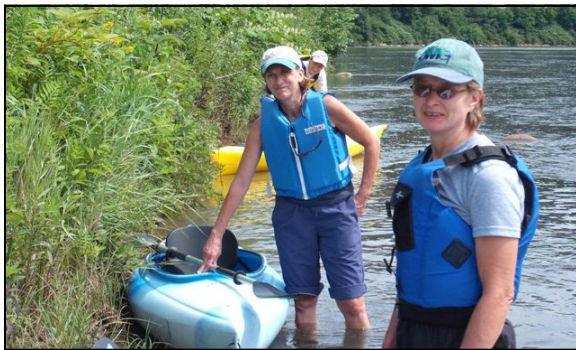
Photo: M. Carrello

Shirley Sholtis and Pam Milavec prepare to sample the river.

Water quality samples were taken from the vertical profile of the main current usually in the center of the stream. In the case of larger tributaries or main stem river sample locations, 3 to 6 samples from across the sample site were composited. A 500-ml raw sample, a 250-ml sample fixed with 15 to 20 drops of HNO₃, and a 250-ml sample filtered through a 0.45-micron filter and then fixed with 15 to 20 drops of HNO₃ were obtained from each site. Samples were placed on ice and transferred to a DEP-accredited laboratory for analysis of 24 parameters (Table 1). In addition, field measurements of pH, temperature, and conductivity were taken at each site.

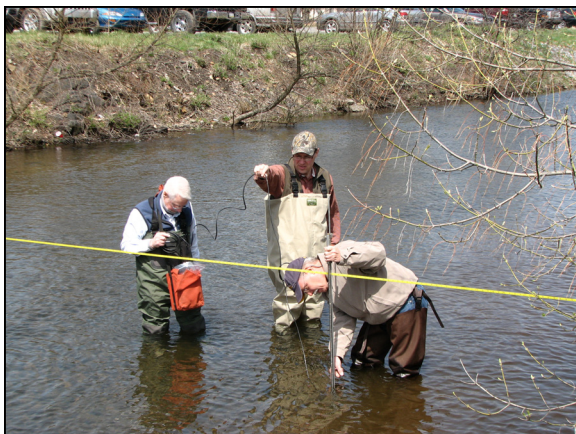
Photo: R. Dunlap

Study participants are trained how to properly take flow measurements.

For quality assurance purposes, an orientation and training session was held during which project participants were trained in proper water quality and flow data collection techniques. Each sampling team consisted of a “leader” from TU or the DEP and all persons collecting data were TU personnel, DEP personnel, County Conservation District personnel, or other relevant professionals.

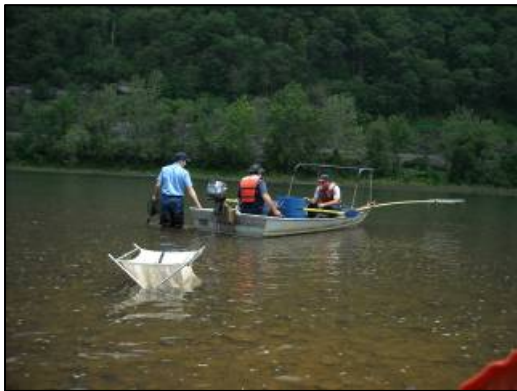
Photo provided by PFBC

Jason Detar, Dave Kristine, and Andrew Leakey prepare to sample the river at Hyner.

Backpack electrofishing samples consisted of two 100-meter single-pass runs along the shoreline. When possible, a 100-meter site was conducted on each side of the river. The fish catch reported for each backpack site is the sum of the two 100-meter samples combined. Mini-boom boat electrofishing samples consisted of two > 20 minute single-pass runs along the shoreline. One run was conducted on each side of the river. The fish catch reported for each mini-boom site is the sum of the two > 20 minute runs combined. An attempt to capture all fish observed was made and all fish captured that could be identified at the site were tallied by species and released. Juvenile cyprinids and other unidentifiable fish were preserved and returned to the laboratory for identification.

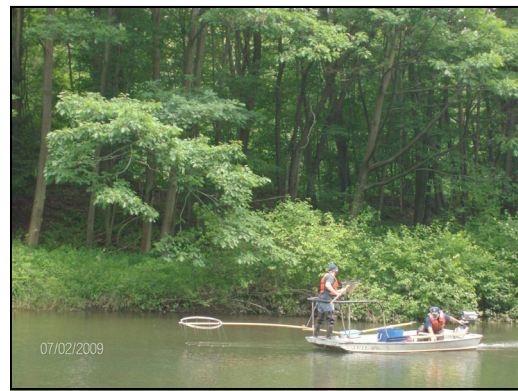
Photo provided by PFBC

Dave Kristine and Andrew Leakey sample the river at Hyner.

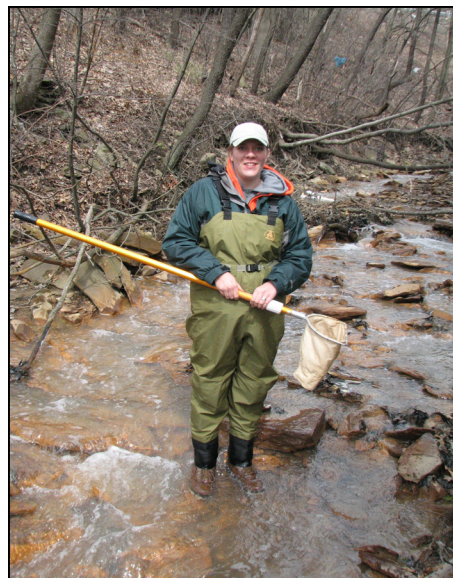
Photo: R. Dunlap

Rachel Kester collects benthic macroinvertebrates from Wolf Run.

In order to provide a baseline of biological and habitat conditions in the AMD impacted tributaries entering the river and in the river itself, benthic macroinvertebrate and habitat data were collected at 66 locations. All benthic collections were carried out according to DEP's ICE protocols (Chalfant 2007) and were conducted by TU personnel who were previously trained by DEP Bureau of Water Standards and Facility Regulation staff in such protocols. Benthic macroinvertebrate samples consisted of a combination of six kick efforts in a 100-meter stream section. These efforts were spread out so as to select the best riffle habitat areas with varying depths. Each effort consisted of an area of 1-m² to a depth of at least 4 inches as substrate allowed and was conducted with a 500 micron mesh 12-inch diameter D-frame kick net. Samples were composited and then identified.

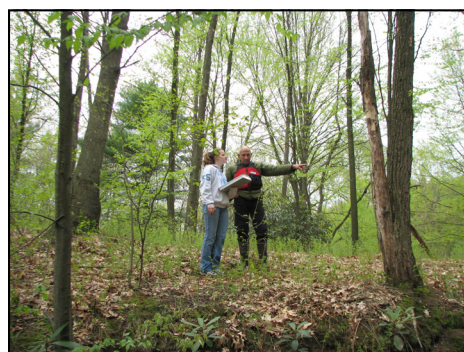
Photo: R. Dunlap

Lori Smith and Carl Undercoffler assess habitat of an unnamed tributary.

A qualitative habitat assessment was also conducted on a 100-meter reach of stream at each site according to DEP's ICE protocols. The habitat assessment included rating twelve parameters (instream fish cover, epifaunal substrate, embeddedness, velocity/depth regime, channel alteration, sediment deposition, riffle frequency, channel flow status, conditions of banks, bank vegetative protection, grazing or other disruptive pressures, and riparian vegetative zone widths) as optimal, suboptimal, marginal, or poor by using a numeric value ranging from 0-20. In order to reduce the amount of variation due to subjectivity by different investigators between sites, habitat evaluations were conducted by the same person at each site when possible.
