II. Watershed Description

The Anderson Creek watershed is located in central Pennsylvania, Clearfield County. Anderson Creek encompasses parts of Bloom, Brady, Penn, Pike, Pine, and Union townships, and lies approximately seven miles west of Clearfield Borough and five miles east of the City of Dubois. The watershed is mostly rural, with a few small communities located in the northern portion and several more densely populated communities in the southern portion. The communities of Chestnut Grove, Laborde, Anderson Station, Rockton, and Anderson Creek lie to the north, while the boroughs of Curwensville, Grampian, and Hepburnia, along with the community of Stronach, are in the southern part of the watershed.

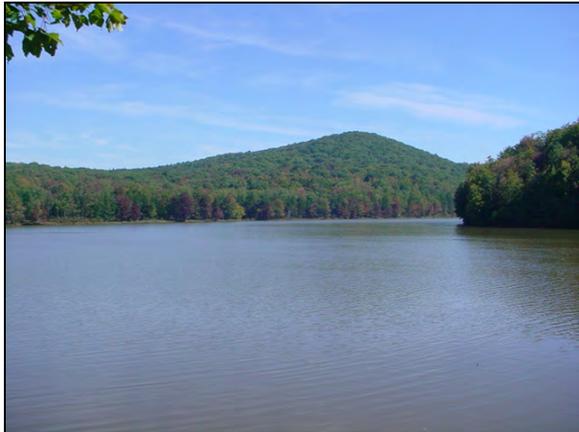
The Dubois Reservoir, located in the northern portion of Anderson Creek, serves as a water supply for the City of Dubois.

Dubois Reservoir, a key water feature located in the northwestern part of the watershed—and impounding water from only the main stem's upper reaches—covers approximately 210 acres. The reservoir serves as the water supply for the city of Dubois.

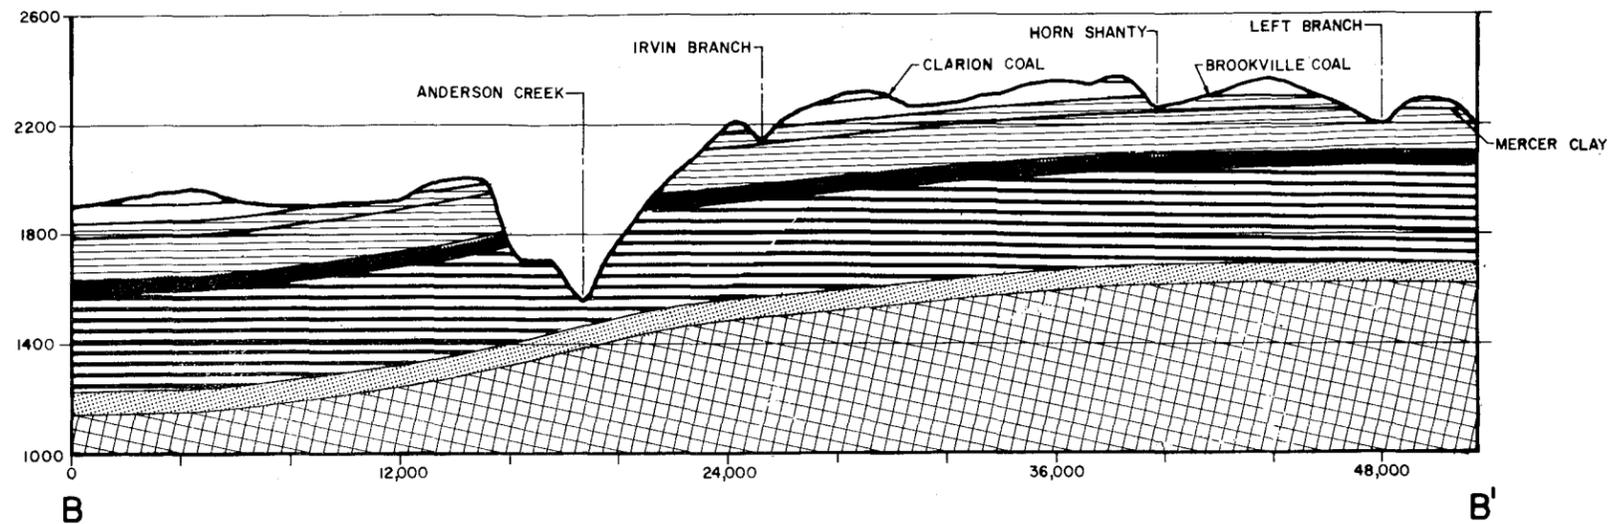
GENERALIZED STRATIGRAPHY
OF THE ANDERSON CREEK WATERSHED

FORMATION	MEMBER	COLUMNAR SECTION	APPROXIMATE THICKNESS	ROCK TYPE
CONEMAUGH	BUFFALO	[Vertical lines]	70'	SANDY SHALES SANDSTONES CONGLOMERATES
	MAHONING	[Vertical lines]	70'	COAL
ALLEGHENY	FREEPORT	[Horizontal lines]	300'	COAL CLAYS SHALES SANDSTONES
	KITTANNING	[Horizontal lines]		
	CLARION	[Horizontal lines]		
	BROOKVILLE	[Horizontal lines]		
POTTSVILLE	MERCER	[Horizontal lines]	200'	COAL CLAYS SHALES SANDSTONES CONGLOMERATES
	CONNEQUENESSING	[Horizontal lines]		
MAUCH CHUNK	UPPER	[Horizontal lines]	50'	SHALES
	LOWER	[Horizontal lines]		
POCONO	BURGOON	[Horizontal lines]	350'	SANDSTONES CONGLOMERATES
	PATTON	[Dotted pattern]	25'	RED SHALES
	SUB-BURGOON	[Cross-hatch pattern]	650'	SHALES SANDSTONES

(For a generalized geologic column of the rocks of the watershed, see Exhibit No. 2 from the Anderson Creek Scarlift report, 1974.)

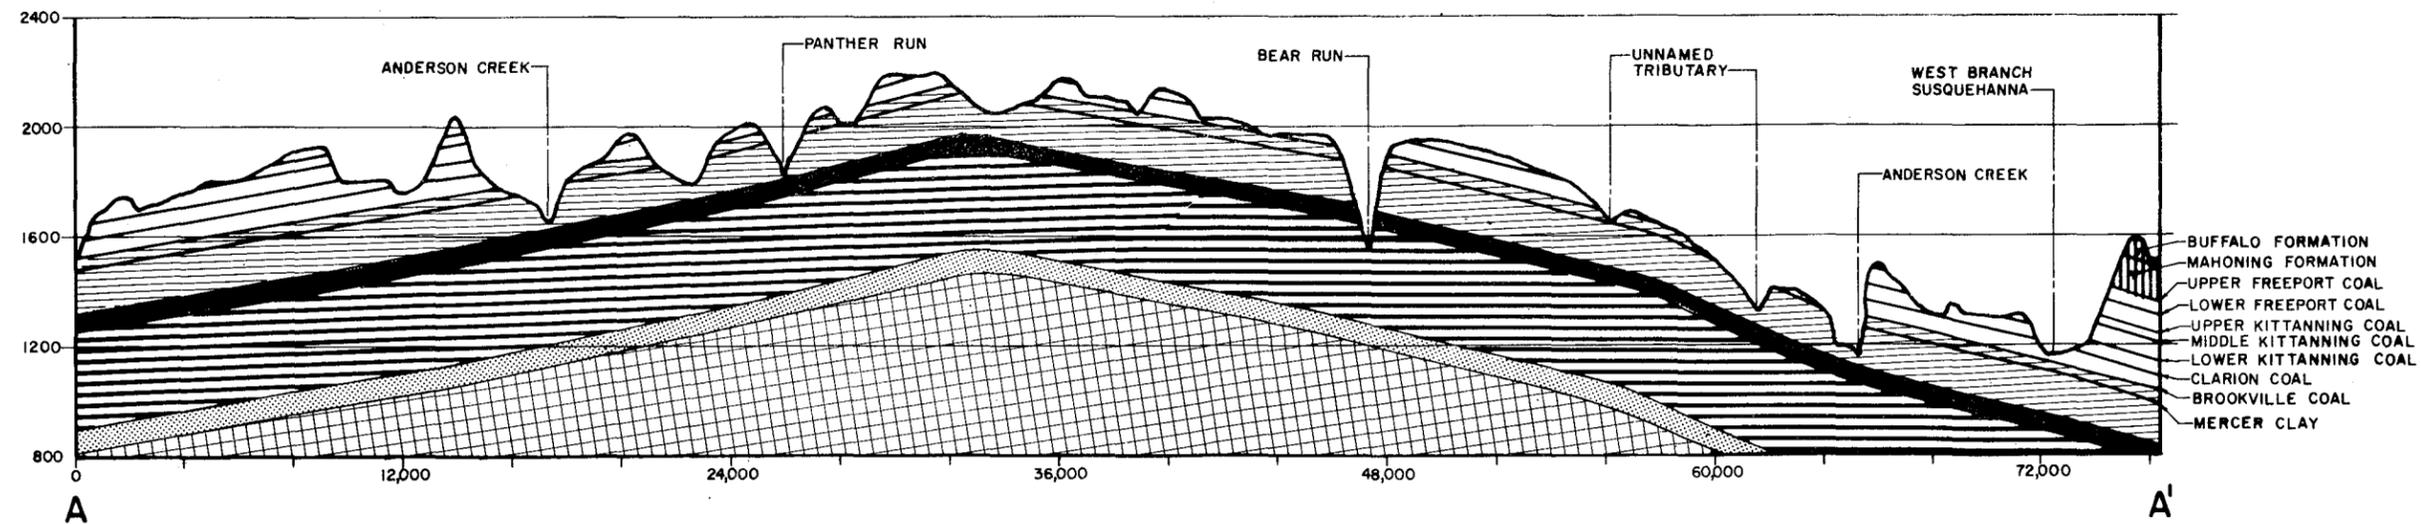
GENERALIZED COLUMNAR SECTION OF EXPOSED ROCKS

System	Group	Formation	Member	Section	Character of Member	General Character of Formation
PENNSYLVANIAN	CONE MAUGH		Lower Mahoning sandstone		Sandstone and sandy shale sometimes separated by thin lenses of coal Red shale occurs -40' above Upper Freeport	Only the lower part of the formation is present - about 40'
	ALLEGHENY	Glen Richey Fm.	Upper Freeport coal		Widely persistent average thickness 3' to 3 1/2'	A variable sequence of shale, sandstone, limestone, clay, and valuable beds of coal. Average thickness is about 300'.
			Lower Freeport coal		Variable, average 2' to 2 1/2' thick.	
		Laurel Run Fm.	Freeport s.s. Upper Kittanning coal		Thin, about 1' to 1 1/2' thick.	
		Mineral Springs Fm.	Middle Kittanning coal		About 3 seams present at this horizon. Usually 1' to 1 1/2' thick.	
		Millstone Fm.	Lower Kittanning coal		Very persistent. Average thickness 2' to 2 1/2'	
		POTTSVILLE	Curwensville Fm.	Clarion coal

Brookville coal					Thin, variable.
	Homewood s.s.				Massive s.s. often separated by shale.	
	Elliott Park Fm.	Connoquenessing s.s.	Mercer coal		Variable, often several thin beds present at this horizon.	
			Mercer clay			
						Fine grained, quite shaly in places almost completely replaced by sandy shale.

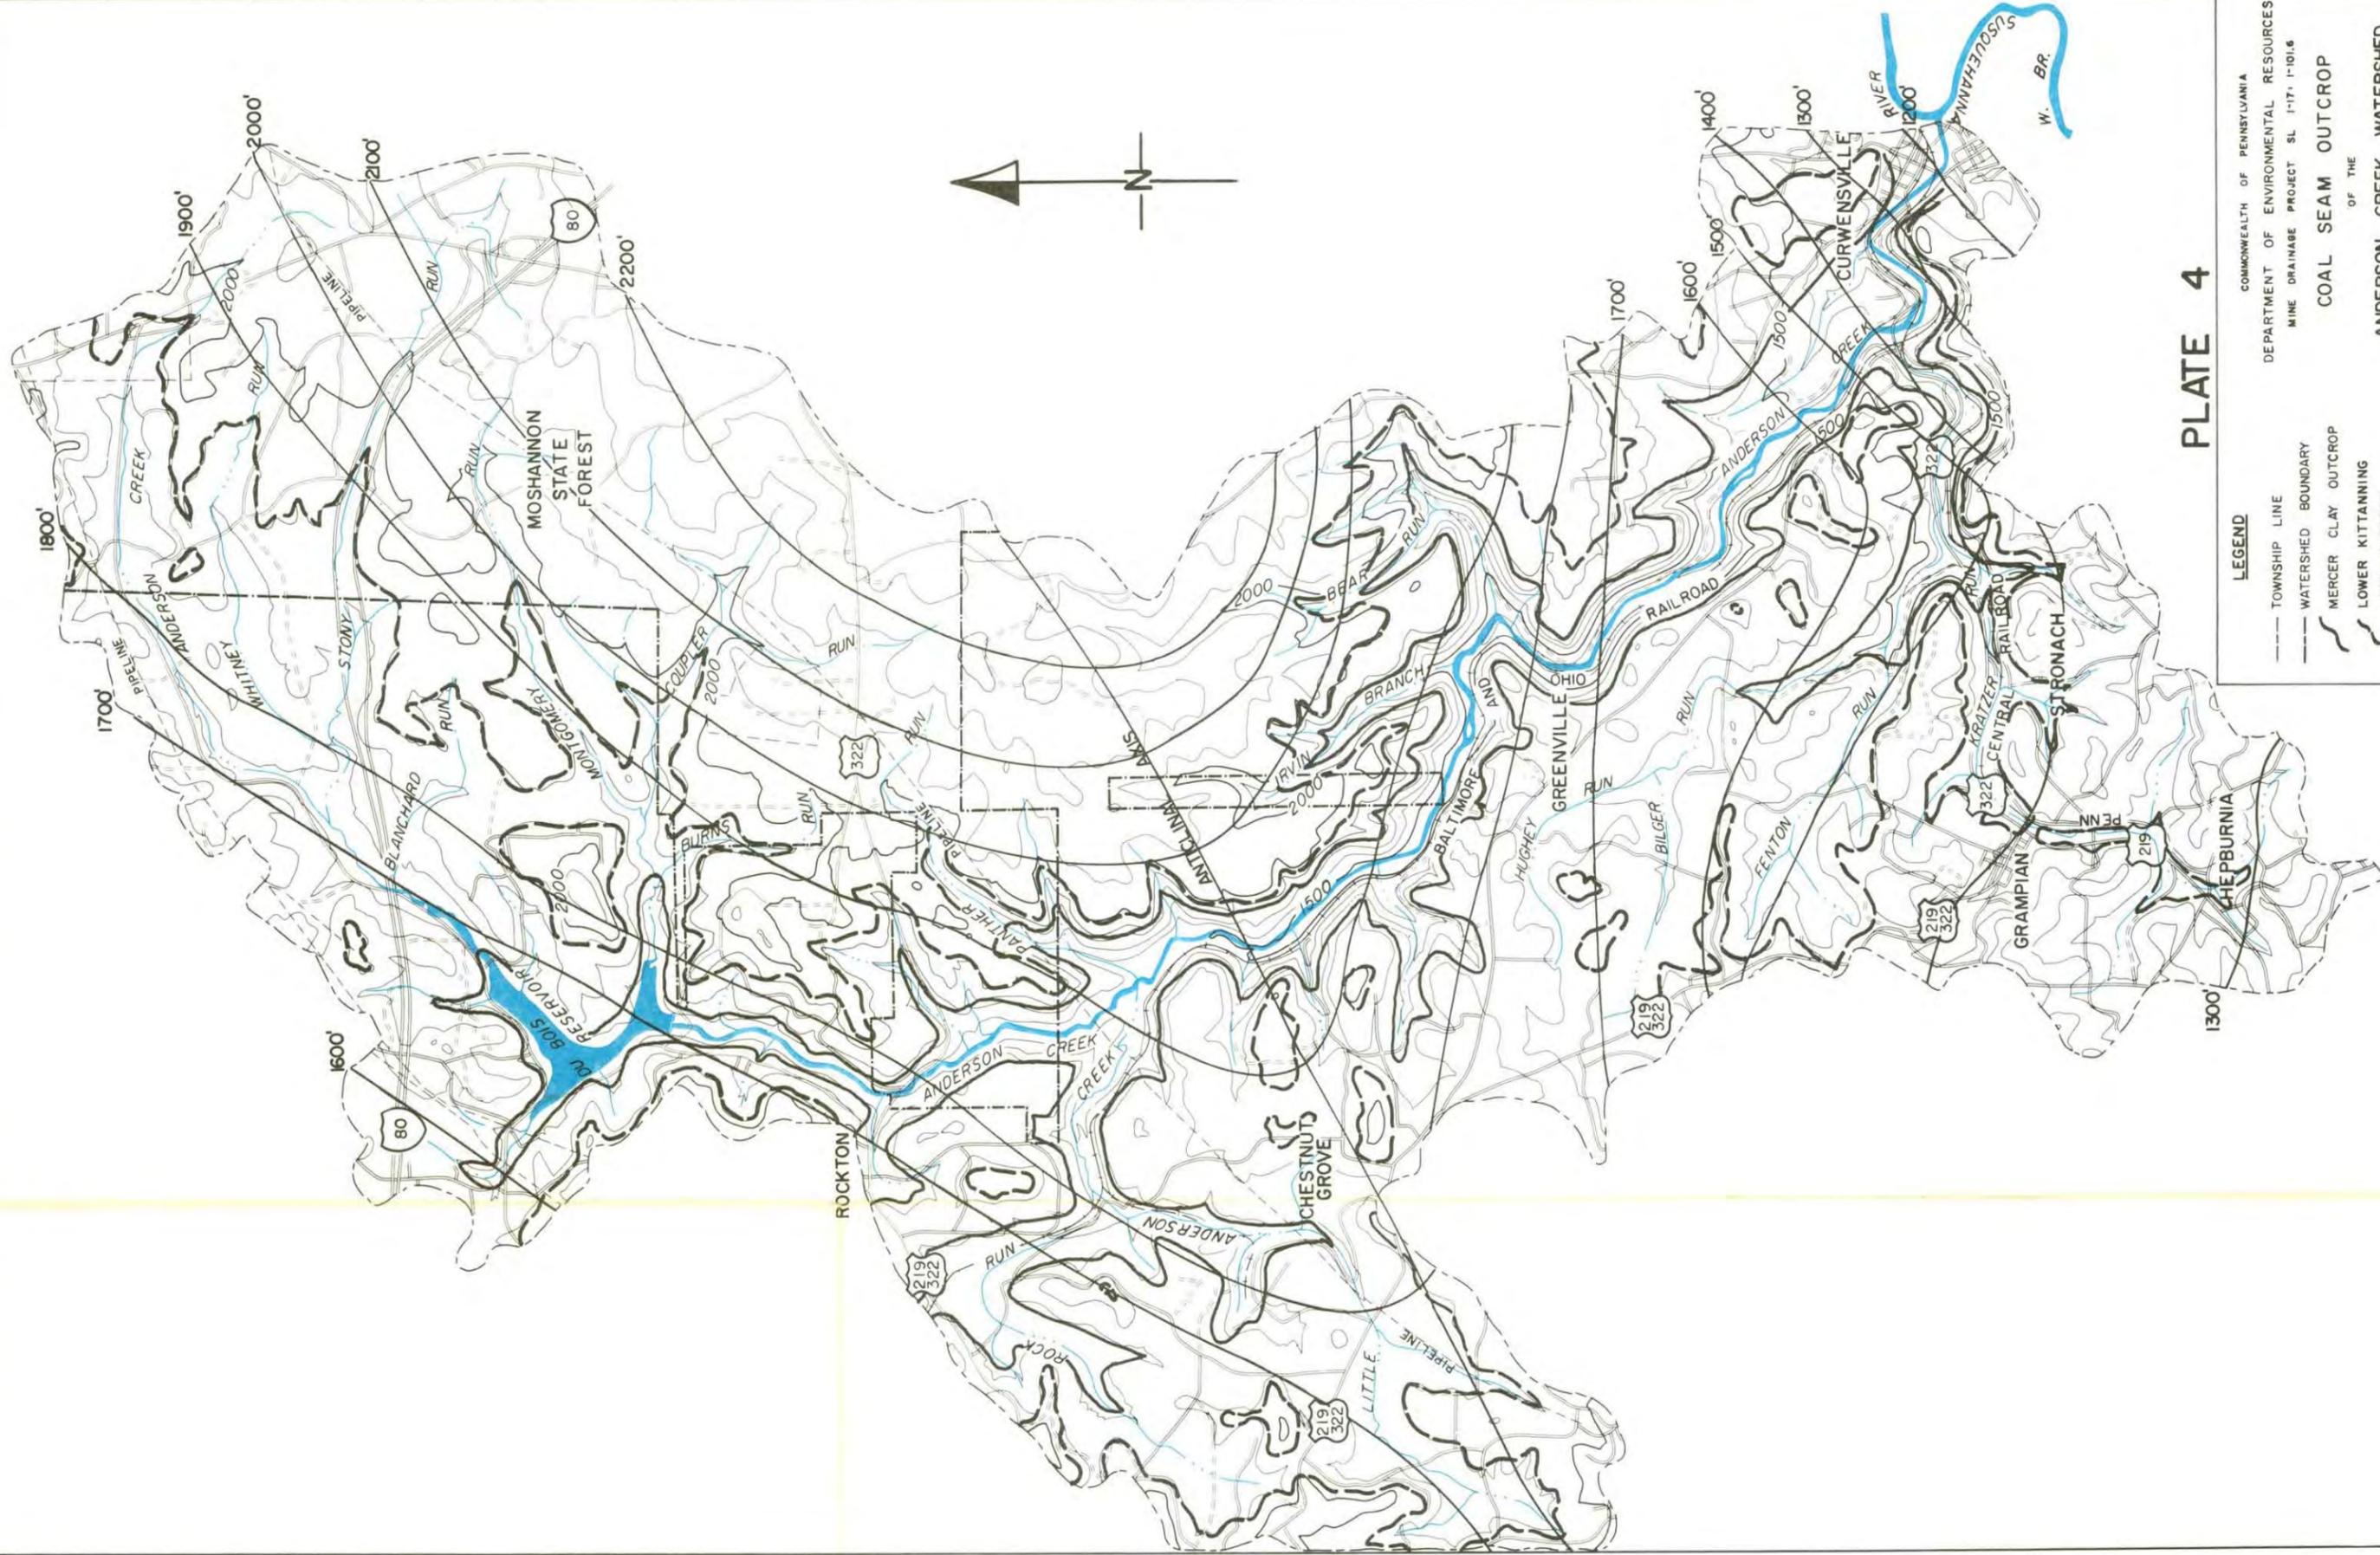
PLATE 4

COAL SEAM OUTCROP
 OF THE

ANDERSON CREEK WATERSHED

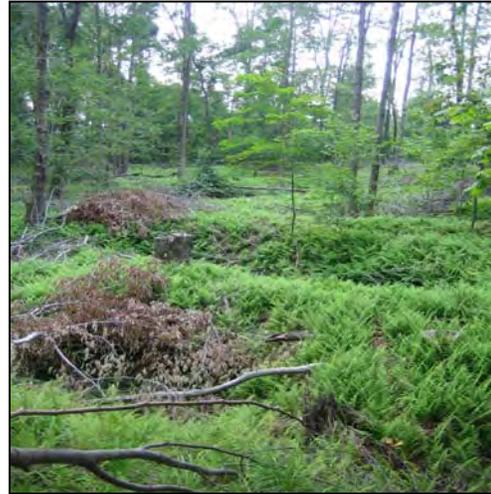
Subsidence area above the Spencer clay mine. Note the numerous depressions. Such areas direct rain and surface water directly into the underground mine, which increases pollution. Subsidence areas are extremely hazardous to nearby residents.

Clay mines account for mine discharges containing high levels of acidity and aluminum, known for its toxicity to aquatic life. Several high-flow discharges from abandoned underground clay mines account for a significant portion of the pollution entering Anderson Creek. In some instances, because the clay seams that were mined were relatively thick and often close to the surface, significant areas of subsidence have occurred. The subsidence not only creates surface depressions that develop flow paths of surface water into the mine voids, it also increases the opportunity for oxygen to enter the mine, which accelerates the chemical reactions that produce AMD. Furthermore, coal often lies above the clay. When subsidence occurs, the coal and surrounding materials, which contain the pyrite that produces AMD, collapses into the clay mine, increases acid production, and helps leach the aluminum from the clay. Eventually, the toxic AMD escapes from the mine and enters surface water streams where it has a devastating effect on all aquatic life.

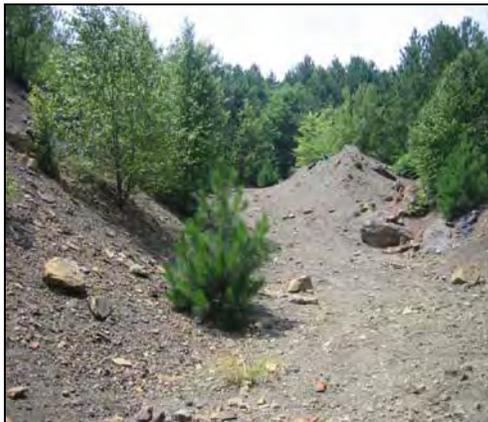
Poorly vegetated mine spoil on an abandoned surface mine.

Problems associated with unreclaimed surface mining also severely degrade the stream. Again, the problem is compounded by the fact that clay was surface mined and coal seams above the clay were regarded as an insignificant resource compared to the clay. Most often this coal and its associated shales were intermixed and “spoiled” on site, often left in unvegetated, haphazard piles without proper drainage. Several of these areas exist throughout the watershed. Some do not show significant surface water impairments on-site, but can be associated with AMD discharges at lower elevations, where they often appear next to the stream. Others create AMD on-site and pollute adjacent watercourses.
