## **A-1 INTRODUCTION TO CONTRARY RUN SECTION OF THE REPORT**

Section A of the report deals with the Contrary Run watershed, one of the watersheds selected for investigation as part of an overall effort of Beech Creek water quality cleanup headed by the Beech Creek Watershed Association. Contrary Run is a tributary to Sandy Run, classified as CWF (cold water fishery). As defined by DEP in Chapter 93 of the regulations, a designation of CWF indicates that the maintenance and/or propagation of fish species including the family Salmonidae and additional flora and fauna indigenous to a cold water habitat is to be protected.

The watershed is located approximately three and a half miles north of Snow Shoe, Centre County, Pennsylvania; the watershed boundary as delineated on a 7½ minute topographic map (Snow Shoe Quadrangle) is shown in Figure A-1.

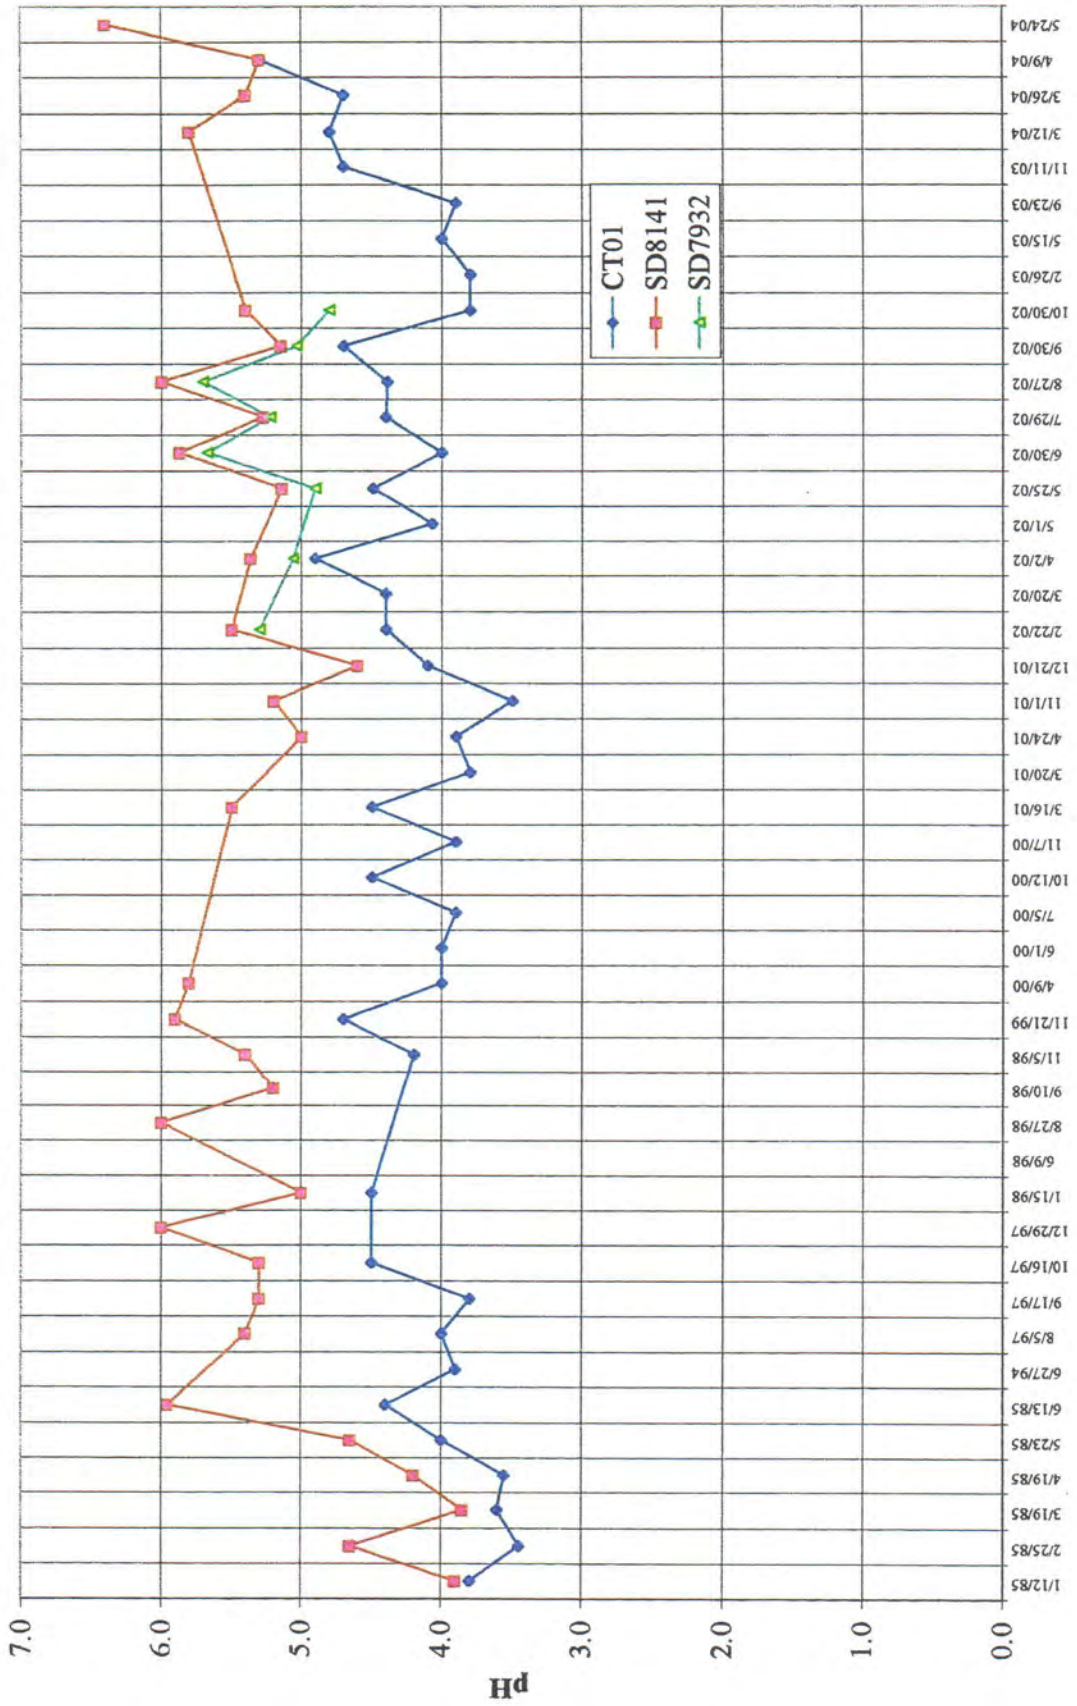
Figure A-4. Time Series Plots for Field pH Levels Measured at Contrary Run (CT01), Sandy Run above Confluence with Contrary Run (SD8141) and Sandy Run (SD7932) below confluence with Contrary Run

The impacts on Sandy Run from the Contrary Run inflow (median field pH of 4.0 at CT01) are measured at sample point SD7932, located approximately 550 feet downstream from the confluence, where the stream pH level drops to 5.1. Figure A-4 is a time-series plot of field pH levels measured at three (near confluence) points, i.e. Contrary Run point CT01 directly above inflow into Sandy Run, and Sandy Run points SD8141 (upstream) and SD7932 (downstream), of confluence with Contrary Run. The impact of Contrary Run inflow on Sandy Run quality is reflected in the lower field pH levels at the downgradient point of Sandy Run as measured in year 2002.

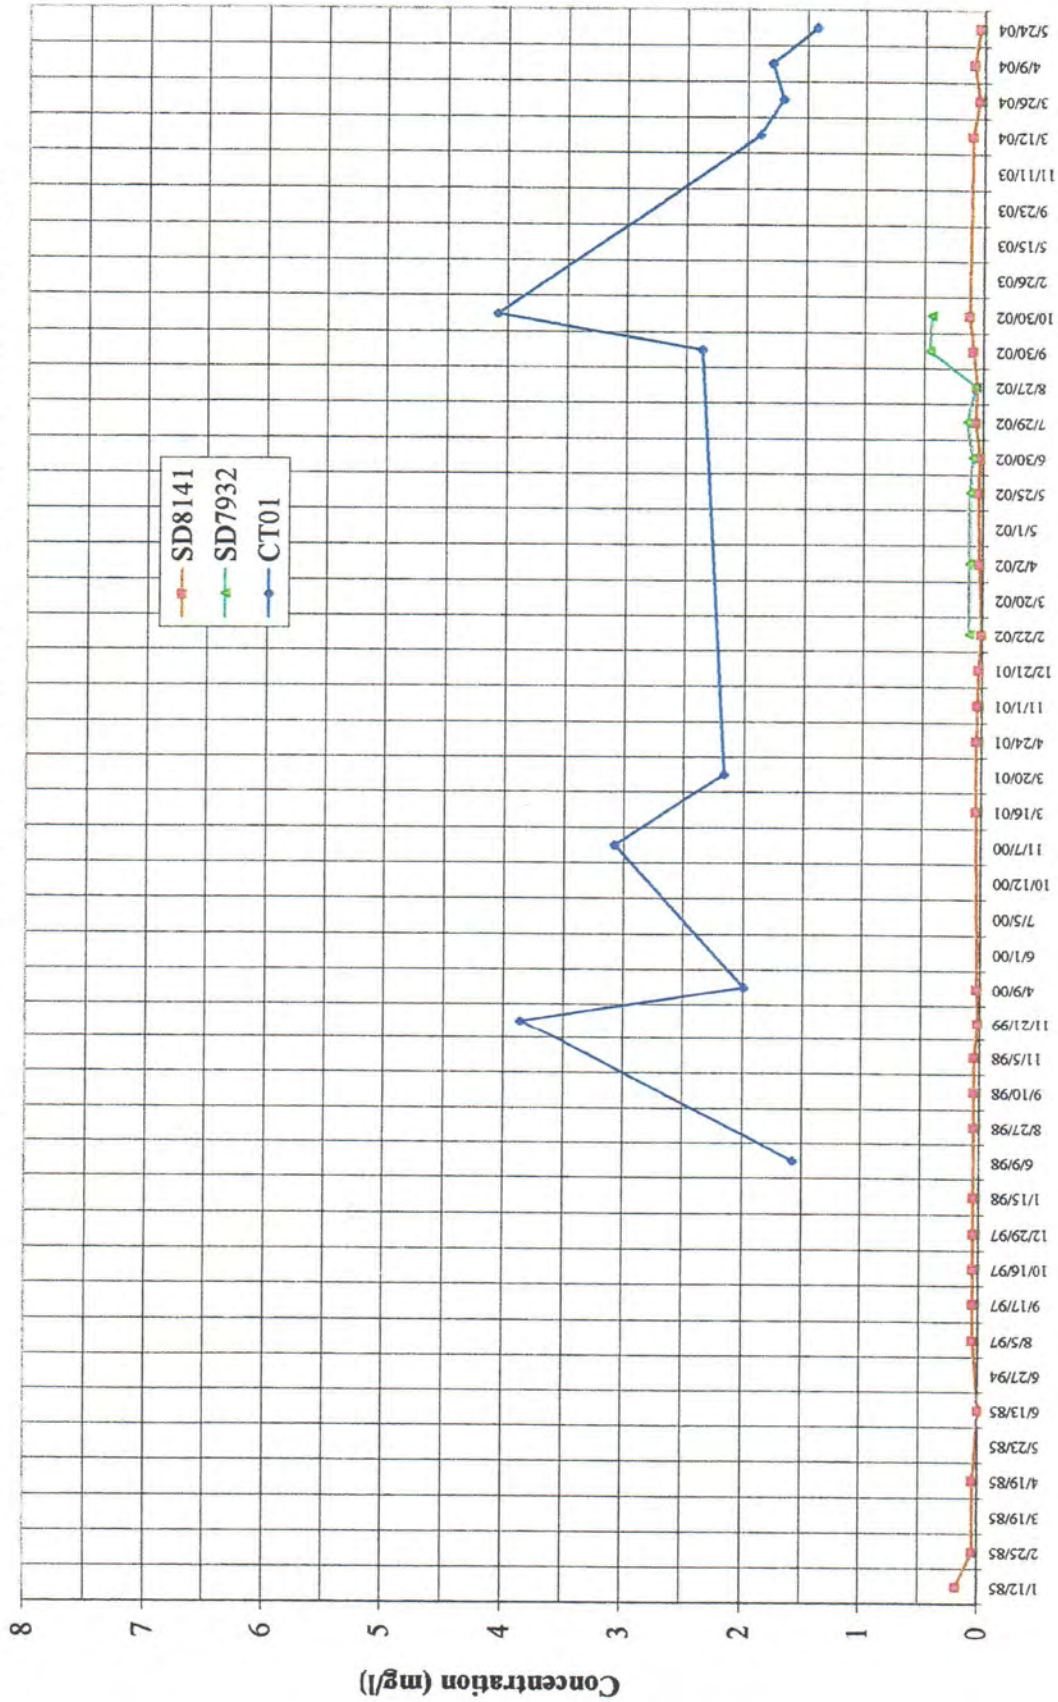
Figure A-11. Time Series Plots for Total Aluminum Concentrations Measured at Contrary Run (CT01), Sandy Run above Confluence with Contrary Run (SD8141) and Sandy Run (SD7932) below confluence with Contrary Run

Total aluminum concentrations as measured in Contrary Run and Sandy Run are shown in a time-series plot given in Figure A-11 for three (near confluence) stream points. The observed total aluminum concentrations of Contrary Run are on average approximately 2.3 mg/l greater than those of upgradient Sandy Run. An impact on the total manganese mean concentrations of Sandy Run downstream from its confluence with Contrary Run was observed in an average increase from 0.08 mg/l to 0.8 mg/l as measured in year 2002.

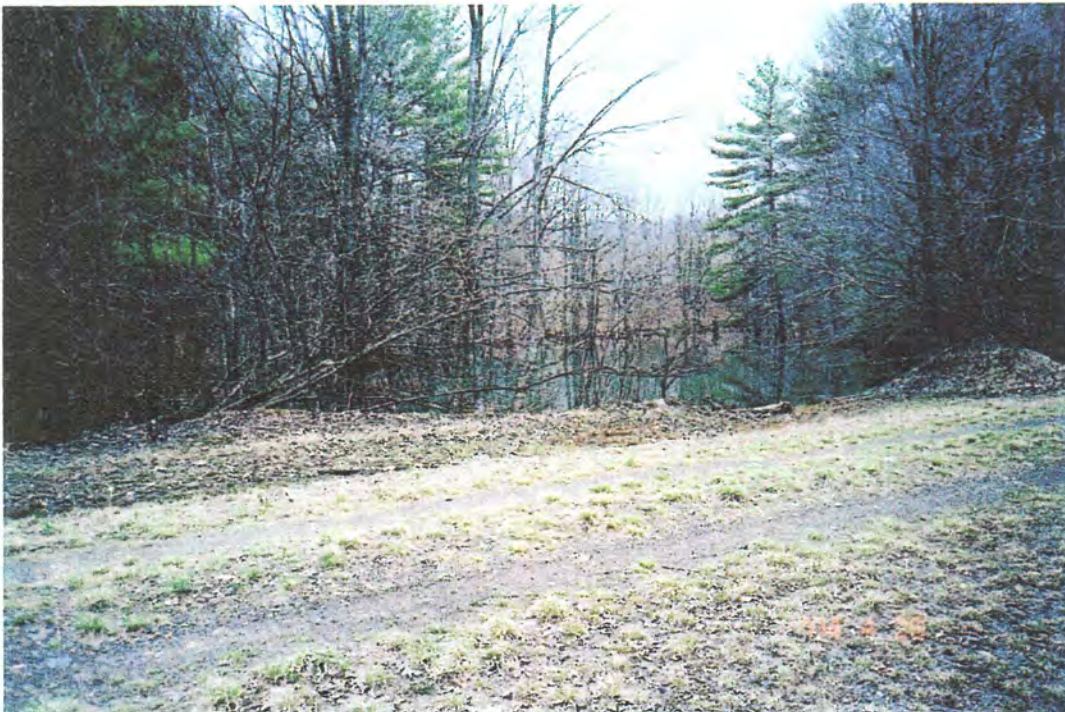
Figure A-14. Impoundment in Lower Kittanning Mine Spoil, Mine Area SM-3C.

The coal extraction in mine area SM-3C was in the headwaters of Contrary Run. The stream bed was obliterated and replaced by mine spoil. Drill hole DH-5 located within mine area SM-3C penetrated 20 feet of the Lower Kittanning mine spoil. Overburden analyses for spoil samples indicate no net neutralization potential.

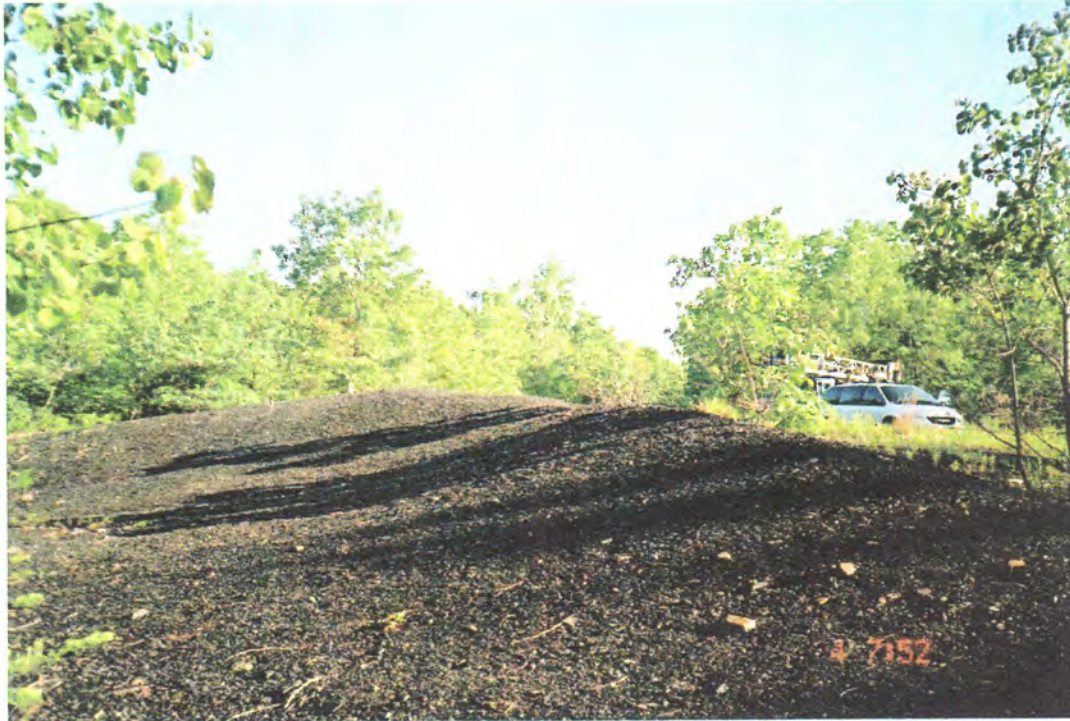
Several coal refuse piles were mapped in mine area SM-3C; the piles are approximately 1-5 feet thick and cover an area of less than 1 acre (see Figure A-16). A coal refuse sample collected from one of the piles is characterized by ash content of 12.42 percent, BTU/LB of 10,167, and total sulfur of 0.47 percent (as received).

Figure A-16. Coal Refuse Pile in Mine Area SM-3C.

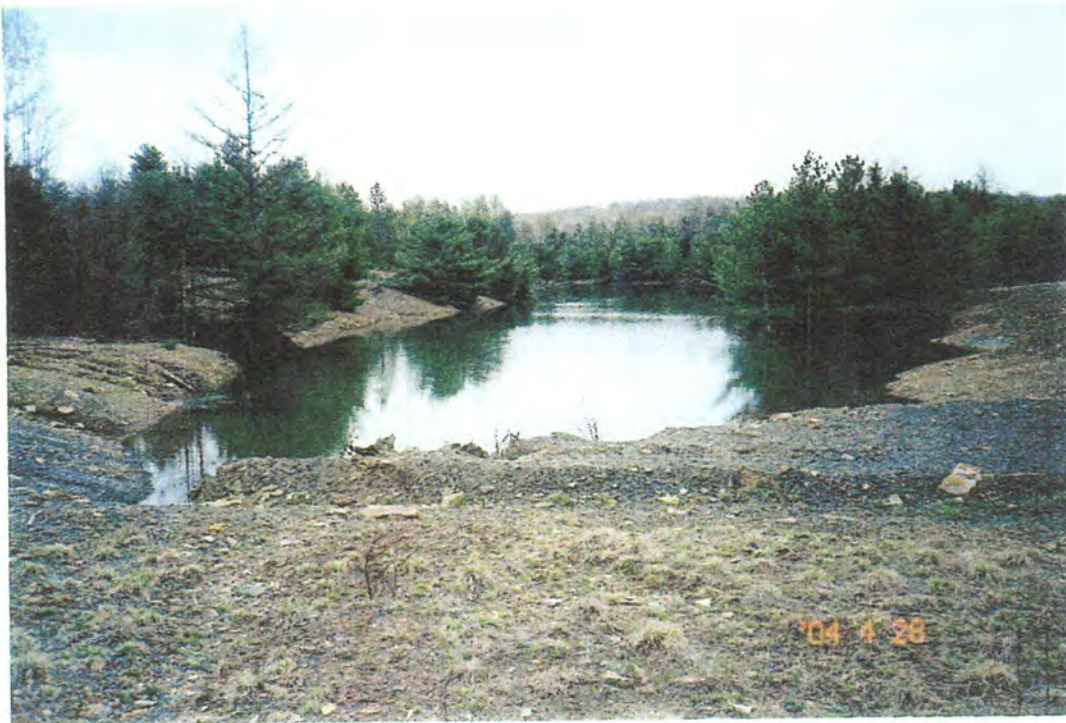
The lake in the box cut receives drainage from the southwest, conveyed by the UT-B tributary, monitored at sample point CT13. There is no outflow from the impoundment and all inflowing water infiltrates the surrounding spoil and ground water system.

Figure A-17. Impoundment in Abandoned Box Cut in Brookville Mine Spoil, Mine Area SM-5, Upgradient from Sample Point CT39.

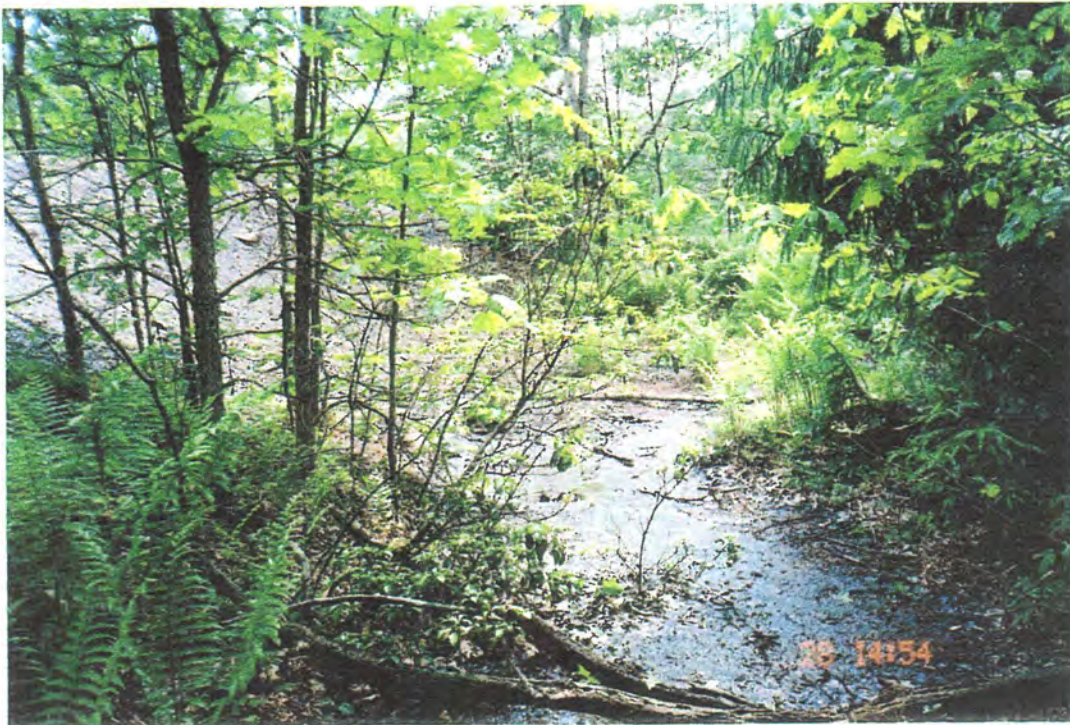
A discharge at the toe of Brookville mine spoil at sample point CT39 (see Figure A-18) seeps into the shallow ground water system and jointly with shallow ground water flow from the mined area recharges the downgradient stream UT-C. Figures A-19 and A-20 show the stream with red iron precipitating in the stream bed when the iron laden base flow enters stream water with elevated alkalinity.

Figure A-18. Discharge at Toe of Brookville Mine Spoil, Mine Area SM-5, Sample Point CT39

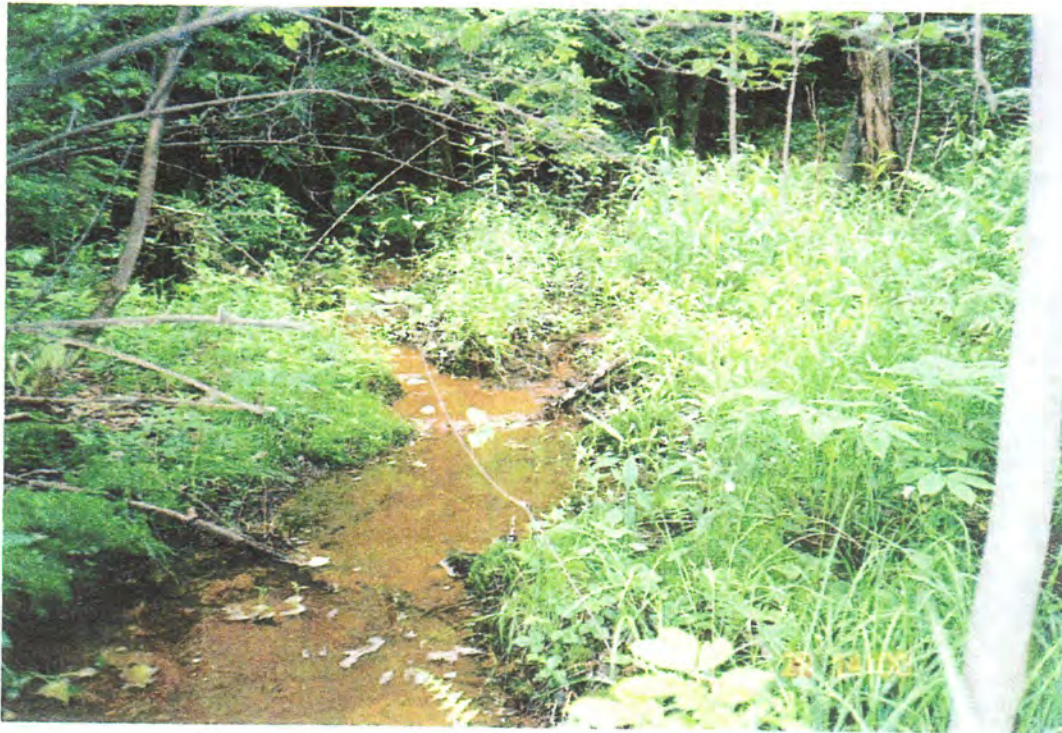
Figure A-19. UT-C after Receiving Base Flow Recharge of Brookville Mine Spoil Water near Sample Point CT37.

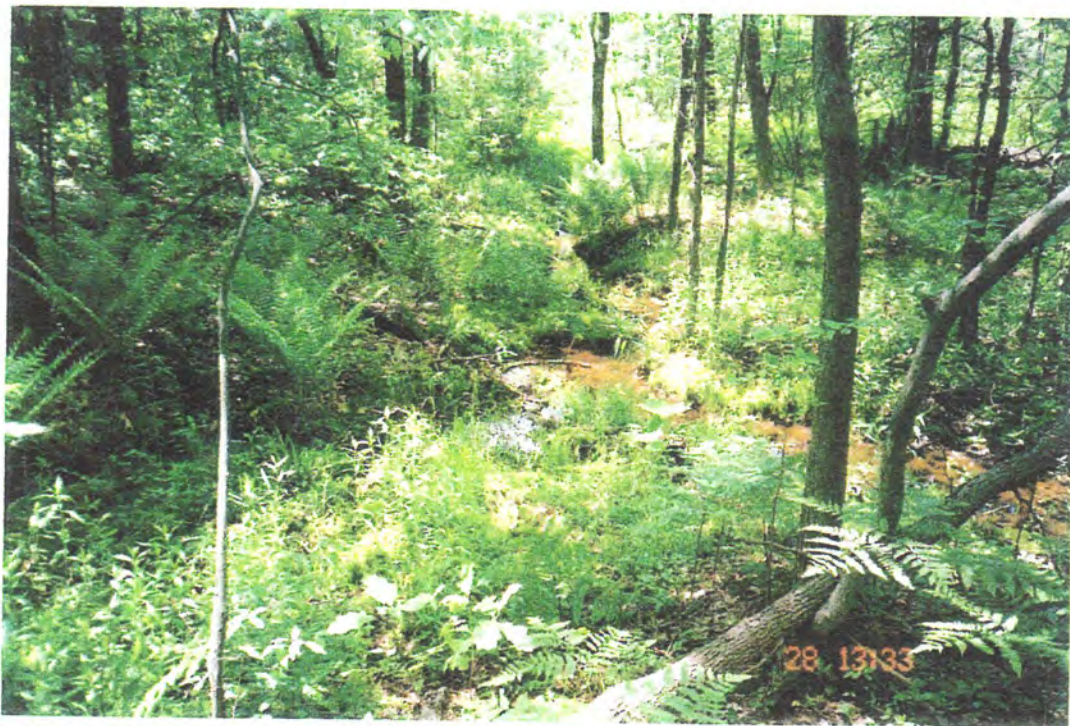
Figure A-20. UT-C after Receiving Base Flow Recharge of Brookville Mine Spoil Water near Sample Point CT11.

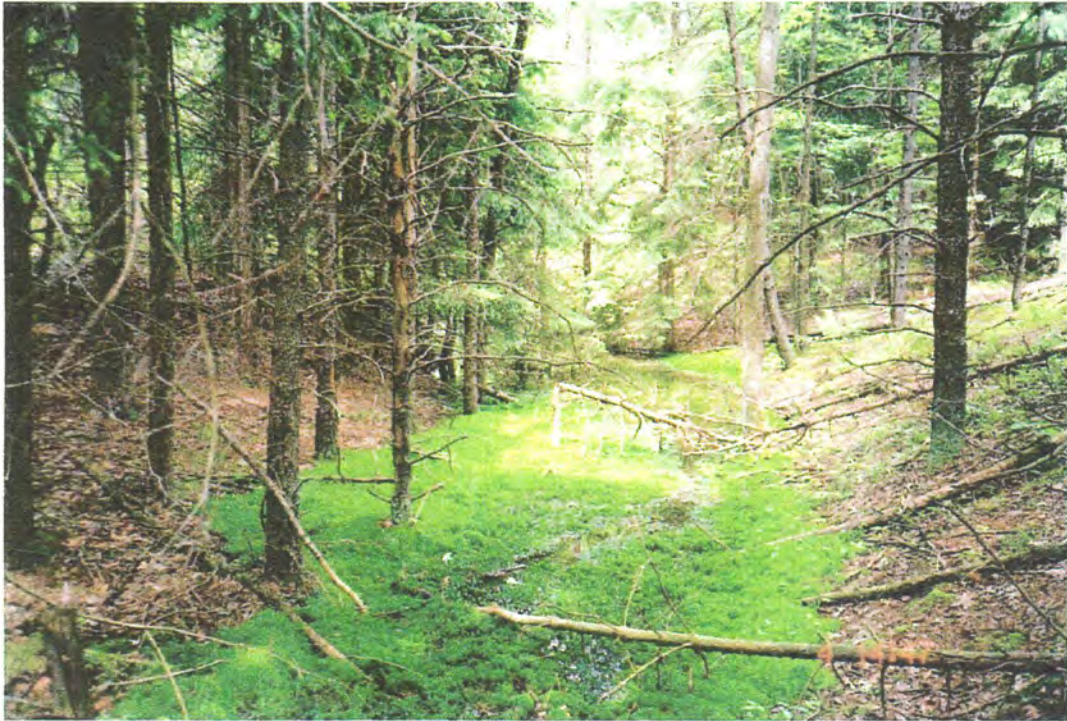
Figure A-21. Drainage Channel in Clarion Mine Spoil, Mine Area SM-6A.

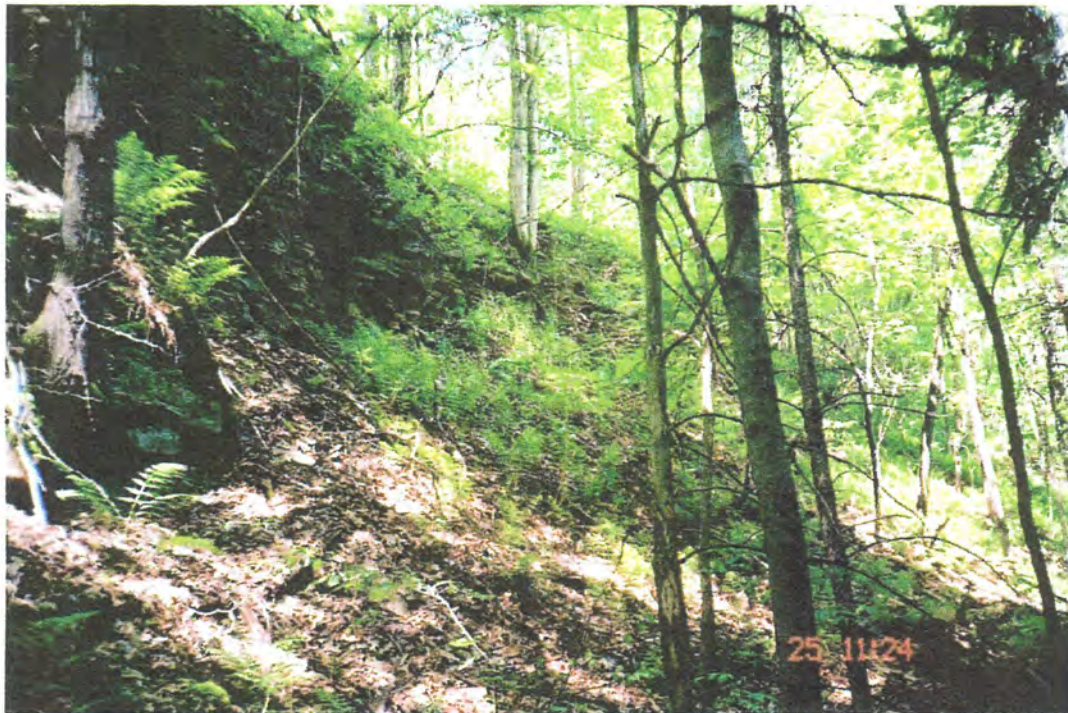
Figure A-22. Clarion Highwall, Southwest of Sample Point CT-16, Mine Area SM-6B.

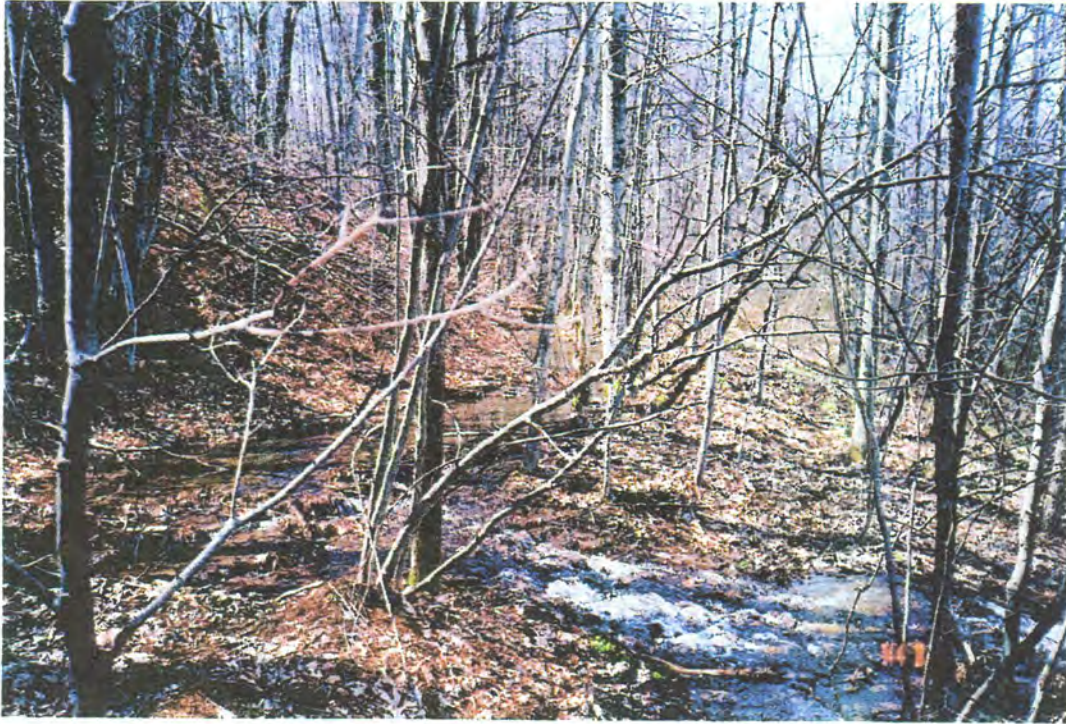
Site characterization - The Clarion seam was mined at right angle (strike parallel) to the structural dip to the existing highwall; the length of the highwall is 1, 670 feet, estimated average highwall height is 15-25 feet. The current highwall conditions are shown in Figure A-22. Mine spoil covers an area of 12 acres; it is recharged by precipitation with mine spoil water draining to the southeast. The mine spoil flow is intercepted by two impoundments; the impoundment in the middle of the mine area drains at sample point CT16, the southernmost impoundment is an inundated un-drained depression within the mine spoil (sample point CT15). The outflow from the middle pond joins a stream diversion ditch of UT-A above the point where the ditch is breached and the stream overflows into the adjacent mine area SM-7 (see Figures A-23 and A-24).

Figure A-23. Flow in Stream Diversion Channel (UT-A) near Sample Point CT17, East of Mine Area SM-6B.

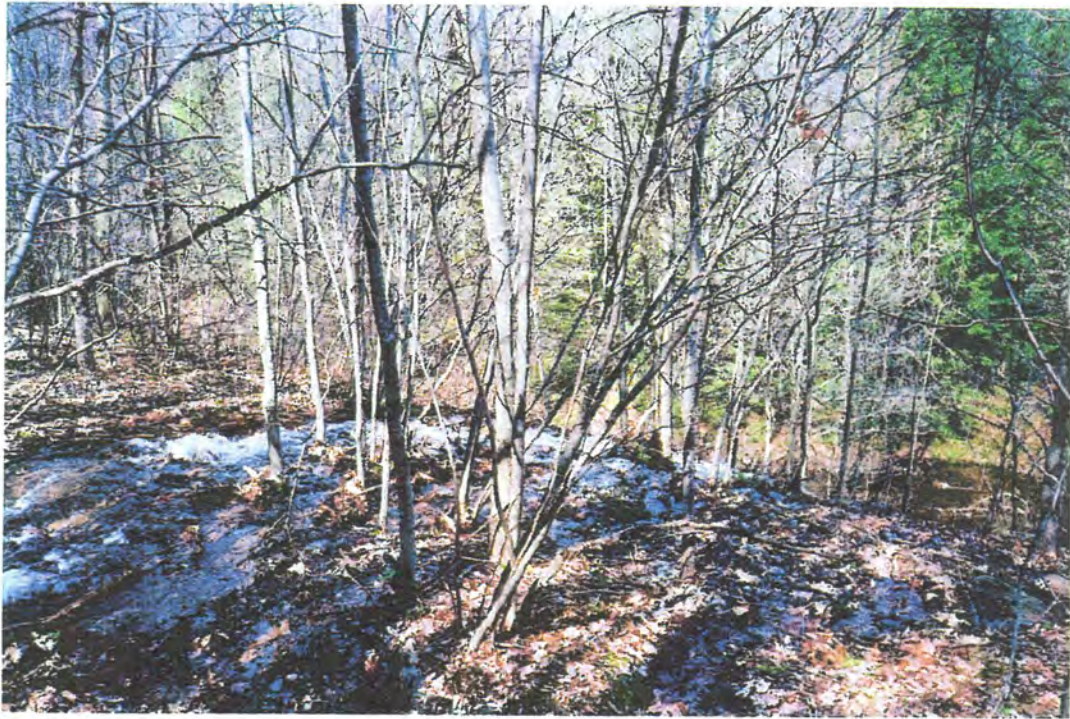
Figure A-24. Breach of Stream Diversion Channel (UT-A) near Sample Point CT17, East of Mine Area SM-6B with Inflow to Mine Area SM-7.

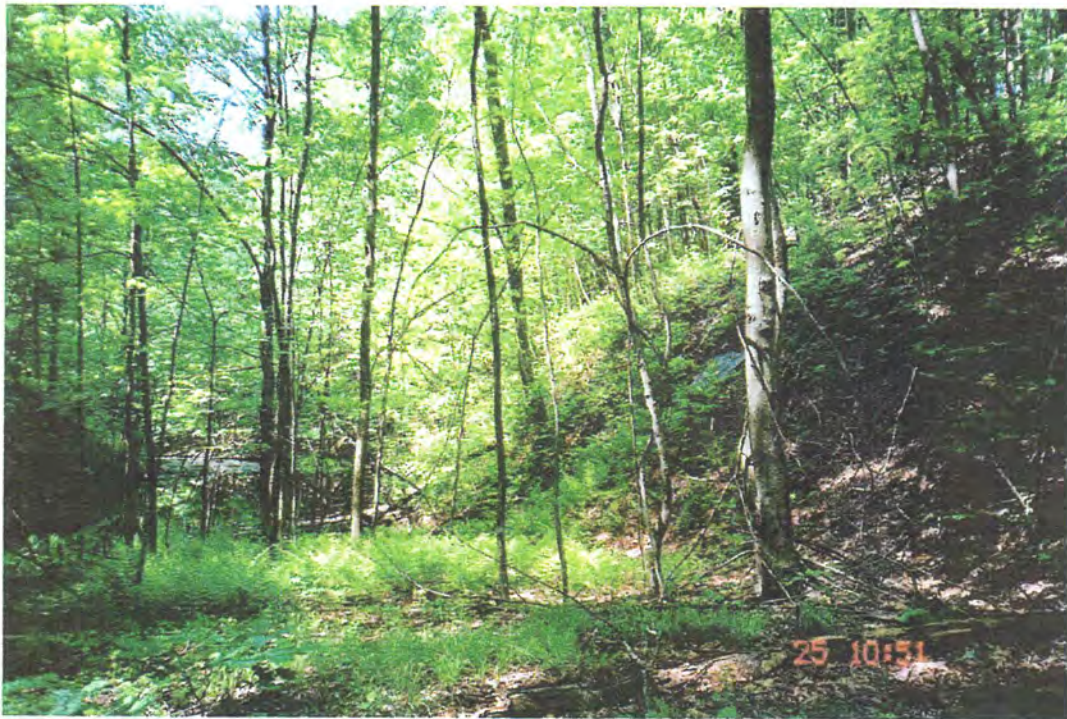
Figure A-25. Clarion Highwall and Impoundment near Sample Point CT20, Mine Area SM-6C.

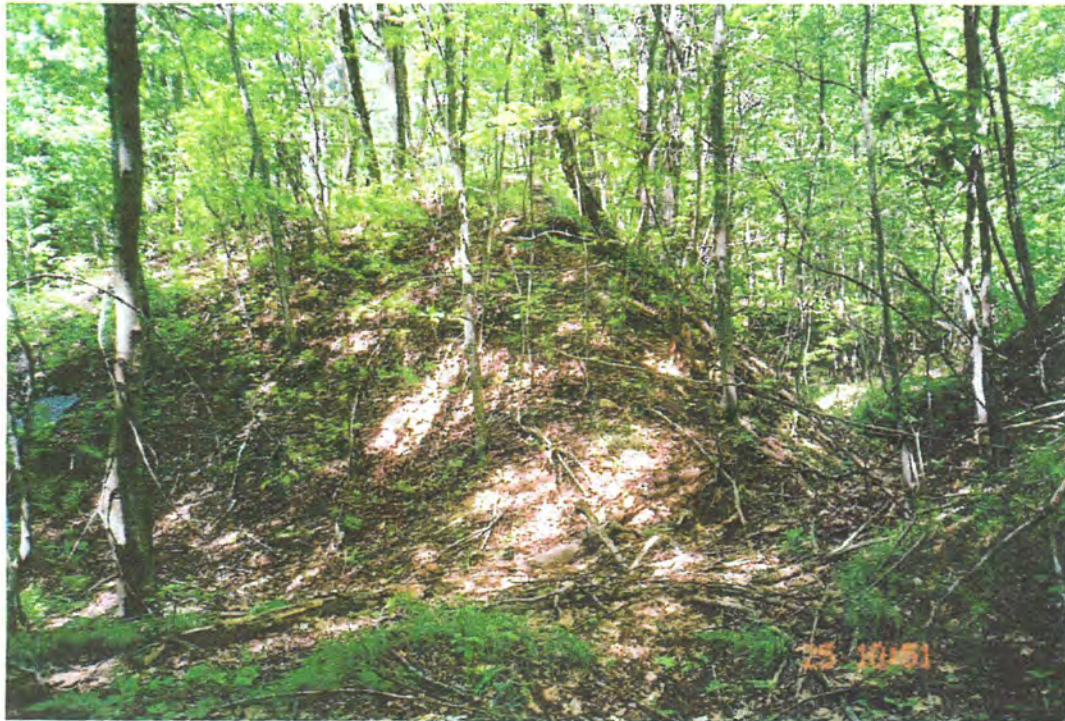
Figure A-26. Clarion Mine Spoil near Sample Point CT20, Mine Area SM-6C

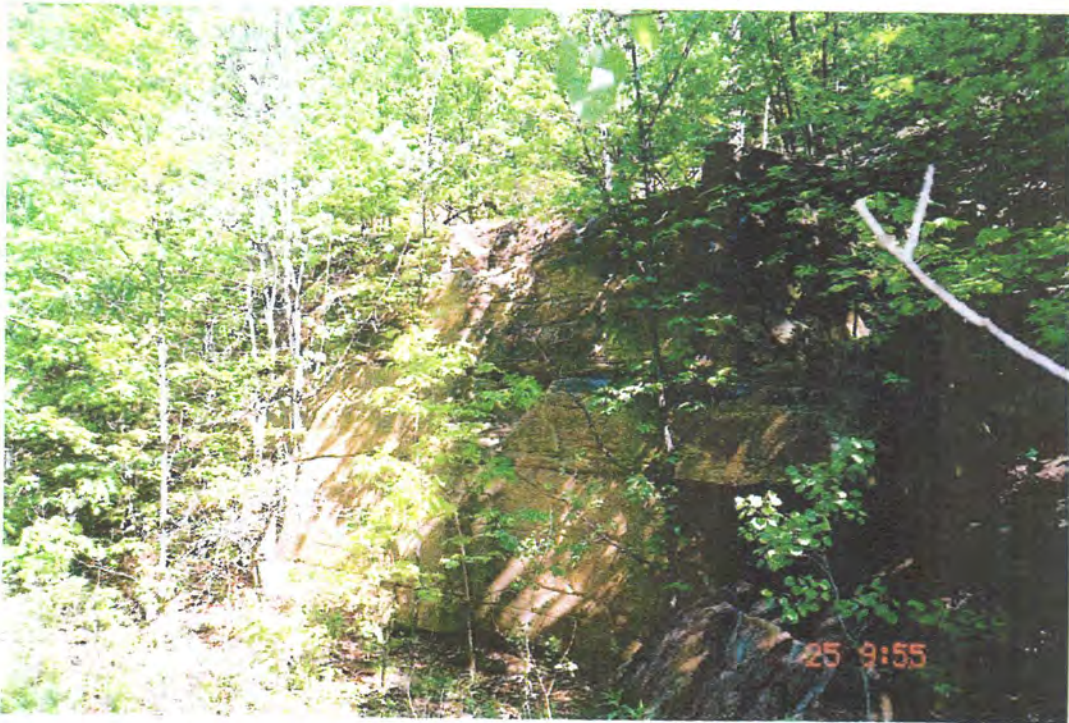
Figure A-27. Brookville Highwall, 500 feet Southwest from Impoundment between Mine Areas SM-7 and SM-8.

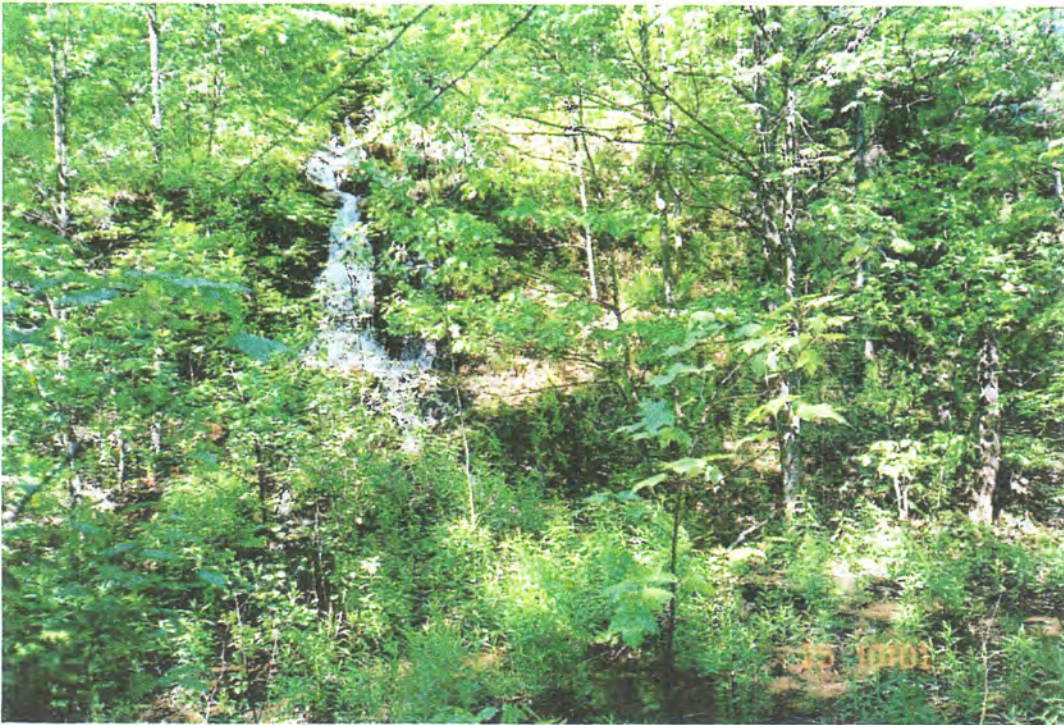
Figure A-28. Inflow into Mine Area SM-7 from Breached Stream Diversion Channel (UT-A), Downstream from Sample Point CT17.

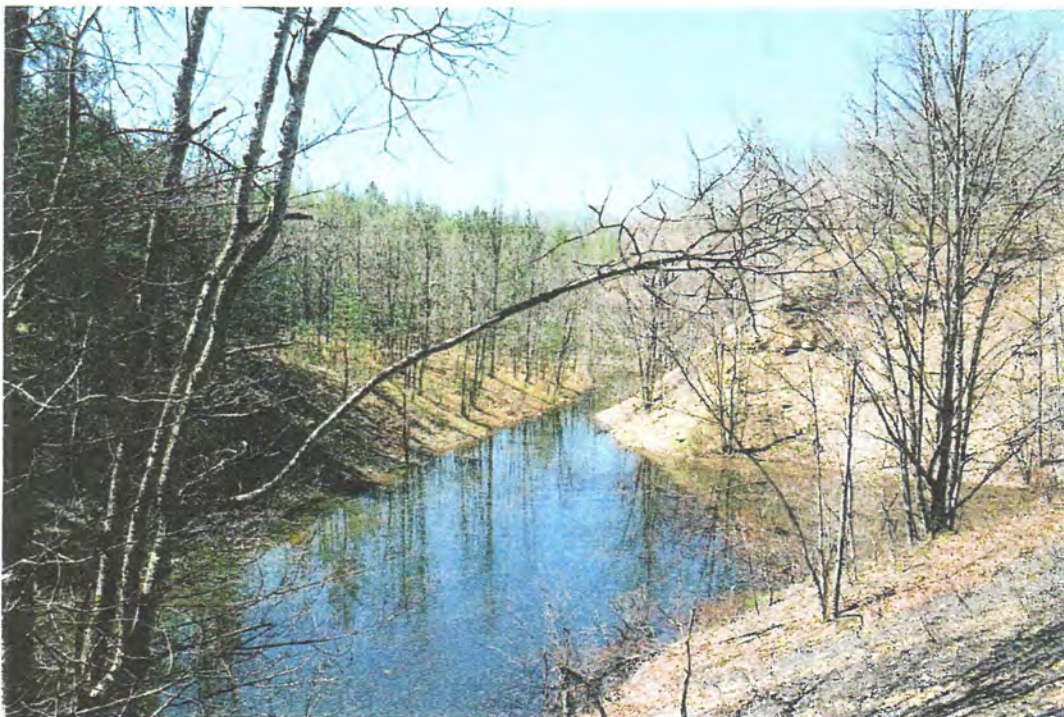
Site characterization - The Clarion seam was extracted from its cropline in the Contrary Run valley updip to the northwest and downdip to the southeast. No highwall exists in the southern limit of the area where the overburden cover was less than 10 feet. A highwall surrounds the rest of the mined area at its western and northwestern limit; the length of the highwall is 1,350 feet, estimated highwall height ranges from 10 to 40 feet (see Figure A-27). Mine spoil covers an area of 15 acres; it is recharged by precipitation and by inflow from the unnamed tributary UT-A diversion ditch. The ditch that was originally constructed to divert the stream flow around the mining operation was breached where the UT-A diversion and pond overflow (CT16) join, east of the surface mine area SM-6B. The stream flows over the highwall (see Figure A-28) and infiltrates the mine spoil. It emerges downgradient in the wetland area of UT-A and UT-B confluence area as base flow recharge to Contrary Run. Mine spoil water may also contribute to the large impoundment separating areas SM-7 and SM-8A (see Figure A-29).

Figure A-29. Impoundment between Mine Areas SM-7 and SM-8.

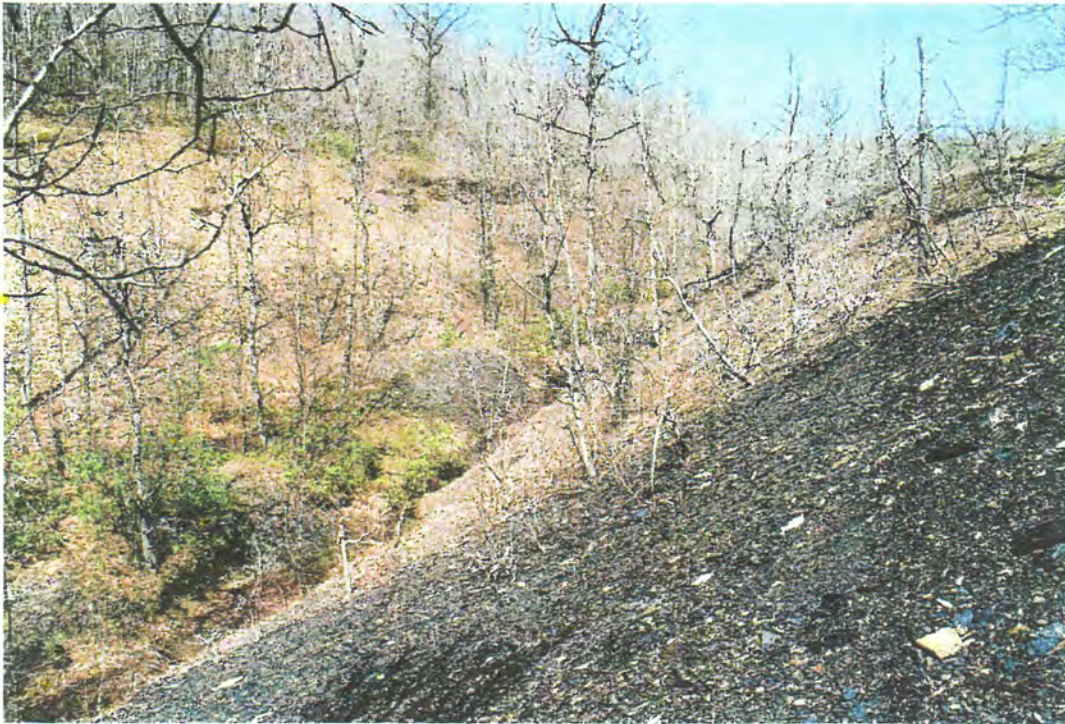
Figure A-30. Brookville Mine Spoil Covered with Coal Refuse and View of Brookville Highwall, Mine Area SM-8.

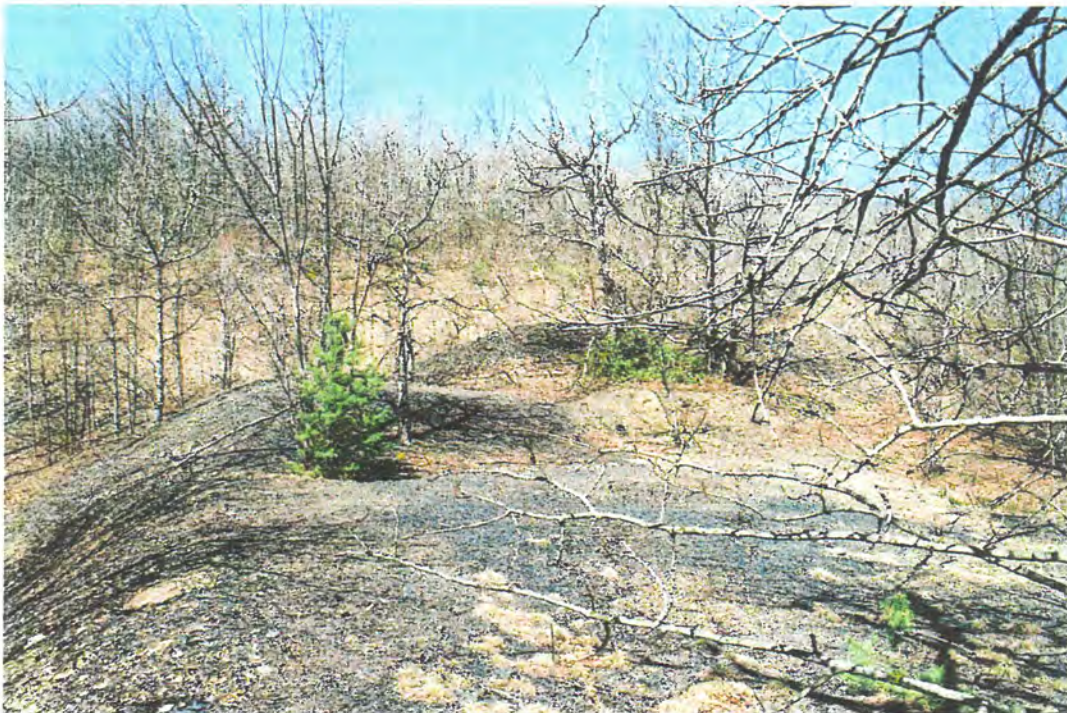
Figure A-31. Brookville Spoil Area with Coal Refuse Piles, Mine Area SM-8.

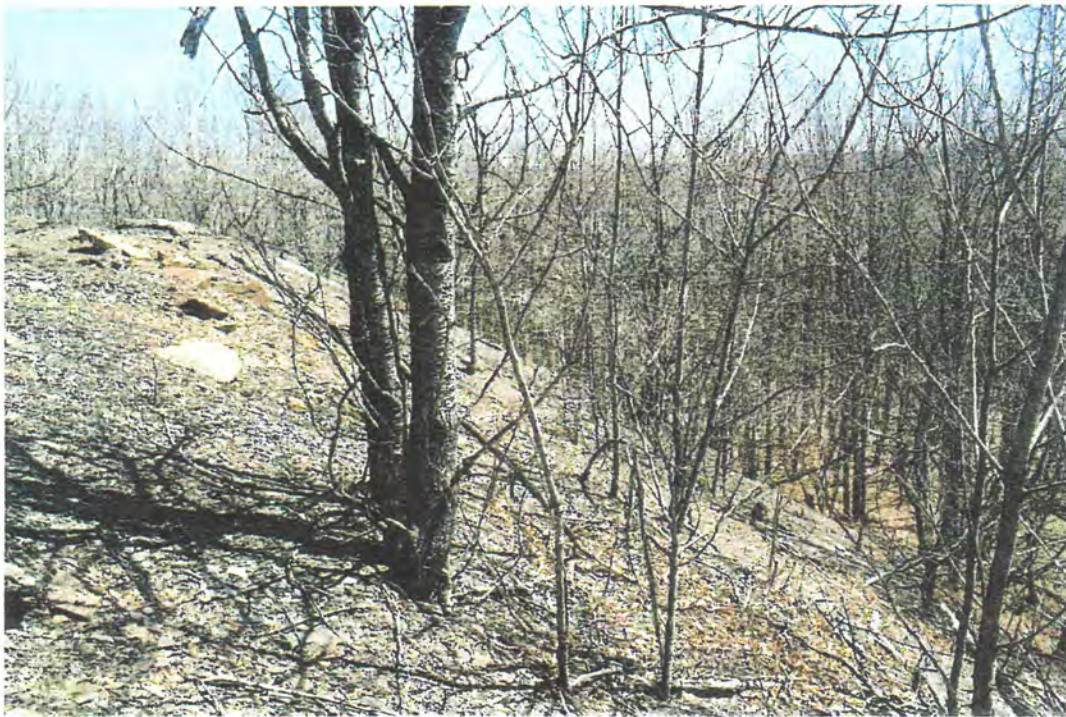
southeast of the currently open box cut; the area of the spoil covers 9 acres (see Figures A-33 and A-34). A spring at the upgradient limit of the box cut (CT28) continues as flow on the pit floor until it enters an impoundment where the water infiltrates into the adjacent spoil and re-emerges at sample point CT27 at toe of the mine spoil (see Figure A-35). The perched spoil water also contributes flow to the southeast where it enters the shallow ground water system of the Contrary Run through base flow recharge. A spring, approximately 600 feet downgradient from the spoil edge, monitored at sample point CT05 shows AMD degradation. The western highwall of the box cut is 1,000 feet long and approximately 50-60 feet high (see Figure A-36). The low wall of the box cut is partially covered by spoil.

Figure A-33. Brookville Clay Mine Spoil Pile, Mine Area SM-11.

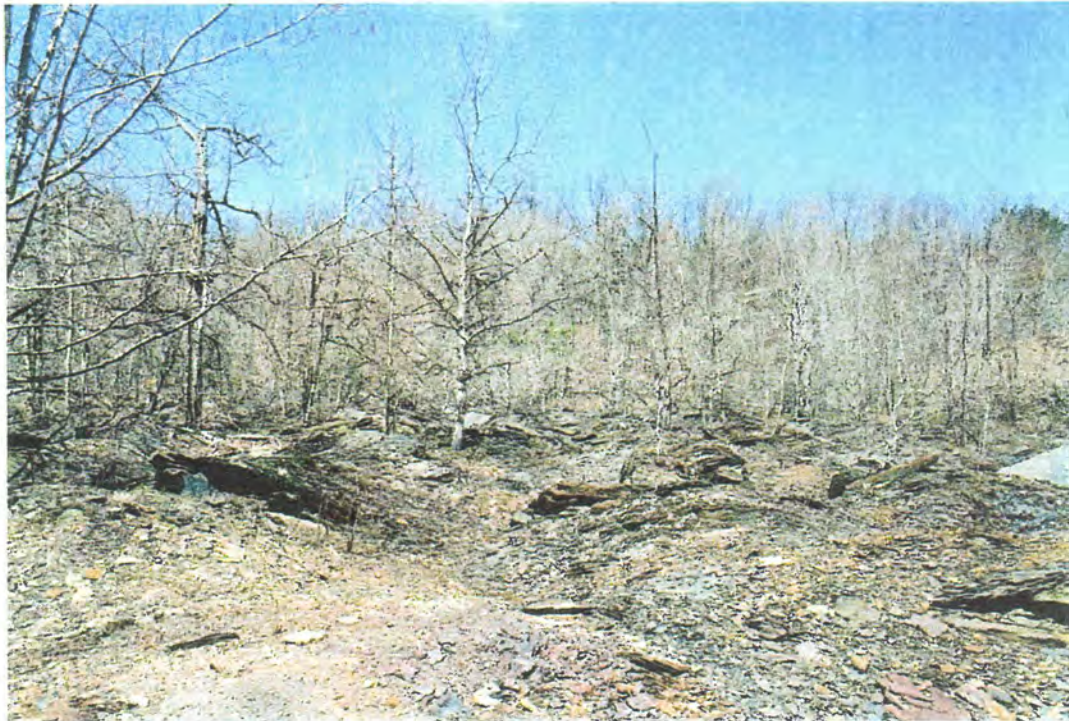
Figure A-34. Brookville Clay Mine Spoil Pile, Mine Area SM-11.

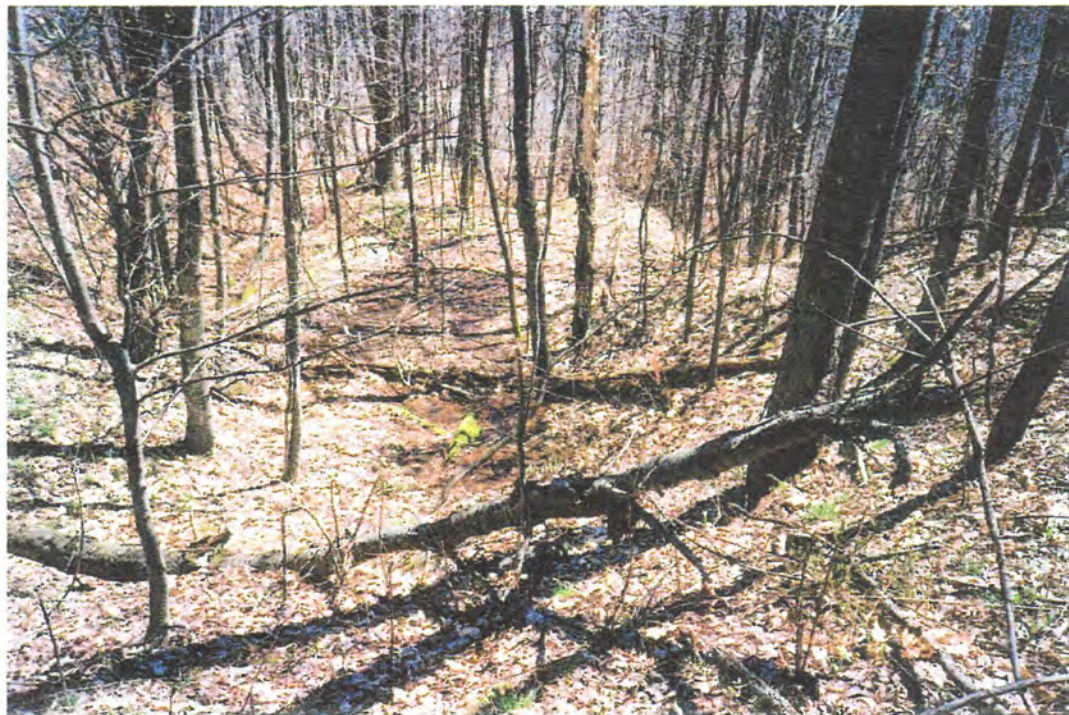
Figure A-35. Discharge from Brookville Clay Mine Spoil, Sample Point CT27, Mine Area SM-11.

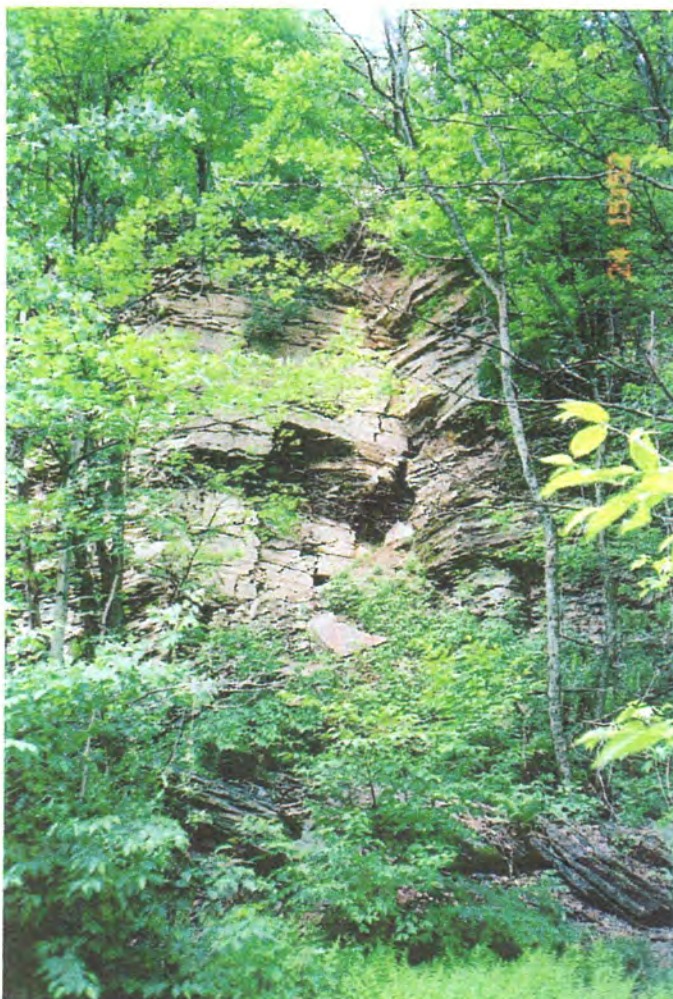
Figure A-36. Brookville Clay Mine Highwall, Mine Area SM-11.

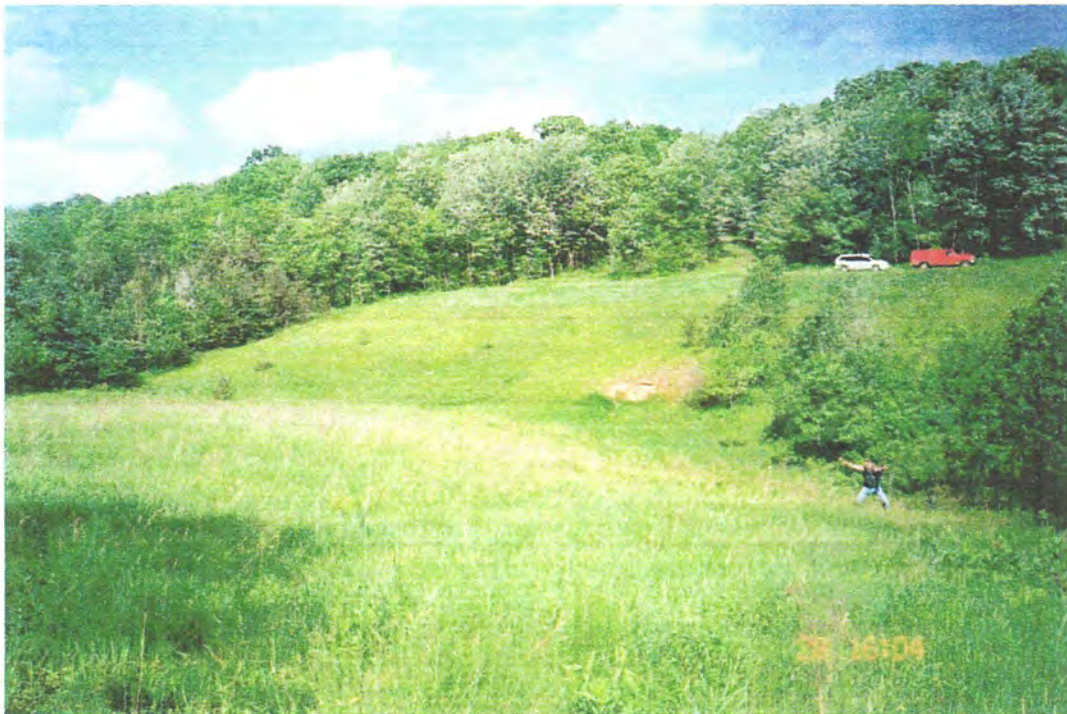
Site Characterization - The coal extraction in the Brookville seam was downdip and at a right angle (strike parallel) to the local structural dip. The mine spoil covers 3 acres; spoil water is perched on the pit floor and drains to the southwest into the adjacent deep mine workings (see Figure A-37).

Figure A-37. Reclaimed Brookville Mine Area SM-12A with Collapsed Deep Mine Entries.
