## **A-1 INTRODUCTION TO CONTRARY RUN SECTION OF THE REPORT**

Section A of the report deals with the Contrary Run watershed, one of the watersheds selected for investigation as part of an overall effort of Beech Creek water quality cleanup headed by the Beech Creek Watershed Association. Contrary Run is a tributary to Sandy Run, classified as CWF (cold water fishery). As defined by DEP in Chapter 93 of the regulations, a designation of CWF indicates that the maintenance and/or propagation of fish species including the family Salmonidae and additional flora and fauna indigenous to a cold water habitat is to be protected.

The watershed is located approximately three and a half miles north of Snow Shoe, Centre County, Pennsylvania; the watershed boundary as delineated on a 7½ minute topographic map (Snow Shoe Quadrangle) is shown in Figure A-1.

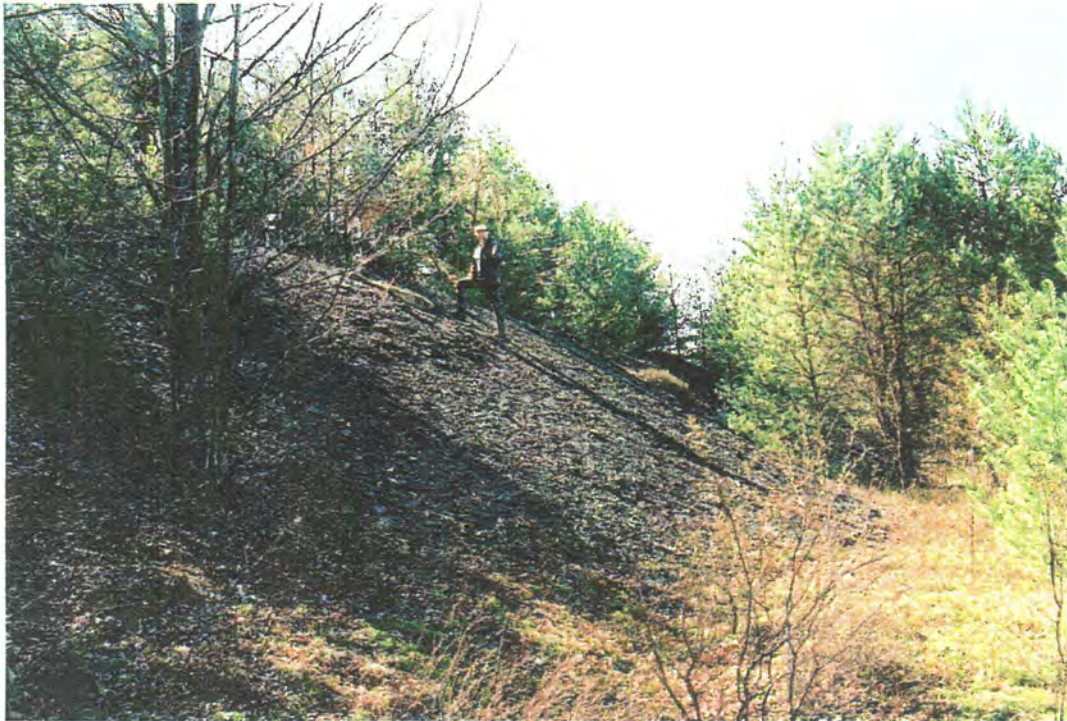
Figure A-38. Brookville Mine Spoil Cover with Coal Refuse, Mine Area SM-12B.

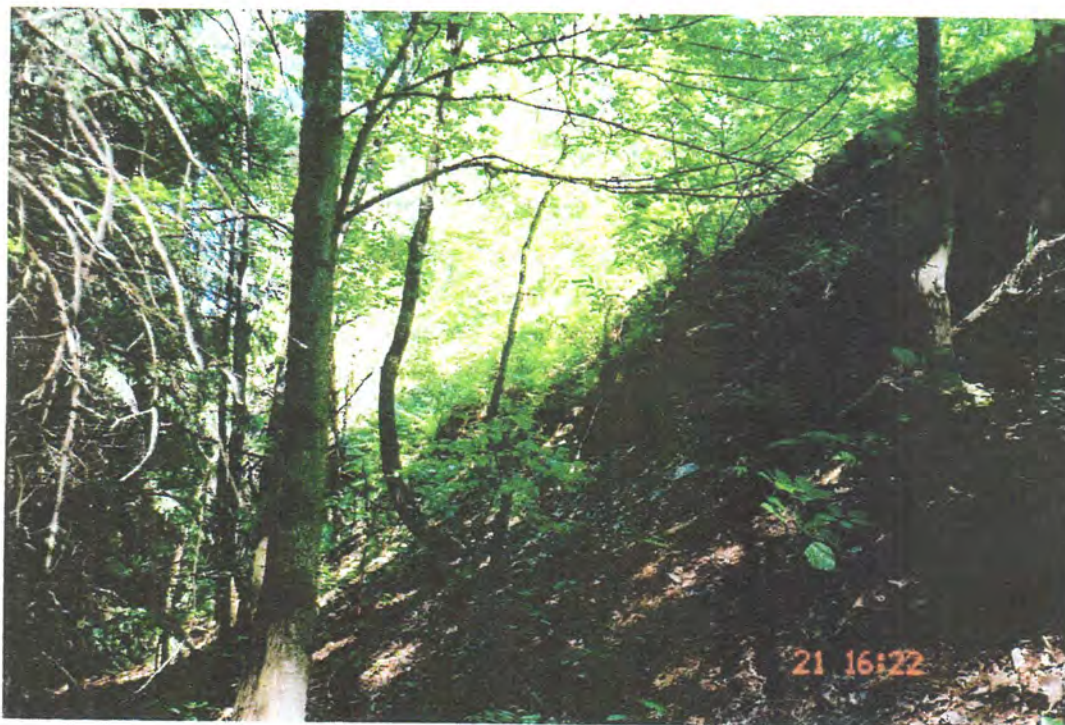
Figure A-39. Clarion Highwall, Mine Area SM-13A.

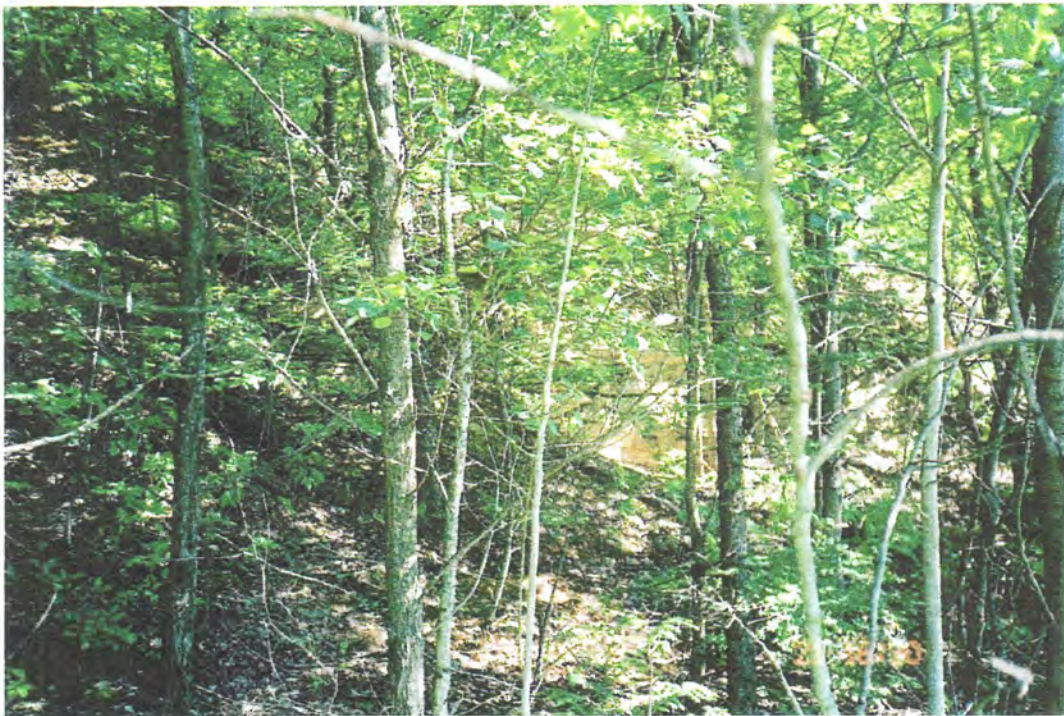
Figure A-40. Clarion Highwall, Mine Area SM-13B.

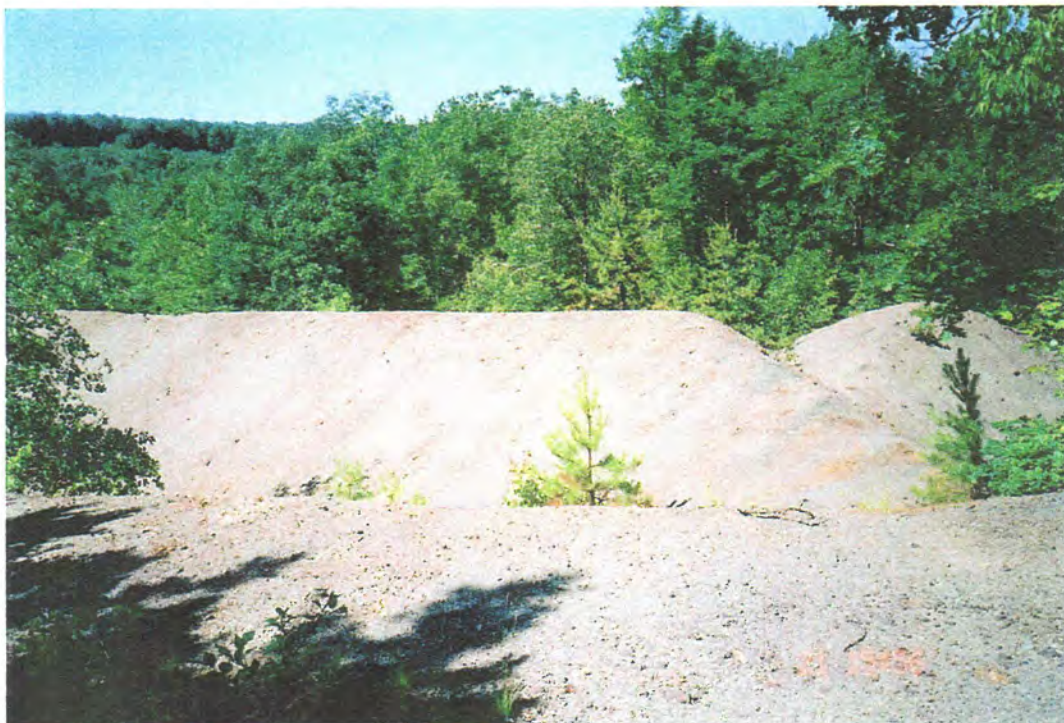
The Brookville deep mine that underlies the northeastern portion of the watershed (deep mine entry D-39 of Gannett et al., 1970) was used for clay extraction; large piles of clay mining refuse were deposited in the valley of Contrary Run, within 200 feet of its stream bed (see Figures A-41 and A-42).

Figure A-41. Mining Refuse from Brookville Clay Deep Mine at D-39 Deep Mine Entry.

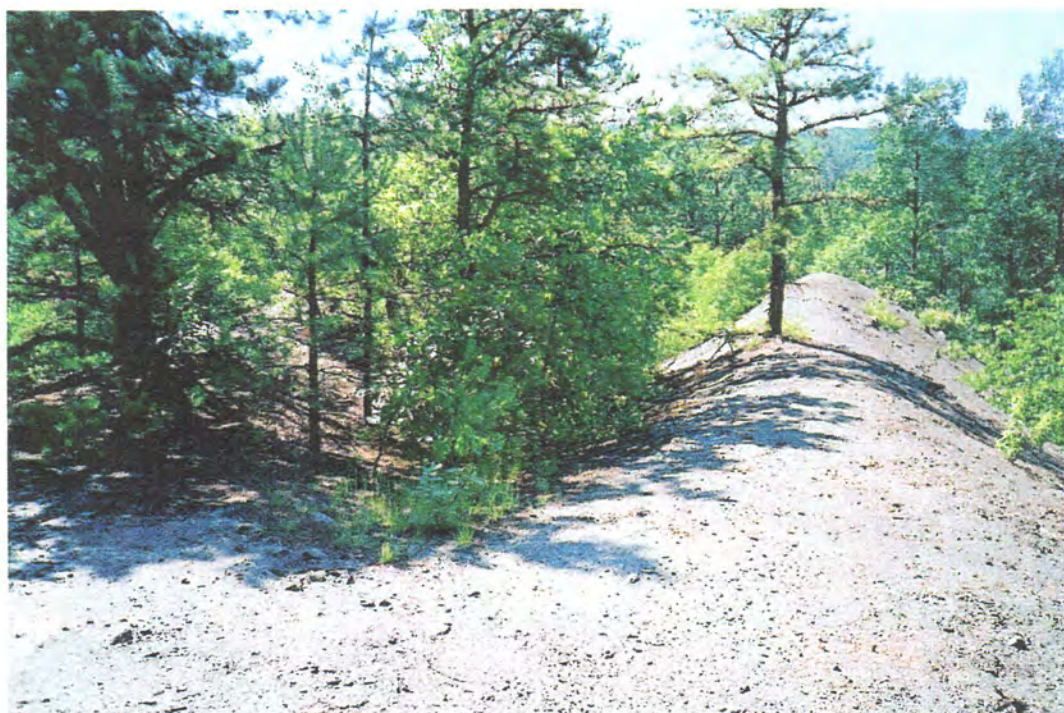
Figure A-42. Mining Refuse from Brookville Clay Deep Mine at D-39 Deep Mine Entry.

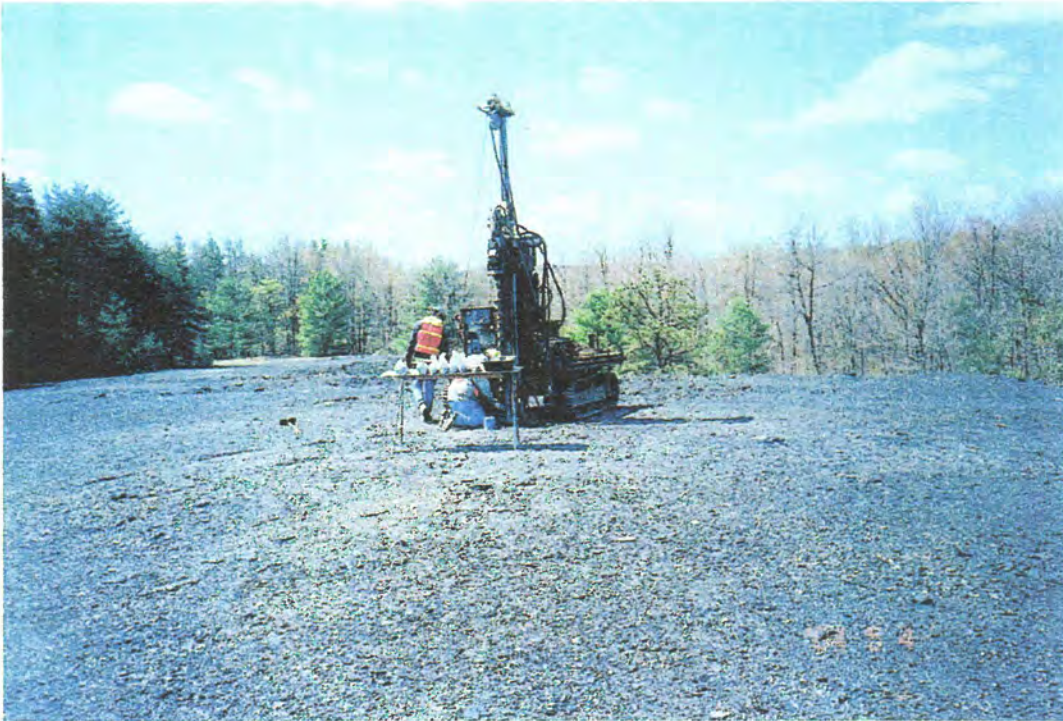
Figure A-43. Coal Refuse Bank RB-1 with Auger Drilling Equipment.

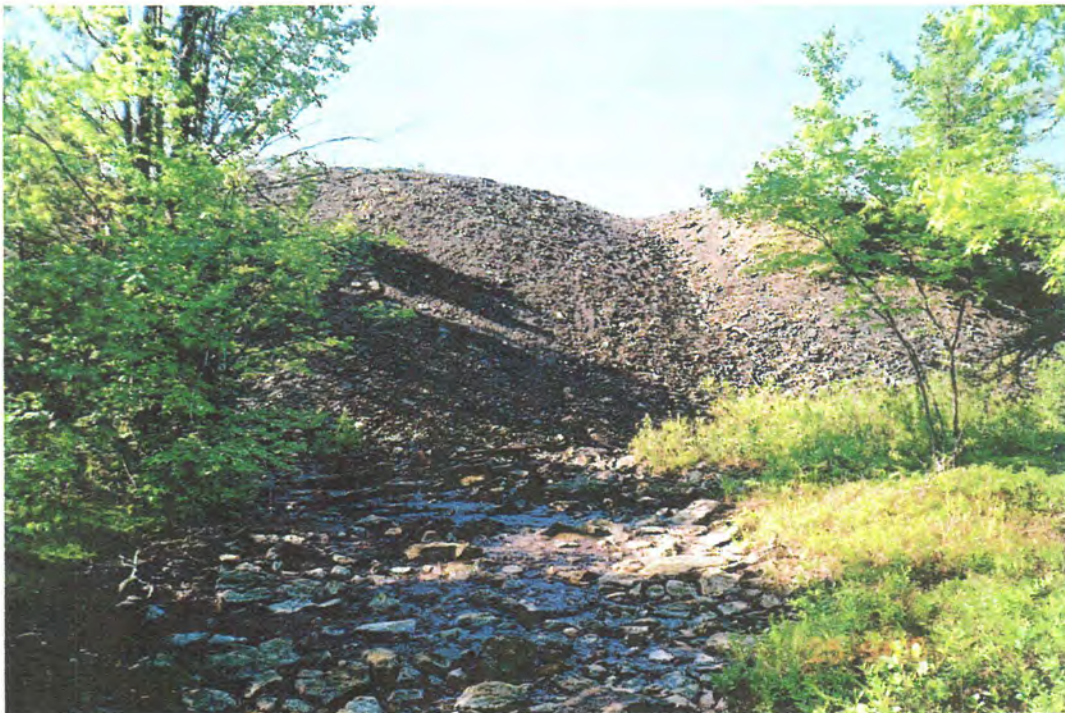
Figure A-44. Discharge CT07 from Coal Refuse Bank RB-1.

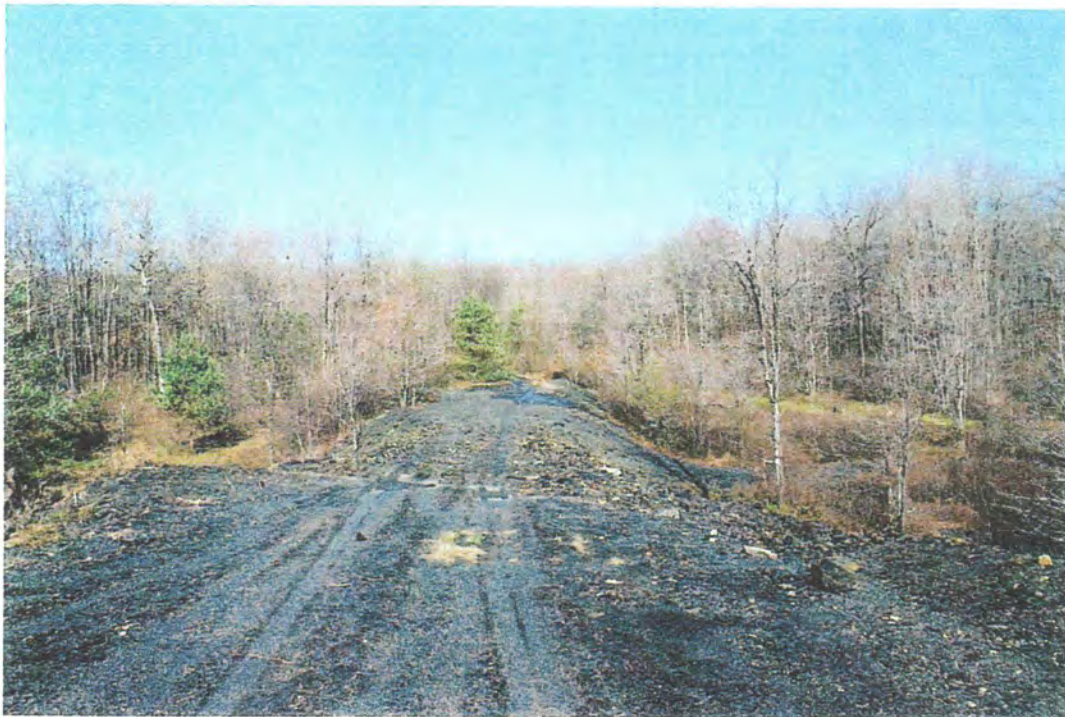
Refuse bank RB-2 is located directly to the south of coal refuse bank RB-1. The coal refuse forms a road fill deposited across the Contrary Run valley as shown in Figures A-46 and A-47. Two culverts were placed in the refuse fill to convey the Contrary Run flow through the bank.

Figure A-46. Coal Refuse Bank RB-2 in the Contrary Run Valley.

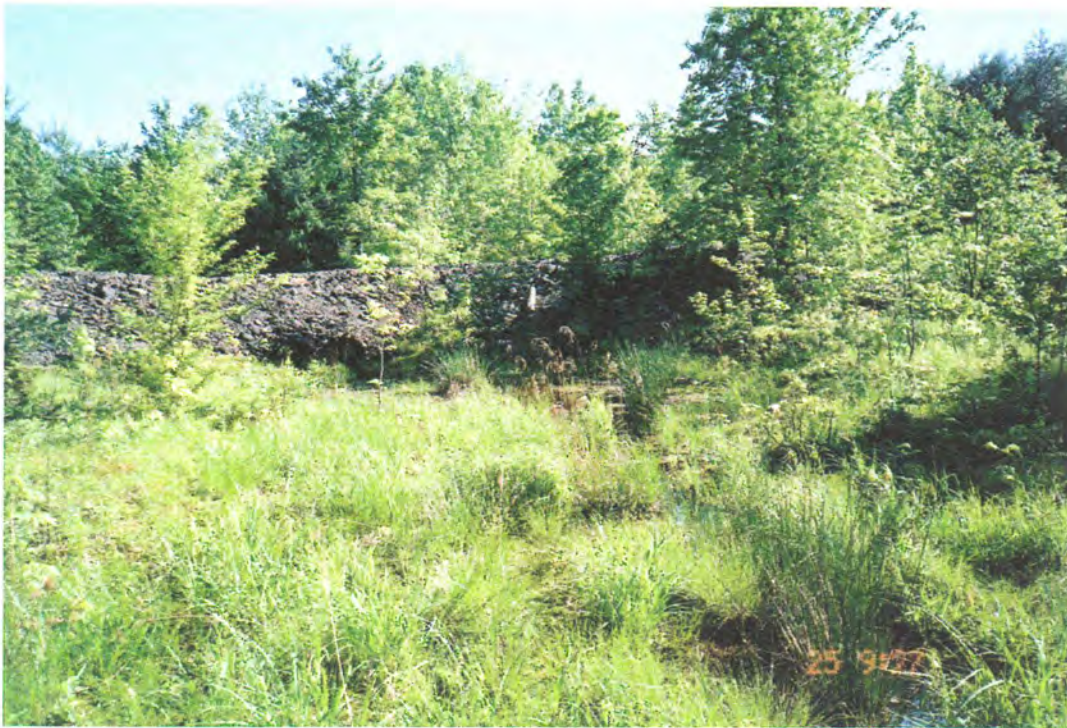
Figure A-47. Coal Refuse Bank RB-2 from the Contrary Run Valley.
