# AMD Assessment and Restoration Plan for the Potts Run Watershed, Jordan & Knox Townships, Clearfield County, Pennsylvania

Prepared by Trout Unlimited

December 2014

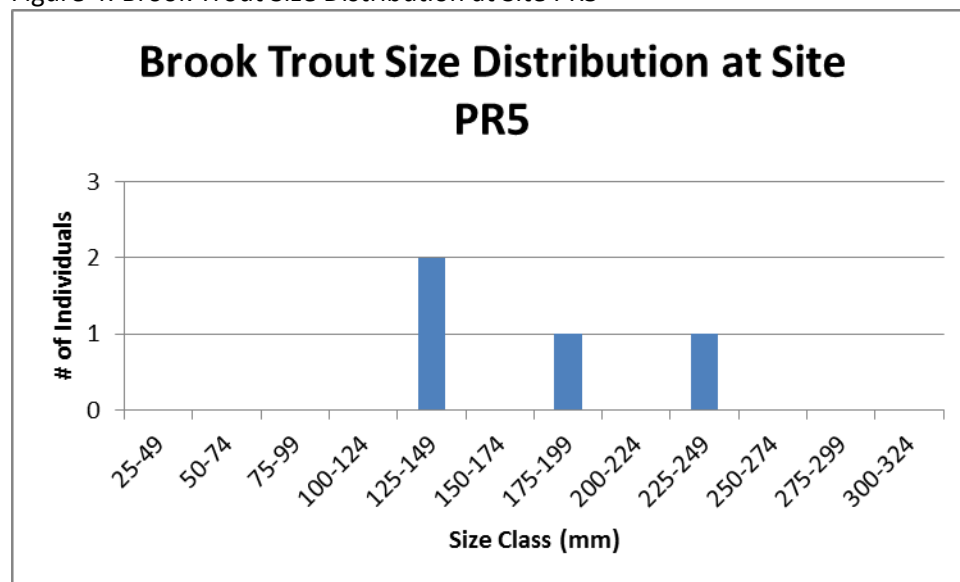
Figure 4: Brook Trout Size Distribution at Site PR5

Fishery surveys were completed at all six in-stream sampling locations during August of 2013 and 2014. The species and abundance of fish captured can be found in Table 8. Overall, the most abundant species was the creek chub (*Semotilus atromaculatus*) followed by the blacknose dace (*Rhynchichthys atratulus*). Brook trout were found at only one main stem location, PR5, during this study. The size distribution for the trout at this location can be found in Figure 4. However, it should be noted that during development

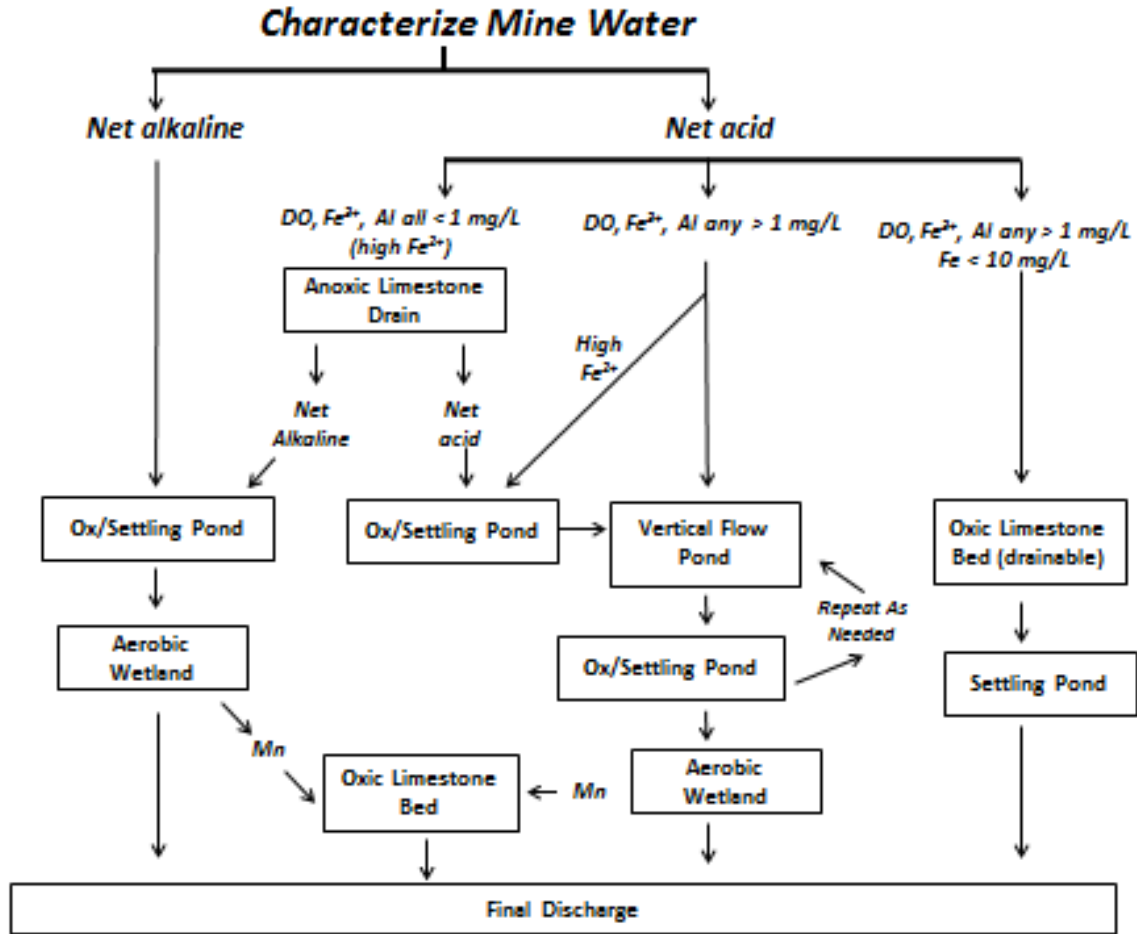
*Design flow chart used to select appropriate passive treatment technologies*
