SUSQUEHANNA RIVER  
BASIN COMMISSION

# West Branch Susquehanna River Subbasin Small Watershed Study: Morgan Run Watershed

*A Water Quality and Biological Assessment,  
November 2003 - September 2004*

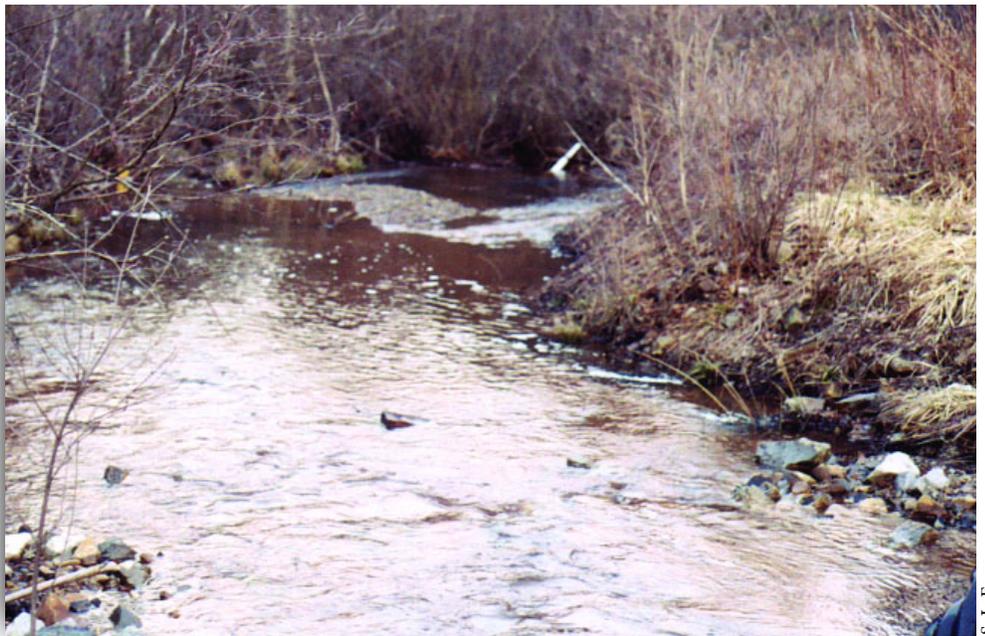
AMD Discharge to Morgan Run at Sanbourn Road

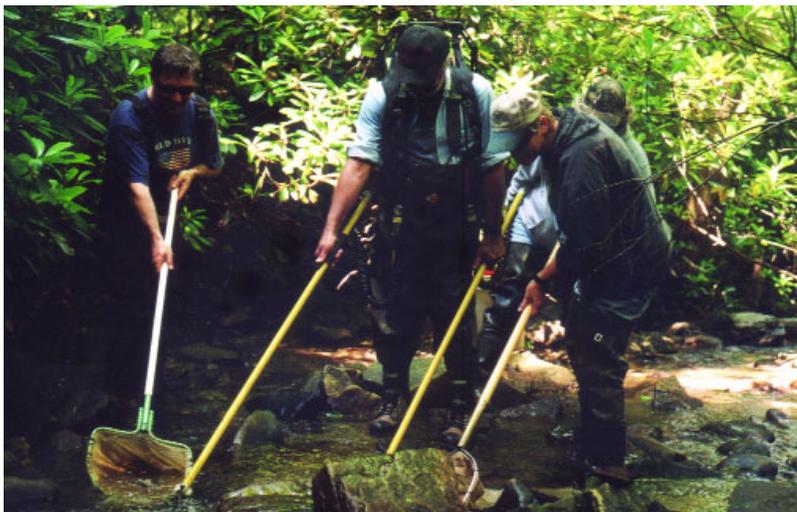
Electrofishing on Crooked Sewer Run.

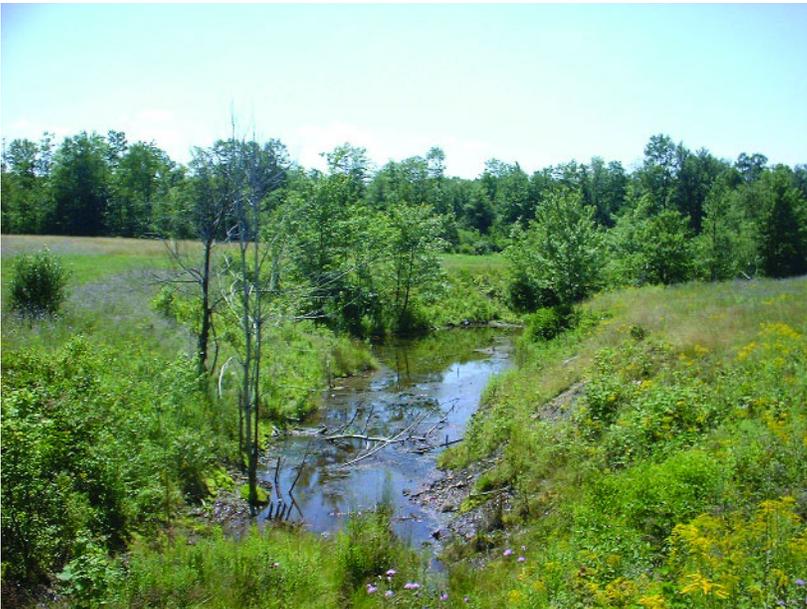
*Discharge (D6) located on Ross Creek*
