6th West Branch Susquehanna Restoration Symposium

Lancashire #15 AMD Treatment Plant and Glasgow AMD Treatment System Tour

Cambria County, Pennsylvania

PASSIVE TREATMENT AT THE C&K GLASGOW SITE

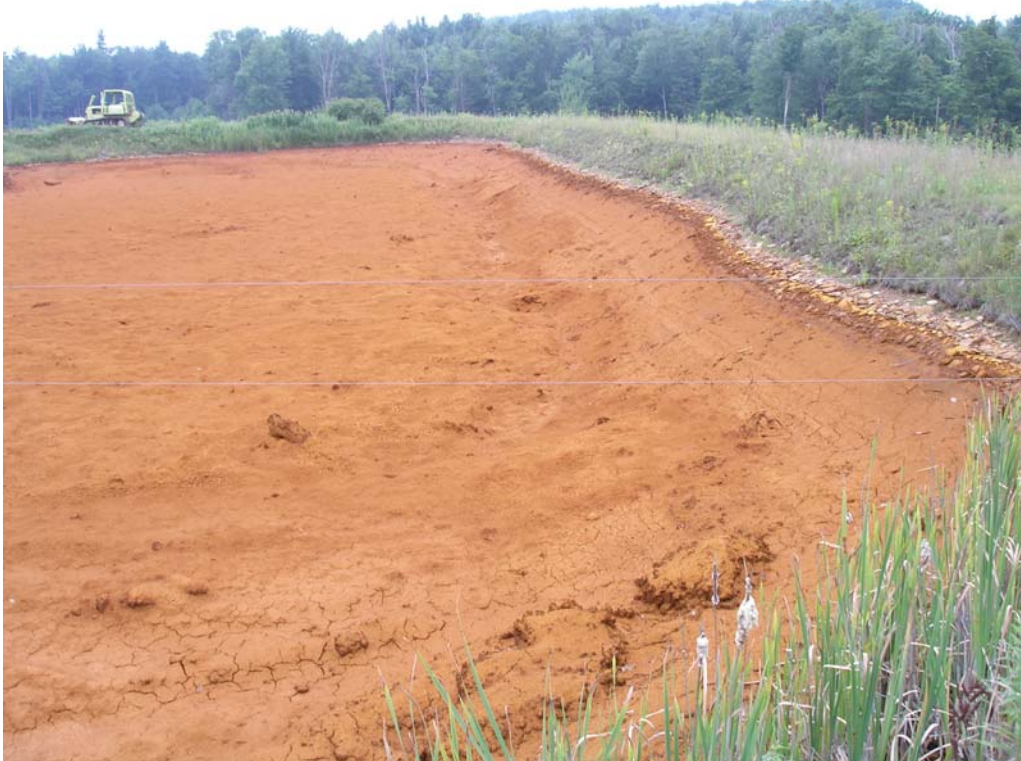
Figure 2. Iron accumulation on bottom of VFP1 after draining for rebuilding. But the pond was flowing through this without overflow.

The C&K Glasgow passive treatment system was constructed by C&K Coal Co in 1998 to treat highly acid and metal-rich water emerging from the toe of a large area of surface mining adjacent to Muddy Run just east of PA 253. The discharge in 2005-08 flowed at 40-200 gpm with pH 3.3-3.8, acidity 600-900 mg/L, Fe 150 mg/L, Mn 150-200 mg/L, and Al 40-60 mg/L. After C&K bankruptcy in 2004, members of the Clearfield Creek Watershed Association flushed the system and evaluated treatment. VFP 1 (see Figure 1) continued to treat moderately well, but VFP 2 was largely plugged and overflowing and the limestone bed for Mn treatment was only partly treating because of Fe and Al influx, with significant acidity and metals at the outflow. A parallel active treatment system using caustic had been built by C&K to treat higher flows. In the passive system, an “autopsy” under a TAG grant in 2005 showed that accumulation of Fe and Al precipitate on top of the limestone in both VFP’s was largely responsible for the problems (Figure 2). Thin and degraded compost, and coating of some limestone was also noted.
