III. Problem Identification

Overview

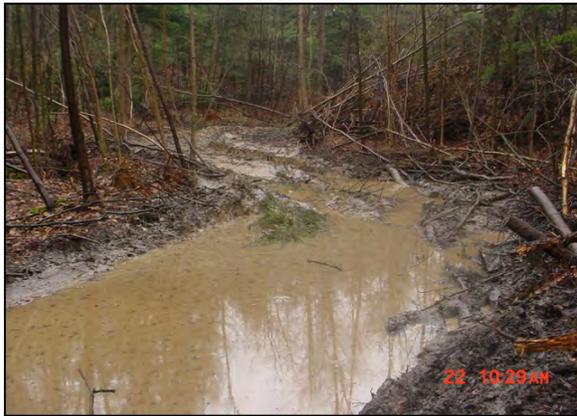
Improperly constructed logging road with poor drainage allows water to collect and sediment to enter the nearby stream.

Techniques that prevent water from flowing long distances down steep slopes, such as following the natural contour of the land and the frequent use of road cross drains, such as water bars, dips, or culverts, can limit erosion problems. Such areas should be drained to undisturbed areas and never directly to a stream. Disturbance within the streamside habitat should be limited or excluded. These methods help prevent silt from reaching the stream and impairing aquatic habitat.

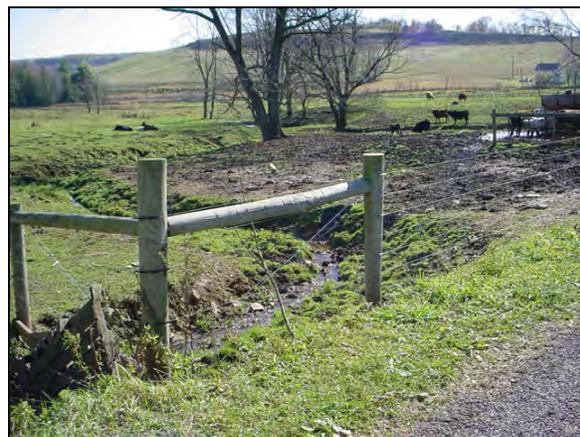
Unlimited cattle access to streams can cause sedimentation, erosion, and nutrient pollution.

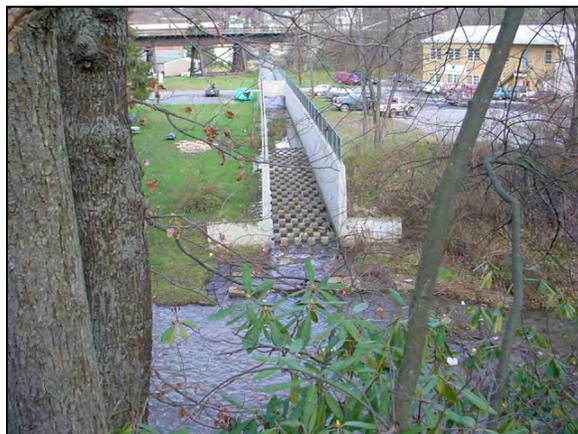
Tanners Run, a tributary to Anderson Creek, is enclosed in a concrete channel in Curwensville.

Some stream segments of tributaries within Curwensville have been channelized with hard structures (concrete channels) for flood control because homes and businesses within the town have been built within the floodplain. Although the structures control water during periods of high flow, they are detrimental to natural stream conditions and functions. However, it is unlikely the concrete-lined stream segments will be returned to anything resembling natural conditions. Therefore, for this assessment, the areas are just noted as impacted.

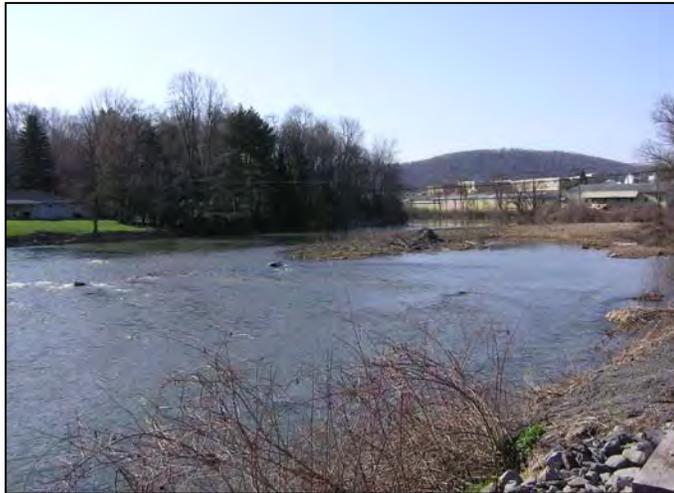
Gravel bar, which has formed in the West Branch of the Susquehanna River at the mouth of Anderson Creek, is causing erosion along the streambank in the background.

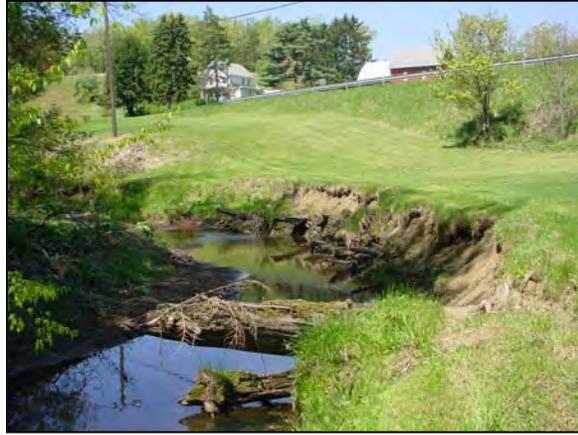
Erosion of streambank due to stream encroachment and poor streamside vegetation

Closely related to stormwater flow is streambank stabilization. When stormwater is released to a stream too quickly, which usually occurs because of an inability of rainwater to soak slowly into the ground, the natural balance of the stream can be quickly upset and its ability to dissipate the energy created within the water during high flows is overwhelmed.

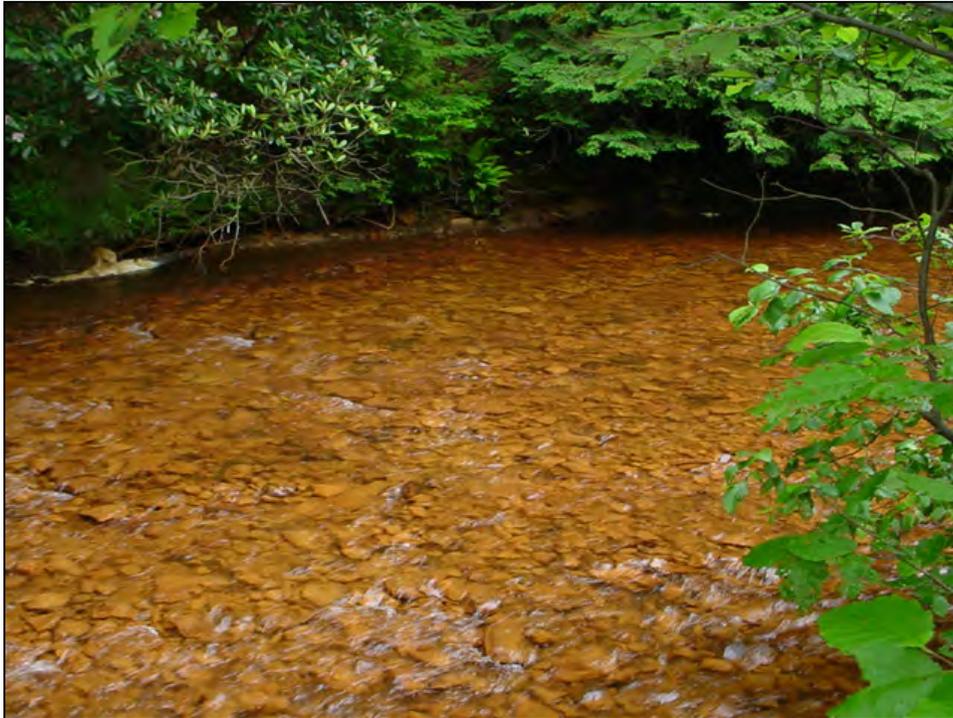
Iron from AMD pollution sources deposited on the streambed of Little Anderson Creek.

from AMD and will impart a white cast to the water or the rocks that it contacts. Approaching pH 6, iron begins to precipitate and will color the water or stain the streambed orange. This orange color is usually associated with AMD-impaired streams.
