# **Shimel Run Mine Drainage Assessment and Restoration Plan**

**Prepared for the Moshannon Creek Watershed Coalition  
by NMBS**

**June 30, 2008**

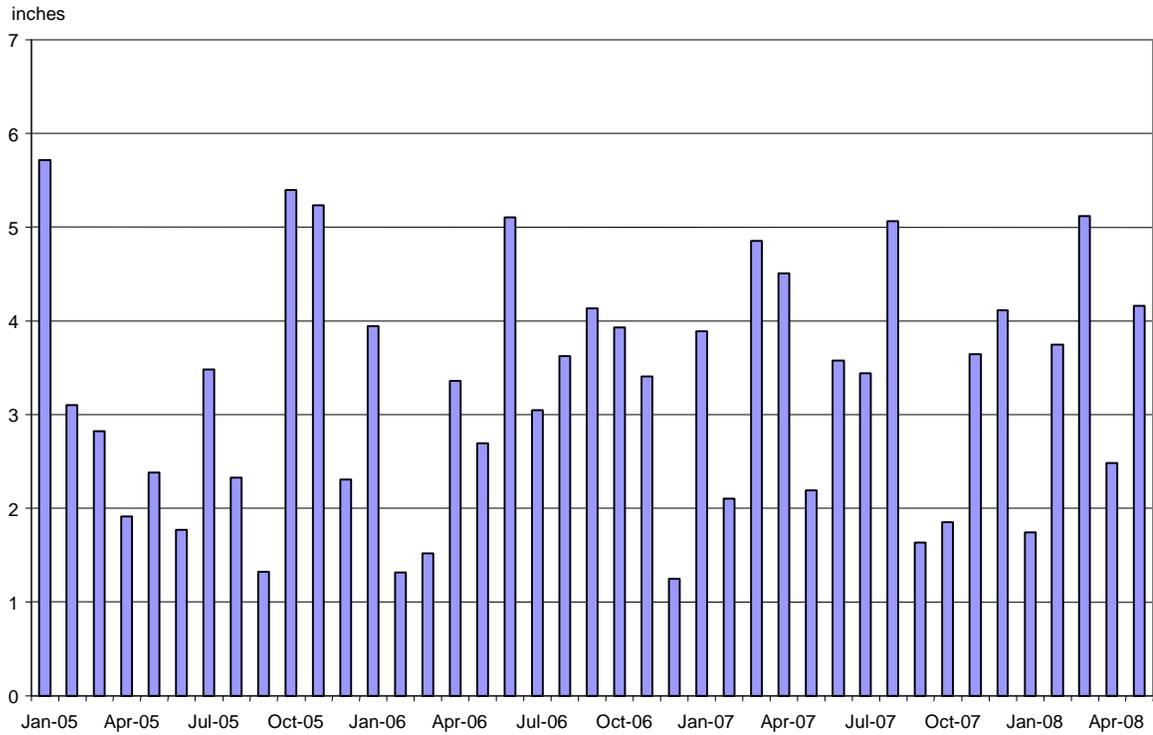
Rainfall during assessment period

The figures below represent rainfall and snowfall from January 2005 through the sampling period and ending in May 2008. By reviewing the precipitation data, it allows us to determine if “normal” conditions exist during the assessment period.

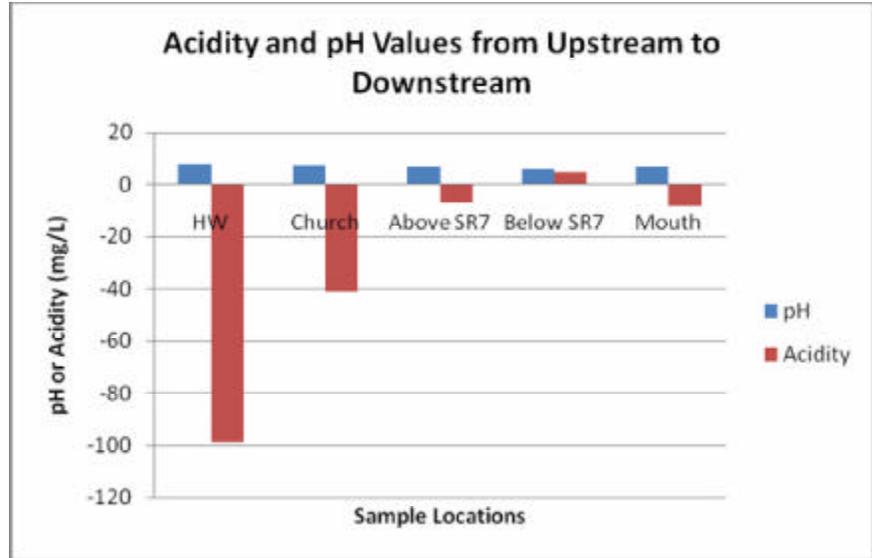
This graph represents the trend of acidity and pH from the headwaters to the mouth of Shimel Run. Alkalinity and acidity trends throughout are affected by mine discharges, while pH remains fairly consistent in the stream channel. In the headwaters of Shimel Run, the pH averages above 7.0 while alkalinity is almost 100 mg/L. The impacts of the Miller-Stein operation can be seen at the “church” sampling location, but still alkalinity is greater than acidity. The largest

adverse impact to the stream is from the deep mine discharge, SR-7, and can be seen at the below SR-7 stream sampling location, where pH decreases and acidity of 5 mg/L, though still not severe, does adversely affect the fish population in the spring when the mine flushes higher levels of acidity. By the time Shimel Run reaches the mouth, it recovers and is alkaline again.

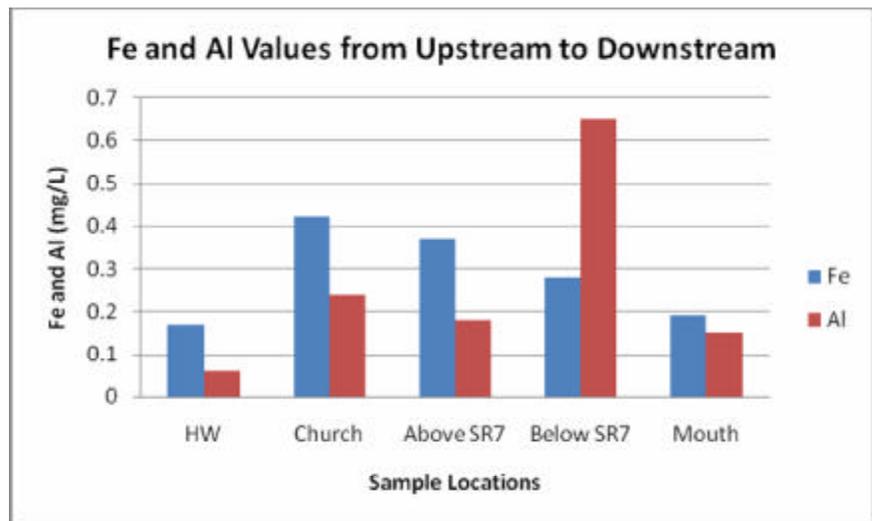
This graph represents the changing quality of iron and aluminum from the headwaters to the mouth of Shimel Run. The metal concentrations maintain extremely low levels, below 1.0 mg/L on average throughout the watershed. Similar to the acidity concentrations, an increase in aluminum is seen in the sample collected below the SR-7 deep mine discharge.

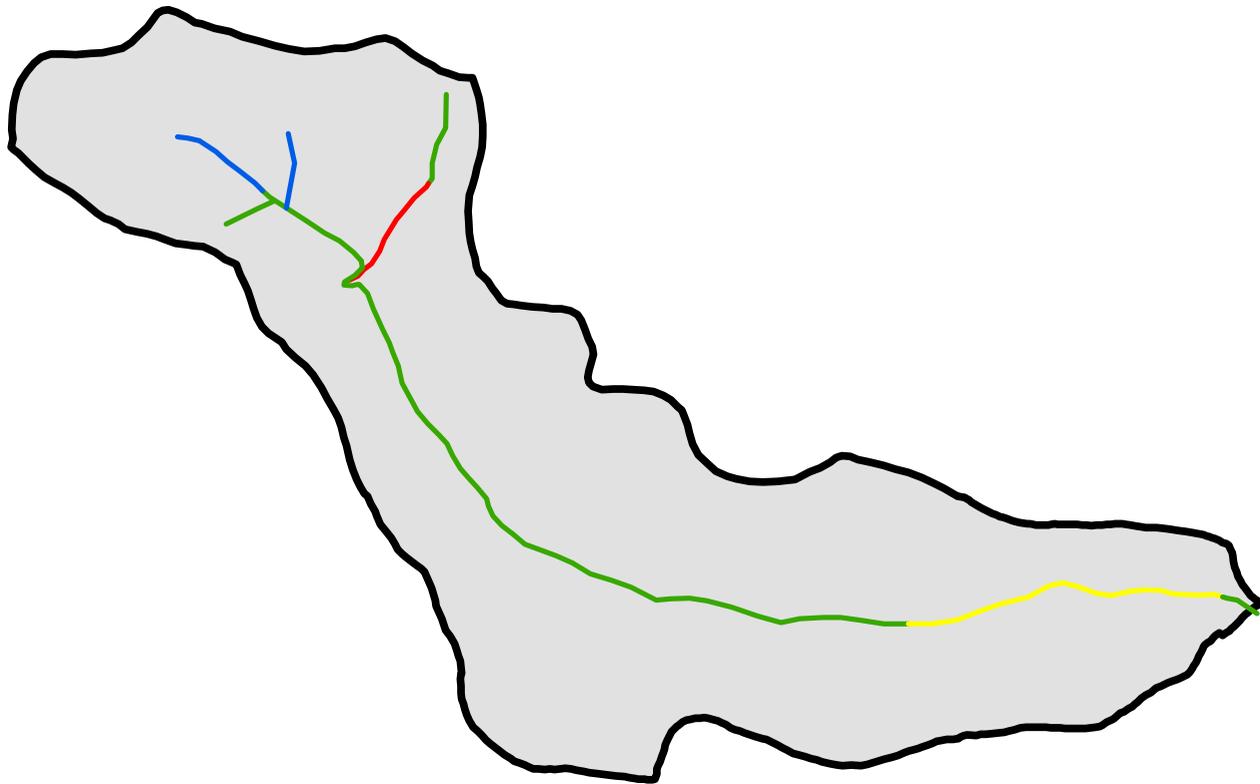
# Shimel Run - Stream Quality

*Highly degraded*
-

*Moderately degraded*
-

*Slightly degraded*
-

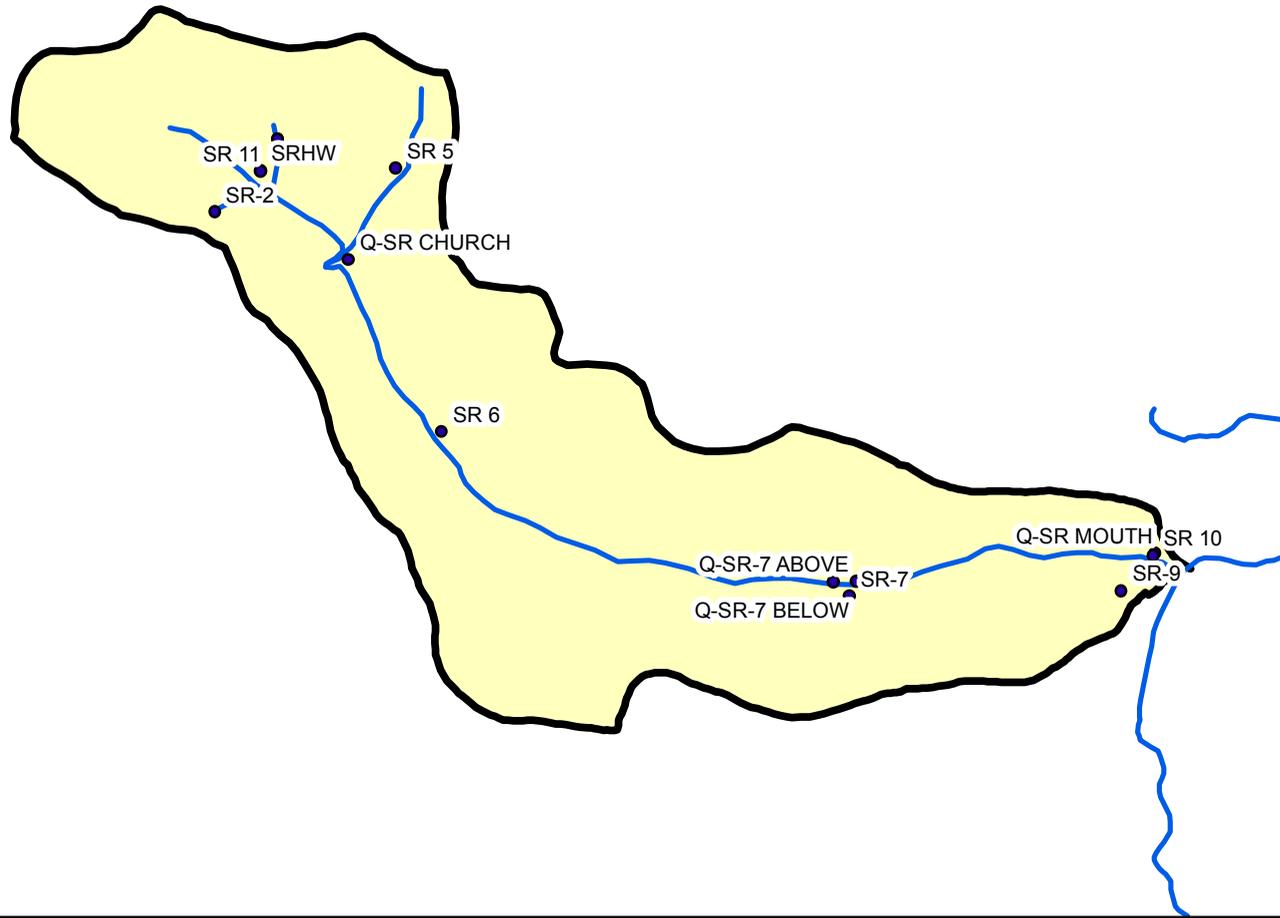
# Shimel Run - Sampling

Location of sampling points in watershed

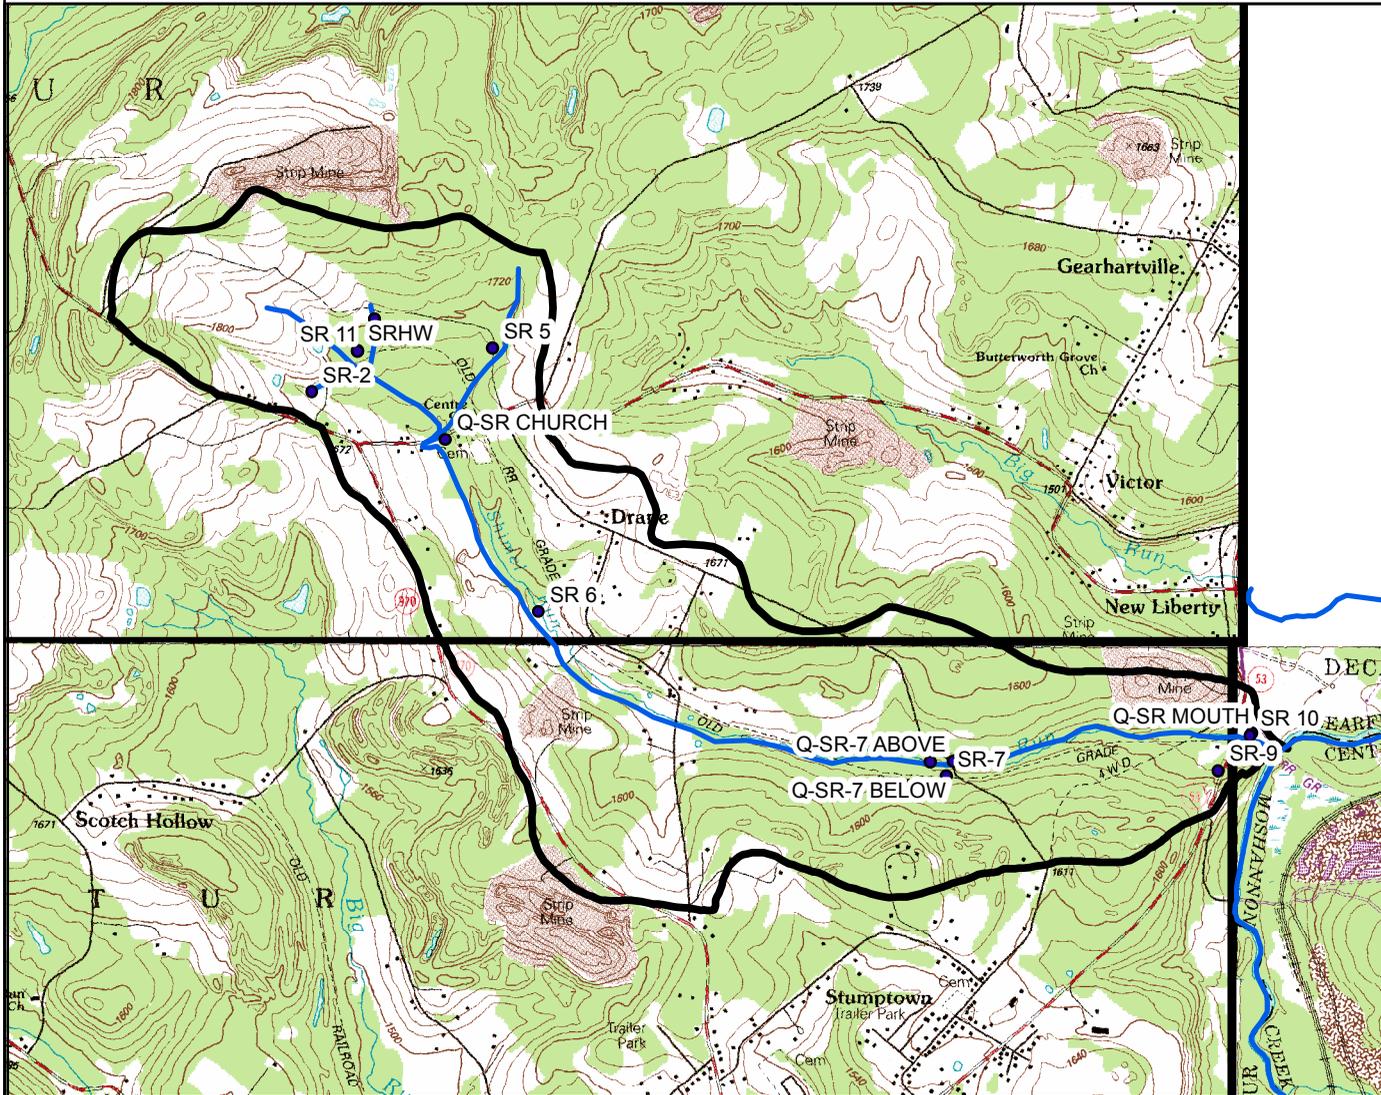
# Shimel Run - Sampling on Topo

Location of sampling points in watershed

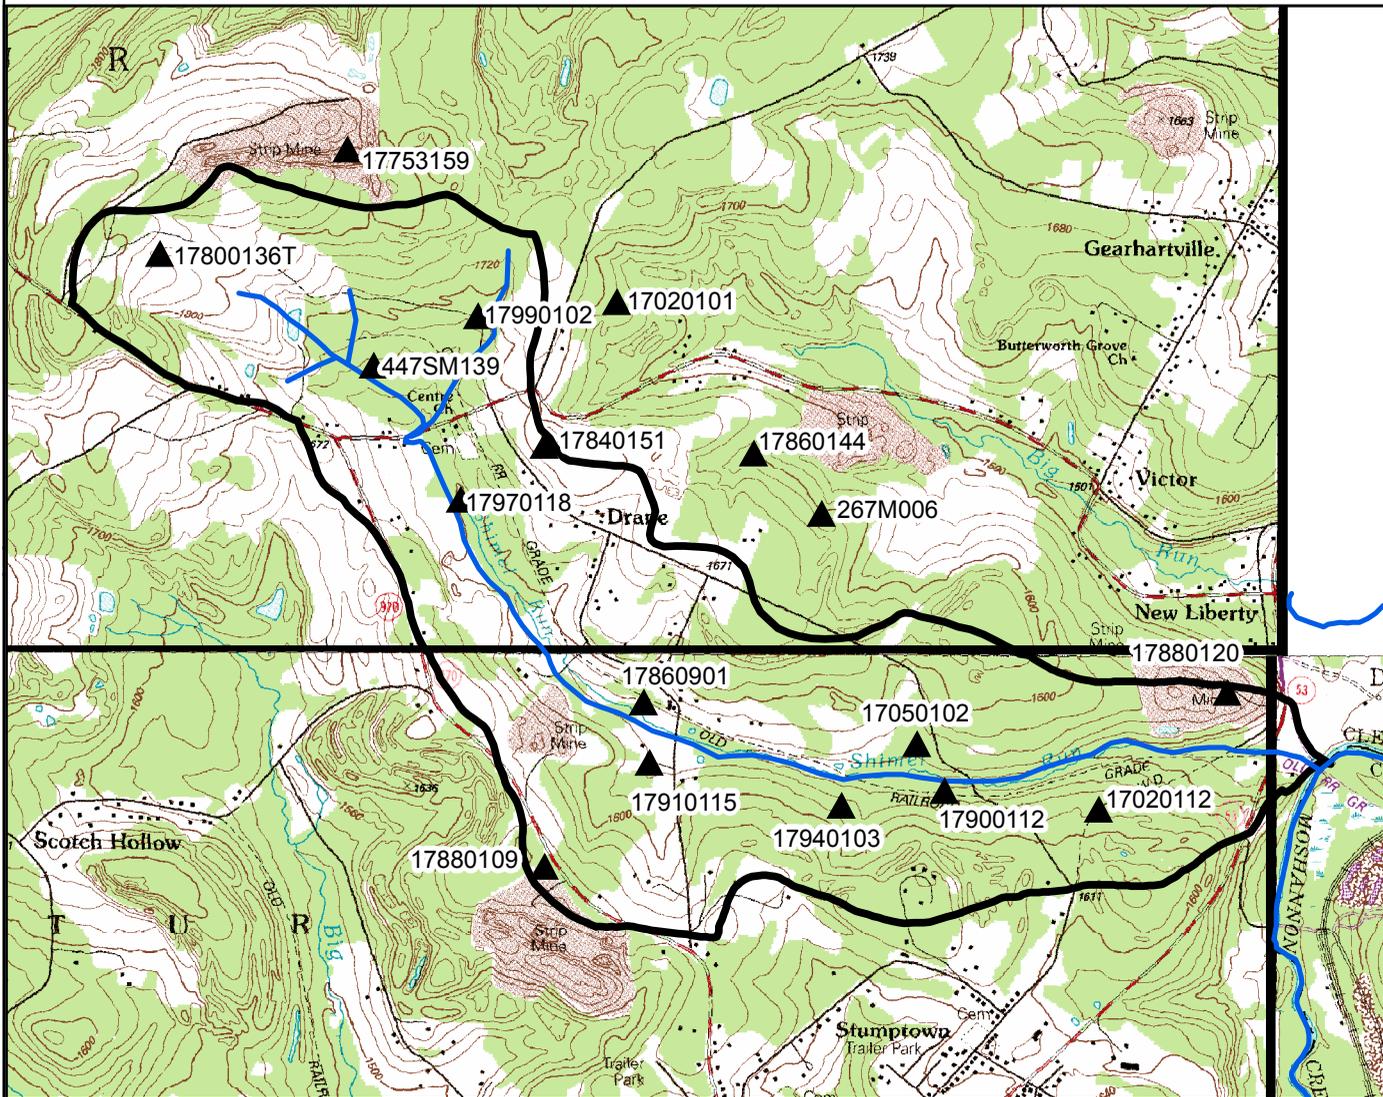
# Shimel Run - Historical Permits

Location of historical sampling points in watershed

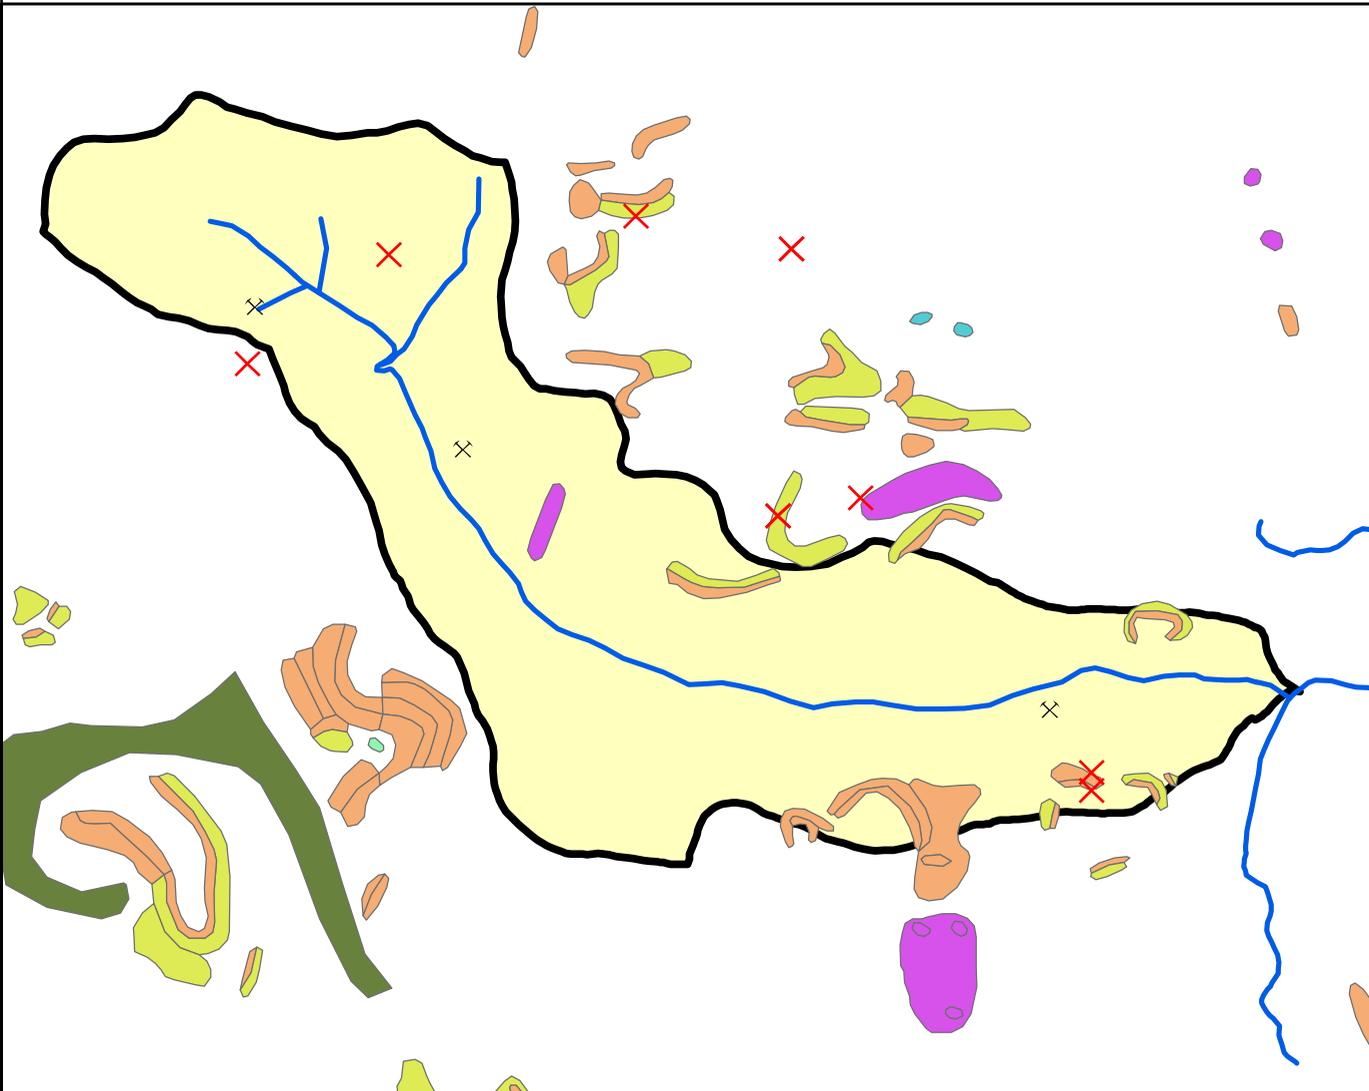
# Shimel Run - Mining Activity

AML data from BAMR AML list

See maps A-7 and A-8 for mapping of the mining activities. These historical mining permits were researched for water quality to include in the database and are discussed below. The historical water quality which was analyzed can be found on the project CD or on the [newmilesOfBluestream.com](http://newmilesOfBluestream.com) website.

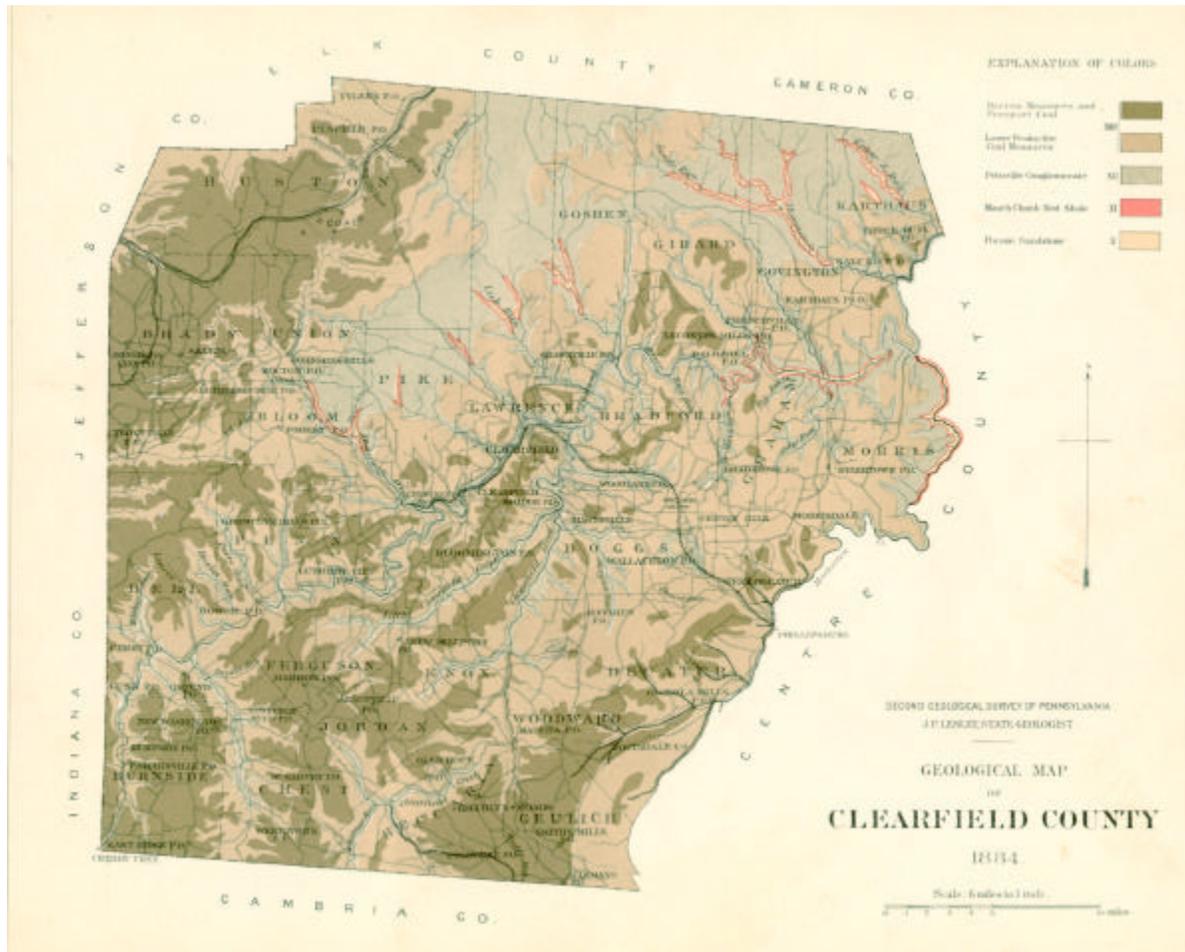
## Clearfield County Geology

A-12	Clearfield County Geology	This displays a map made in 1884 which displays the geology determined at the time.
A-13	Treatment Areas	This displays the location of recommended treatment areas.

The description of the Geology of Clearfield County can be found at the Penn State University libraries and a map can be found on page A-12. Additionally, a (more current) geological map based upon data from DCNR (which originated with the Bureau of Topographic and Geologic Survey) appears on page A-11. Additional information can be found in the Geologic Surveys for the Houtzdale and Wallacetown Quadrangles. Clearfield County encompasses 1130 square miles. Based on geologic maps of the area surrounding Shimel Run, it lies almost entirely in the Allegheny High Plateaus of the Appalachian physiographic province west of the coastal plain physiographic province. This area is northwest of the Allegheny Front. The Houtzdale-Snowshoe syncline runs through this area. The stratigraphy in the study area consists predominantly of Mississippian and Pennsylvanian aged rock. In addition, thin local deposits of unconsolidated recent alluvium may be found along Shimel Run. Other than coals, the lithostratigraphy consists of heterogeneous succession of flat-lying beds of sandstones, siltstones, claystones, minor limestones, shales and other lithologies representing gradations between these various types. Some of the coals appear as major seams, while others appear as rider seams or as splits.
