Twomile Run Watershed AMD Remediation Master Plan

February 2007

**Developed for Trout Unlimited
and the Kettle Creek Watershed Association**

by Hedin Environmental

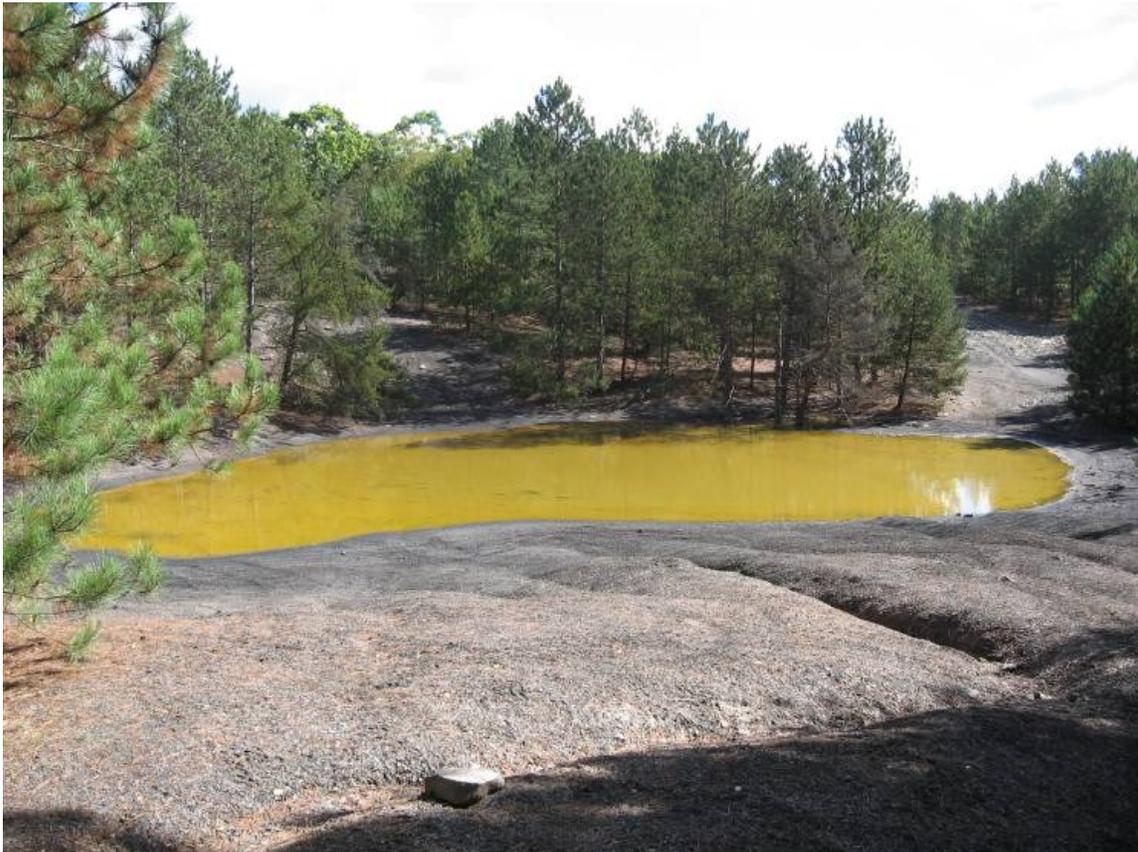
Closed depression in unreclaimed spoil in Area 5N
